It Jumps Out of Gear!

by Tom Endy

The Model A Ford Transmission:

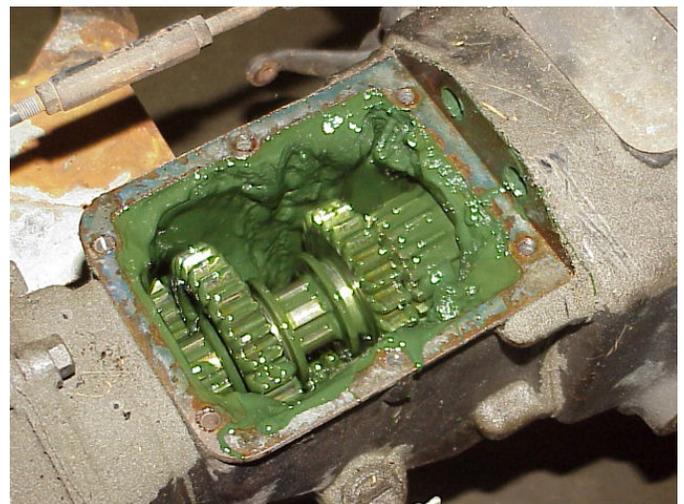
Not exactly 600W
