Transmission Overhaul Pictorial August 2018

by Tom Endy

The Model A transmission is not difficult to overhaul. It can be done with simple hand tools. However you do need a shop press to remove and install the front and rear ball bearings. There are some areas that can cause grief unless you are aware of some subtle differences in the evolution of the design. In addition, there are also some parts that can easily be installed incorrectly.

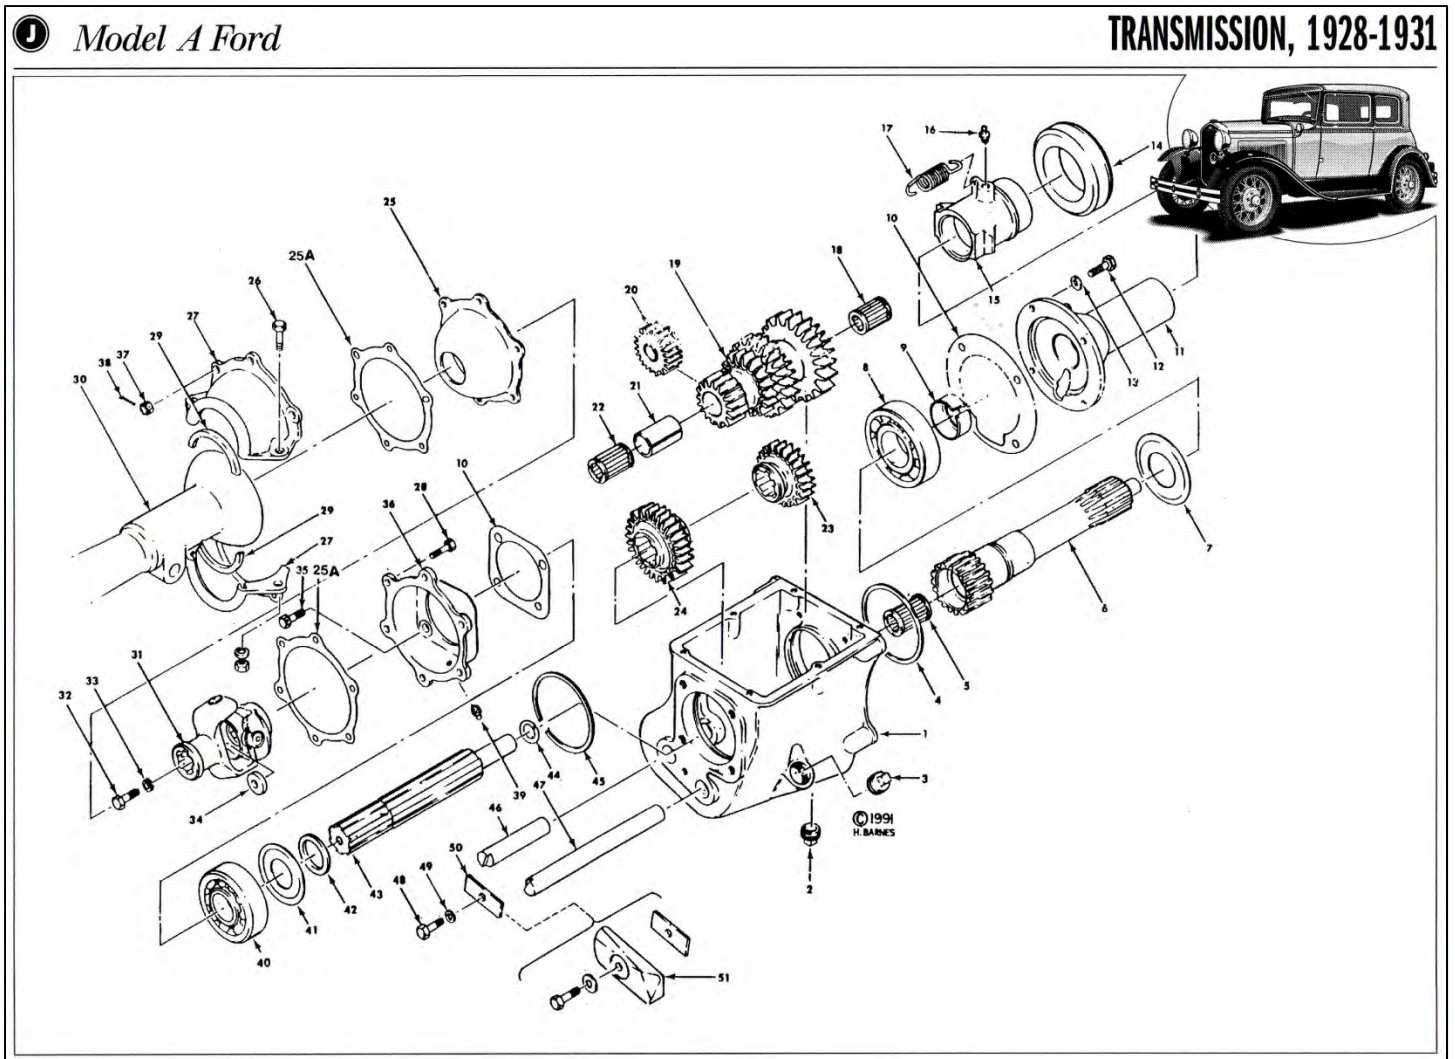
The drawing shown above was done by the late Howard Barnes. Years ago he granted the Victoria Association permission to use this drawing. The drawing depicts a later transmission that uses snap rings in each end of the housing to retain the two ball bearings. The later transmissions also did not have bronze thrust washers at each end of the cluster gear. The later transmission also uses a replaceable front spacer on the main shaft. More important the later transmissions used oil baffles that are slightly larger in diameter. This is an area of grief; if you install the later oil baffles in an early transmission you will jam it up. Suppliers only sell the later oil baffles, so beware.

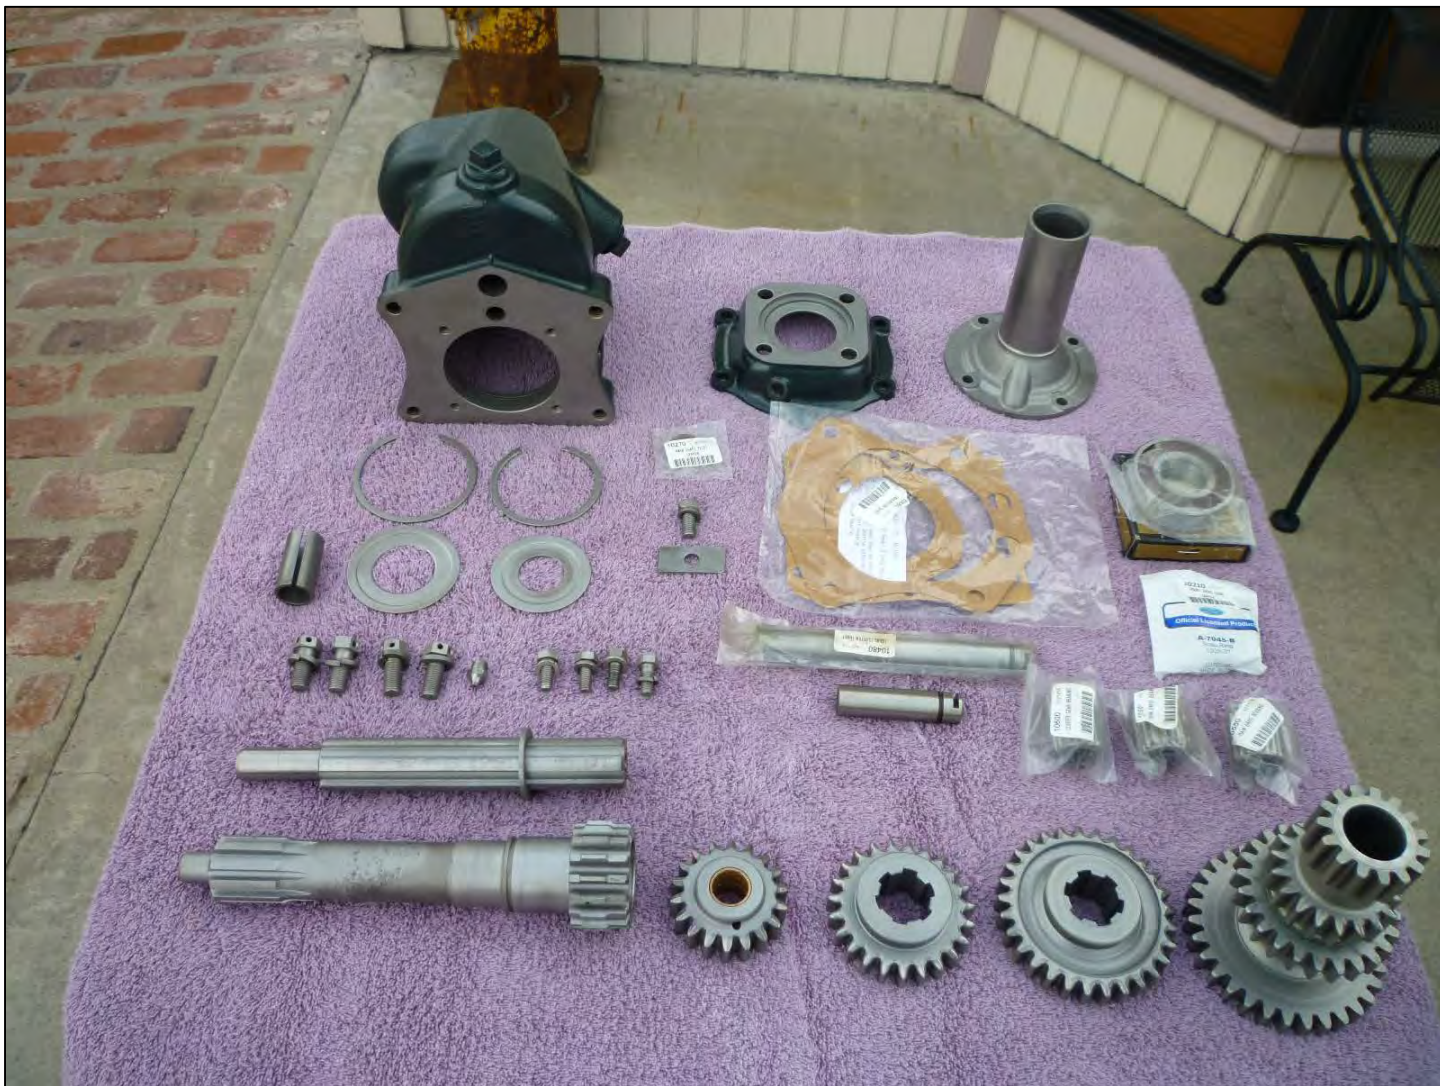
Shown here is a complete later transmission ready for assembly including the new parts that I consider 100% replaceable.

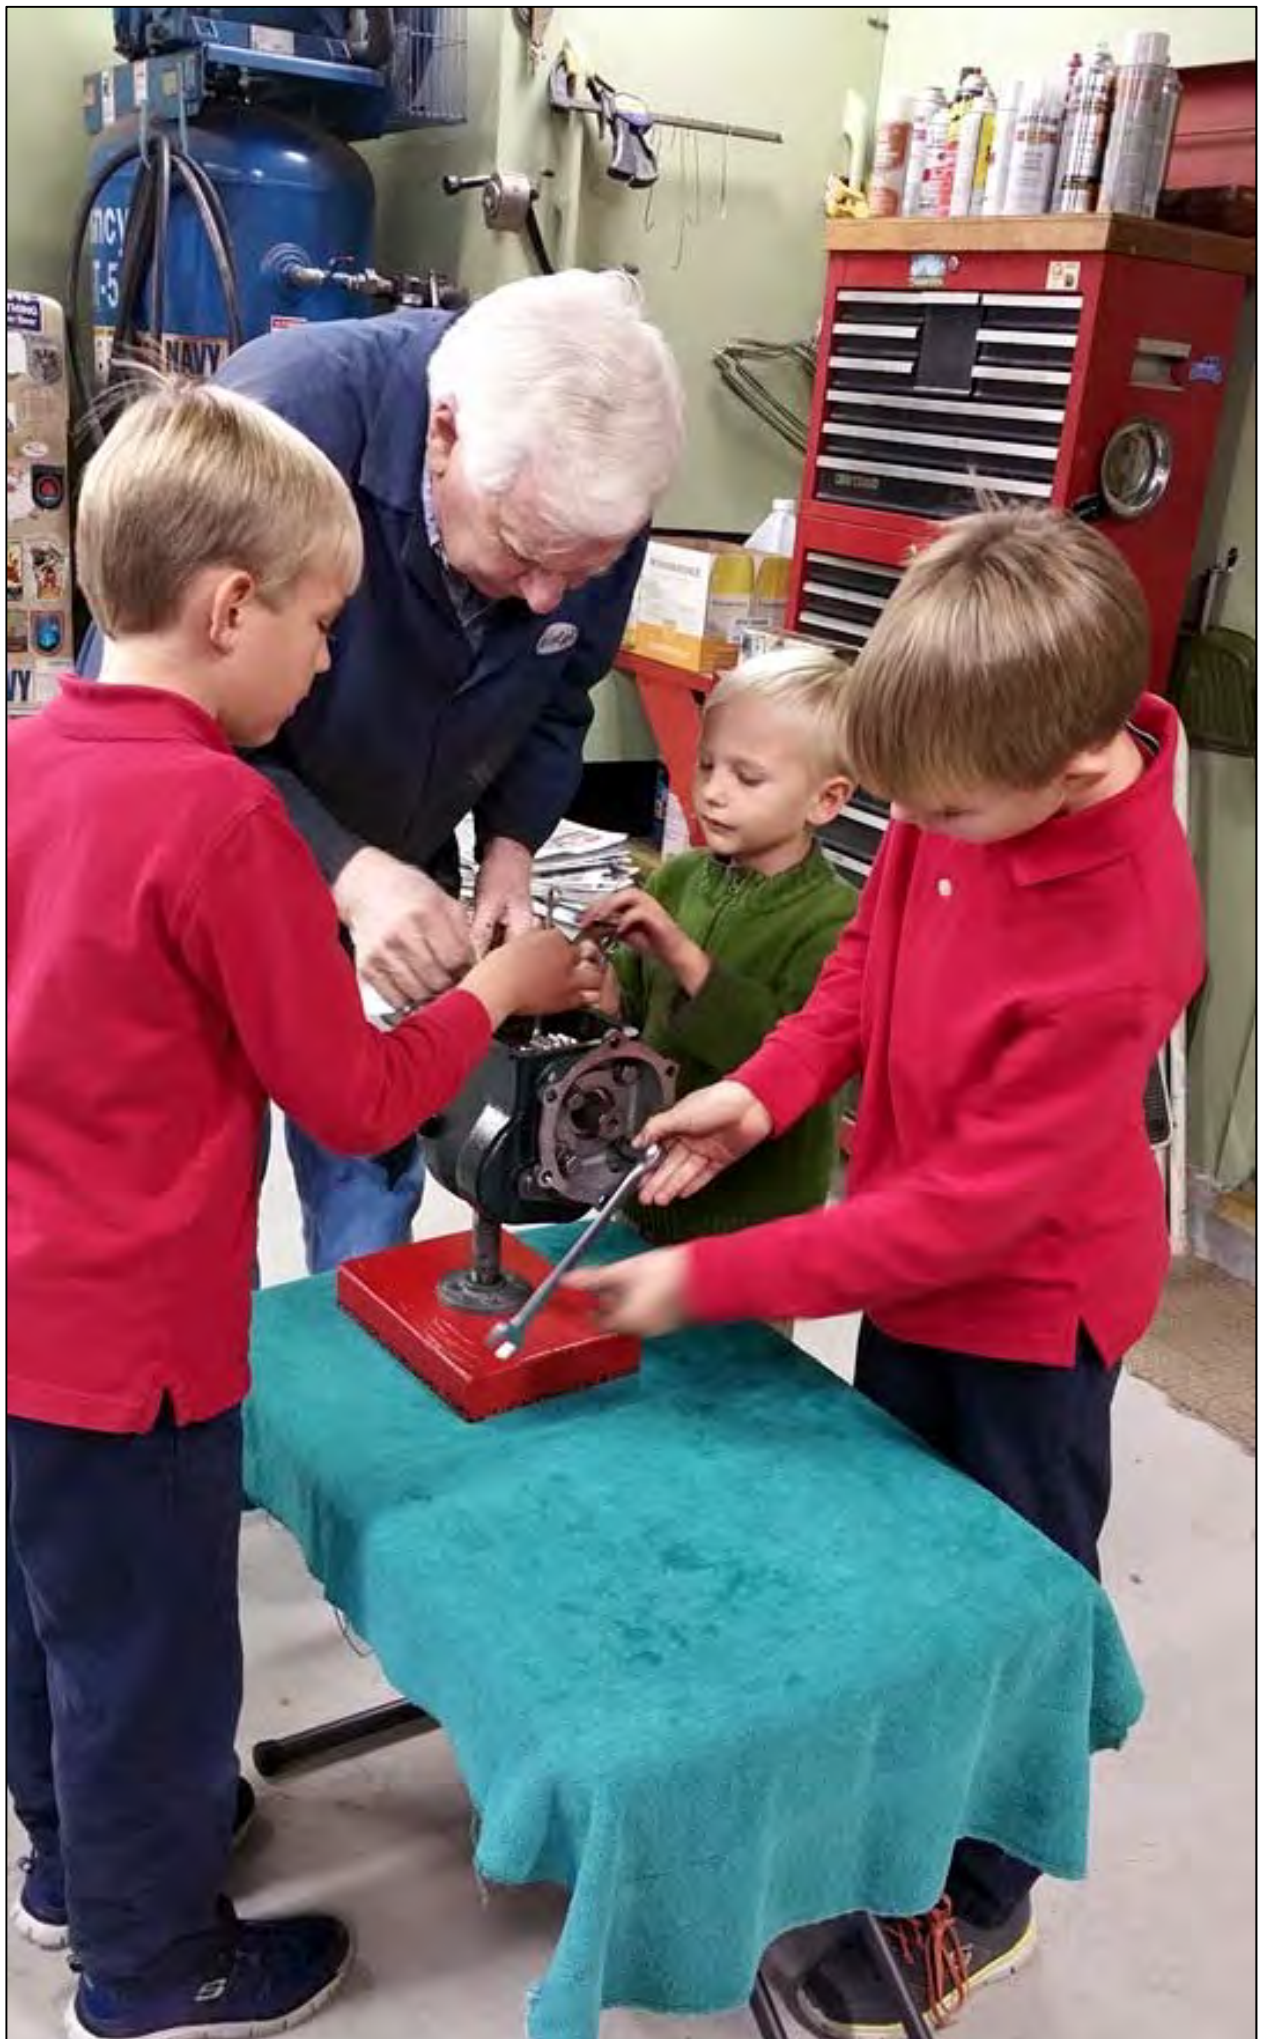
Shown here is the evolution of the transmission housing. On the left is a very early housing that used a large idler gear assembly as can be seen by the large hole on the lower left. The housing also has solid bearing stops integral to the housing.

In the center is a mid-early housing that has solid bearing stops integral to the housing.

On the right is a later housing that uses snap rings in the housing for bearing stops.

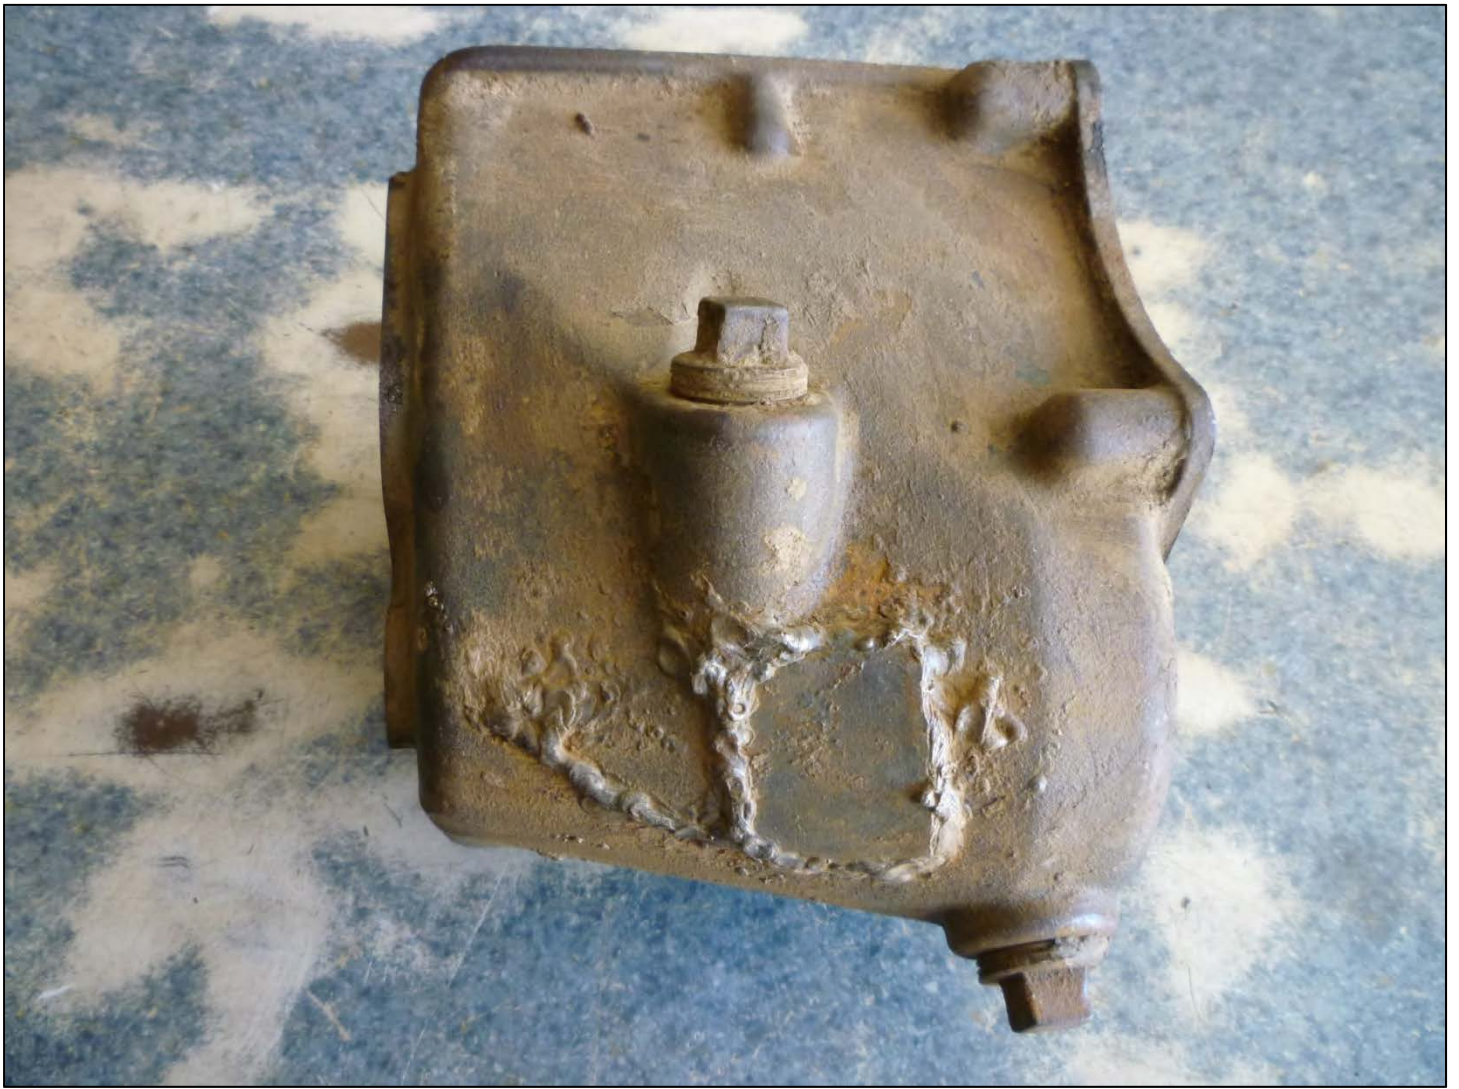
Shown here is a repair to a transmission housing that was done years ago during a time when things were repaired instead of replaced.

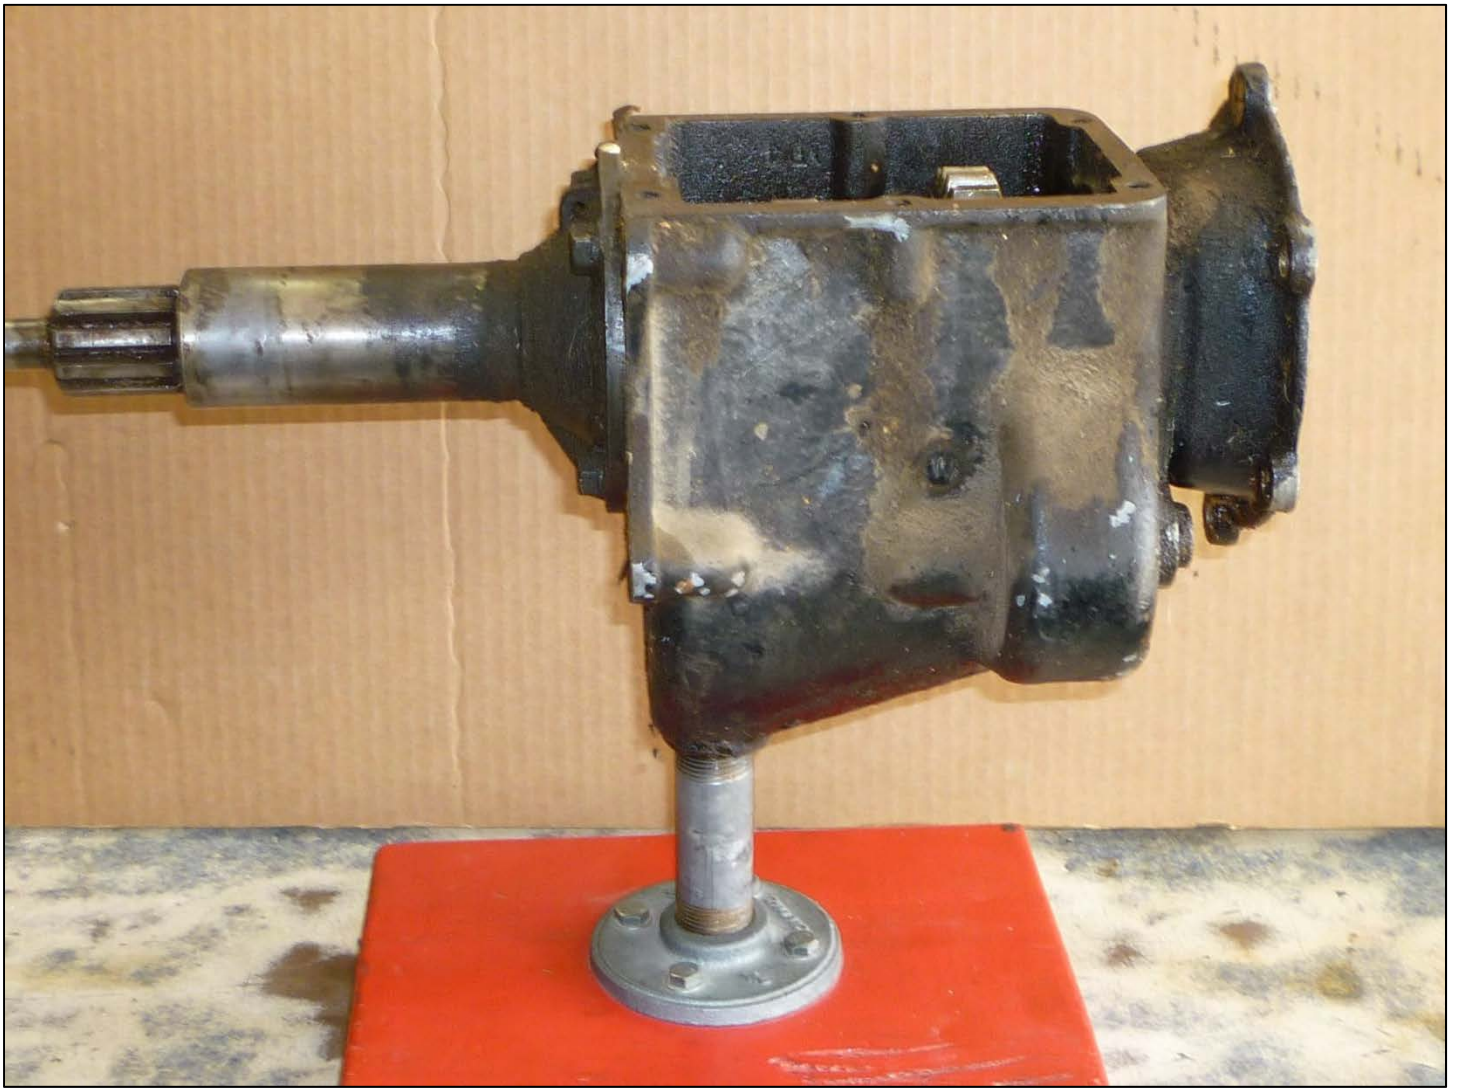
The transmission pictorial overhaul starts with this photo and will continue until the completion of the project.

This transmission has come into the shop for overhaul. The customer complaint was: “profusely leaking oil”.

This is what they normally look like when removed from a car, extremely cruddy.

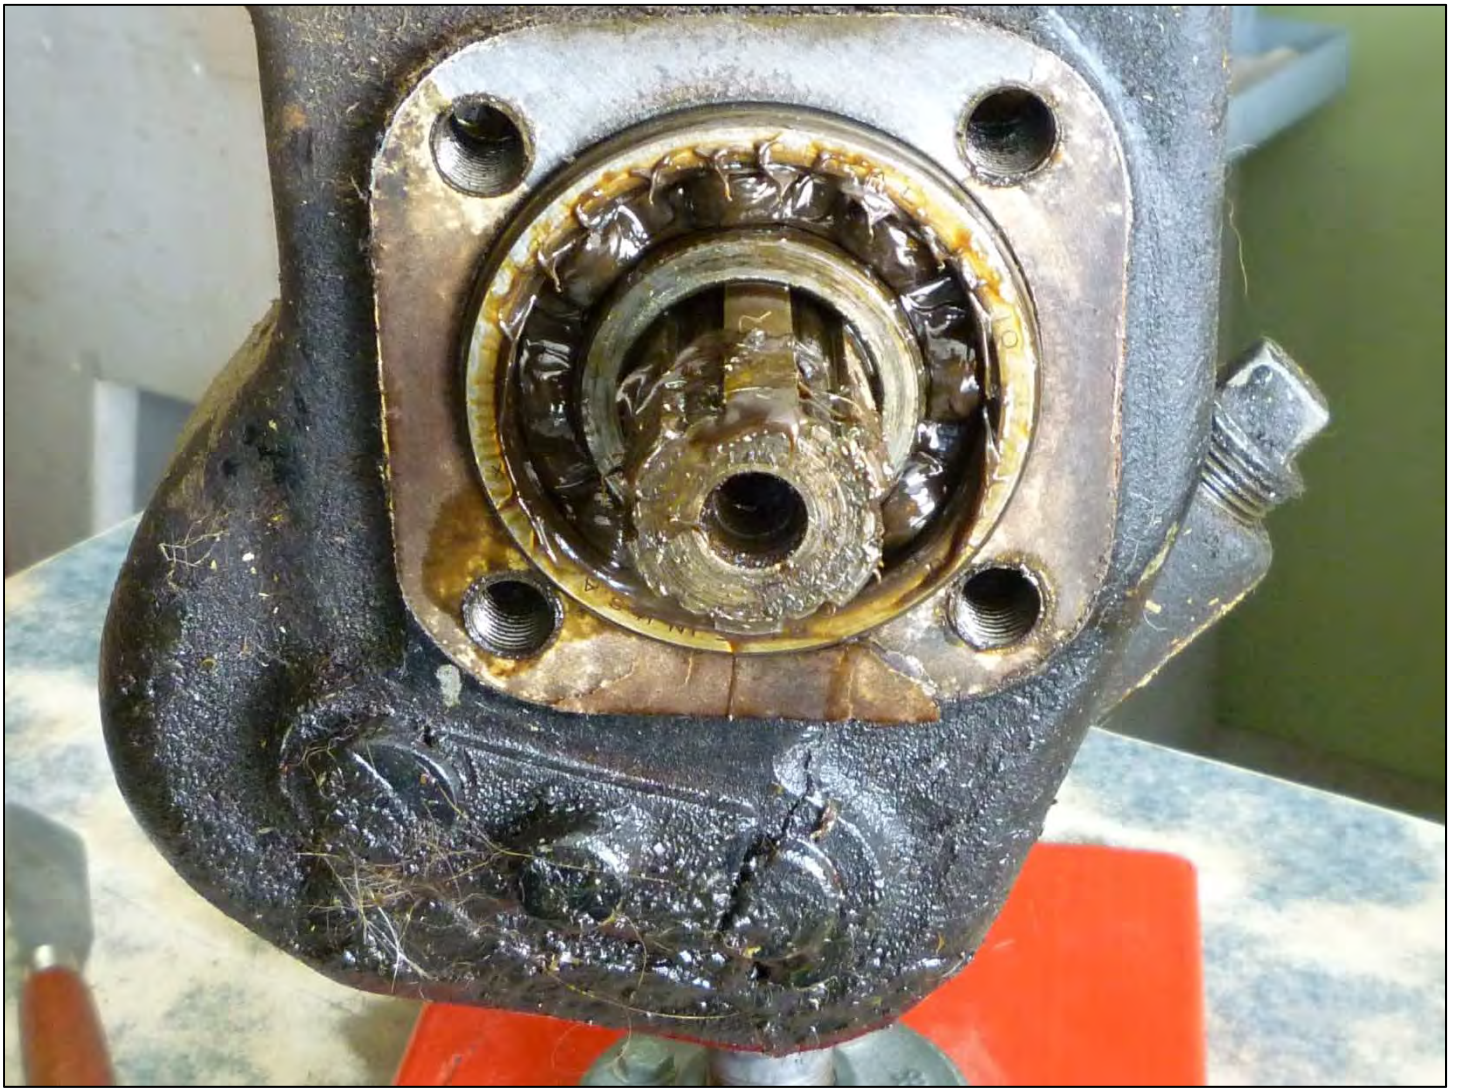
Once the four bolts are removed the rear bearing retainer is removed by just pulling it off.

Directly below the rear bearing retainer mounting is a 9/16" hex bolt that holds the cross piece that retains the end of the cluster gear shaft and the reverse idler gear shaft; this bolt is also removed, along with the cross piece.

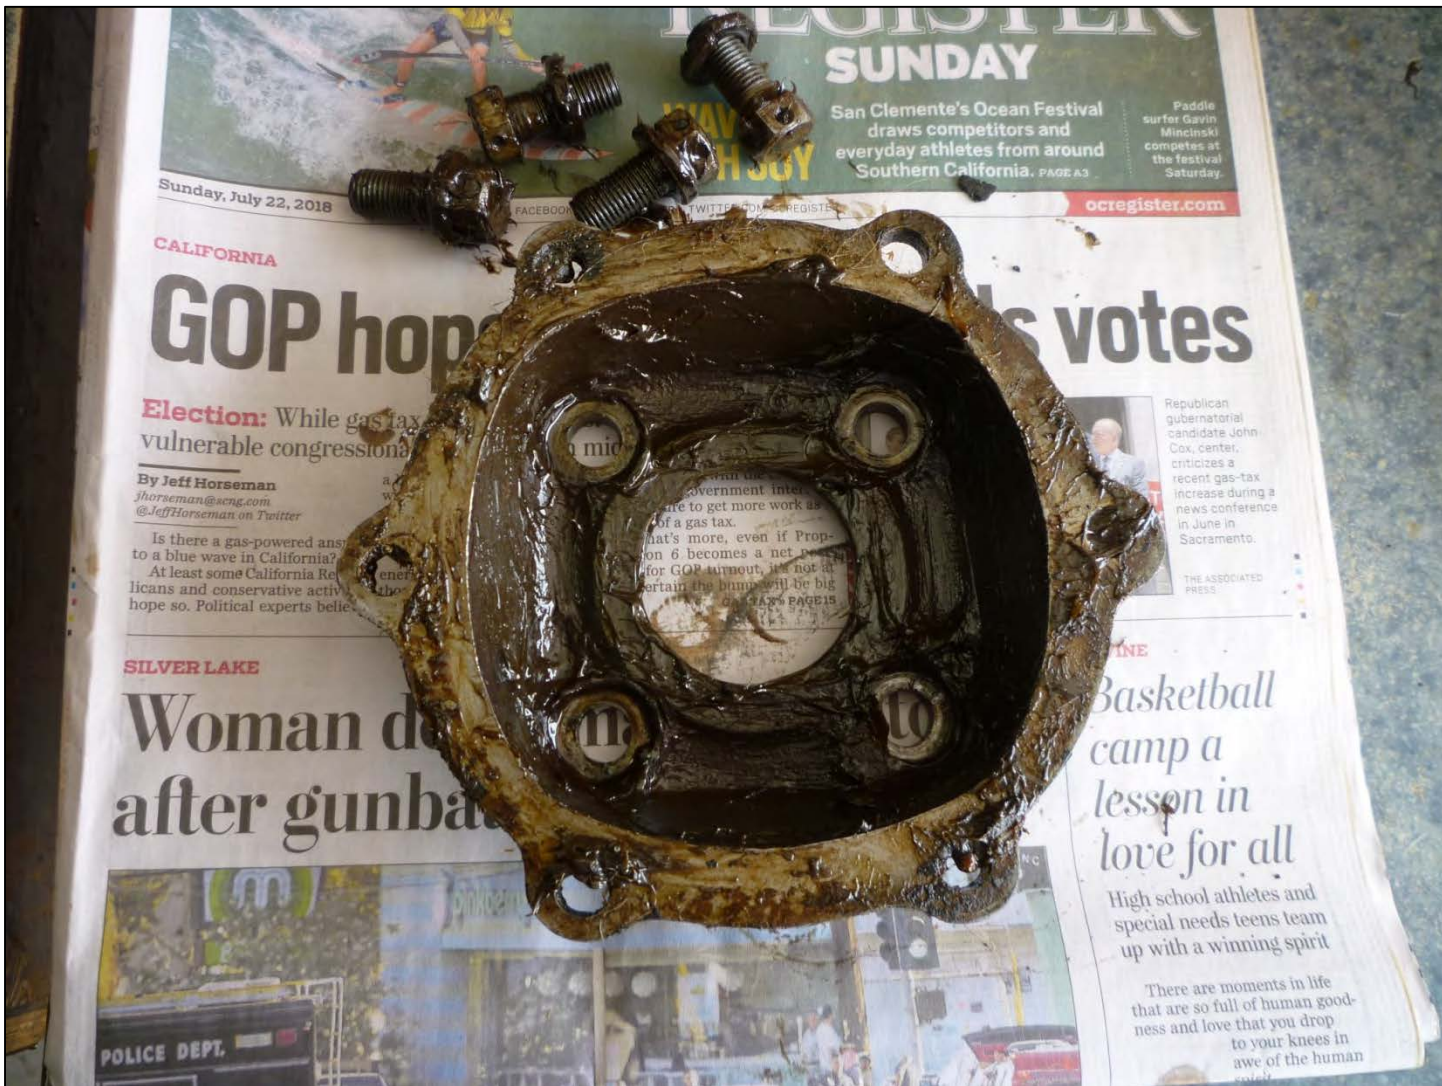
The rear bearing retainer and the four bolts are shown removed.

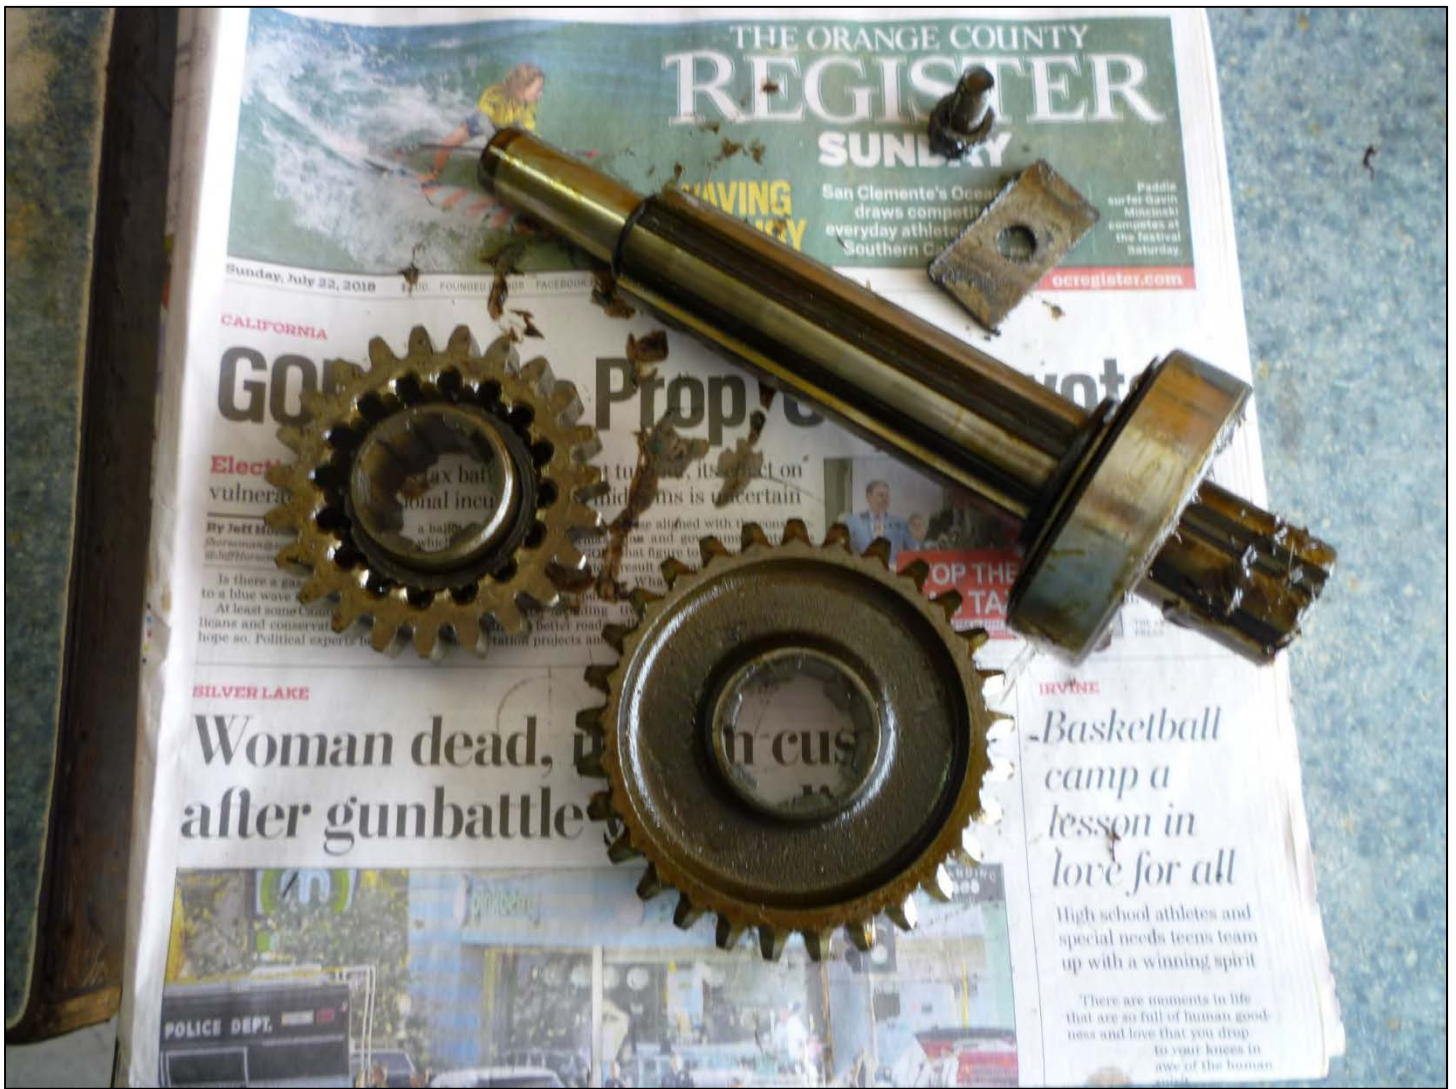
With the rear bearing retainer removed the main shaft can easily be pulled out to the rear by hand. The two slider gears will also come loose and both can be removed from inside the transmission.

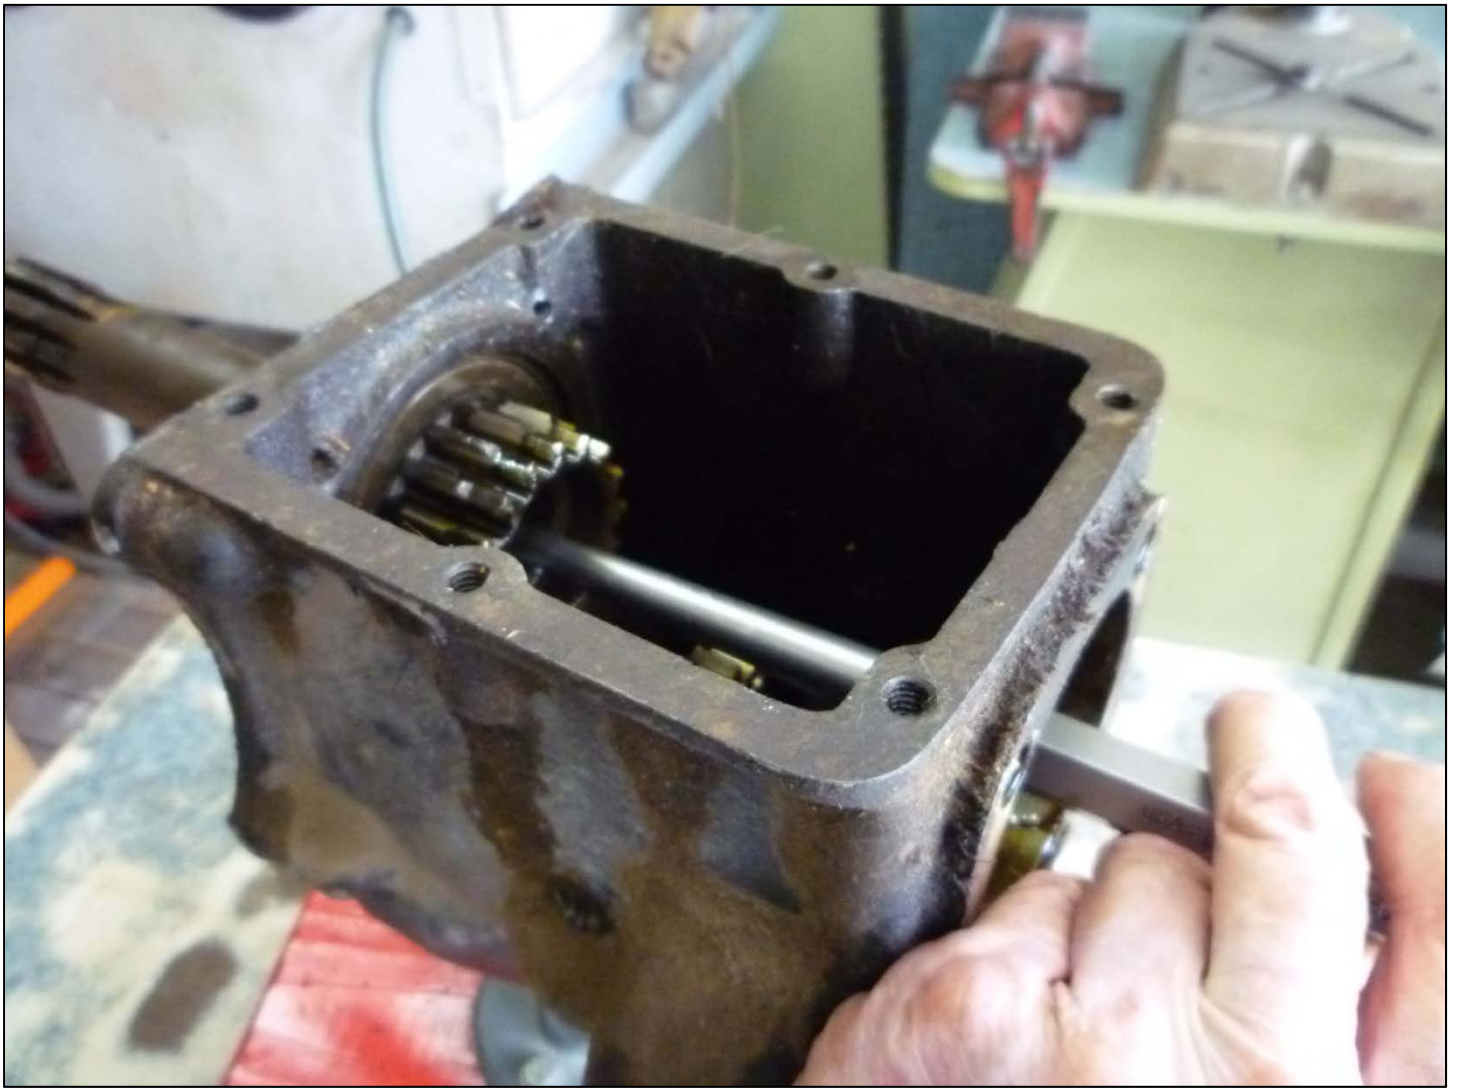
With the front bearing retainer removed reach into input shaft where the gear is shown and with your fingers remove the roller bearing.

Using a long punch, insert it into the area where the roller bearing was removed and tap on it with a hammer to drive the input shaft out the front of the transmission.

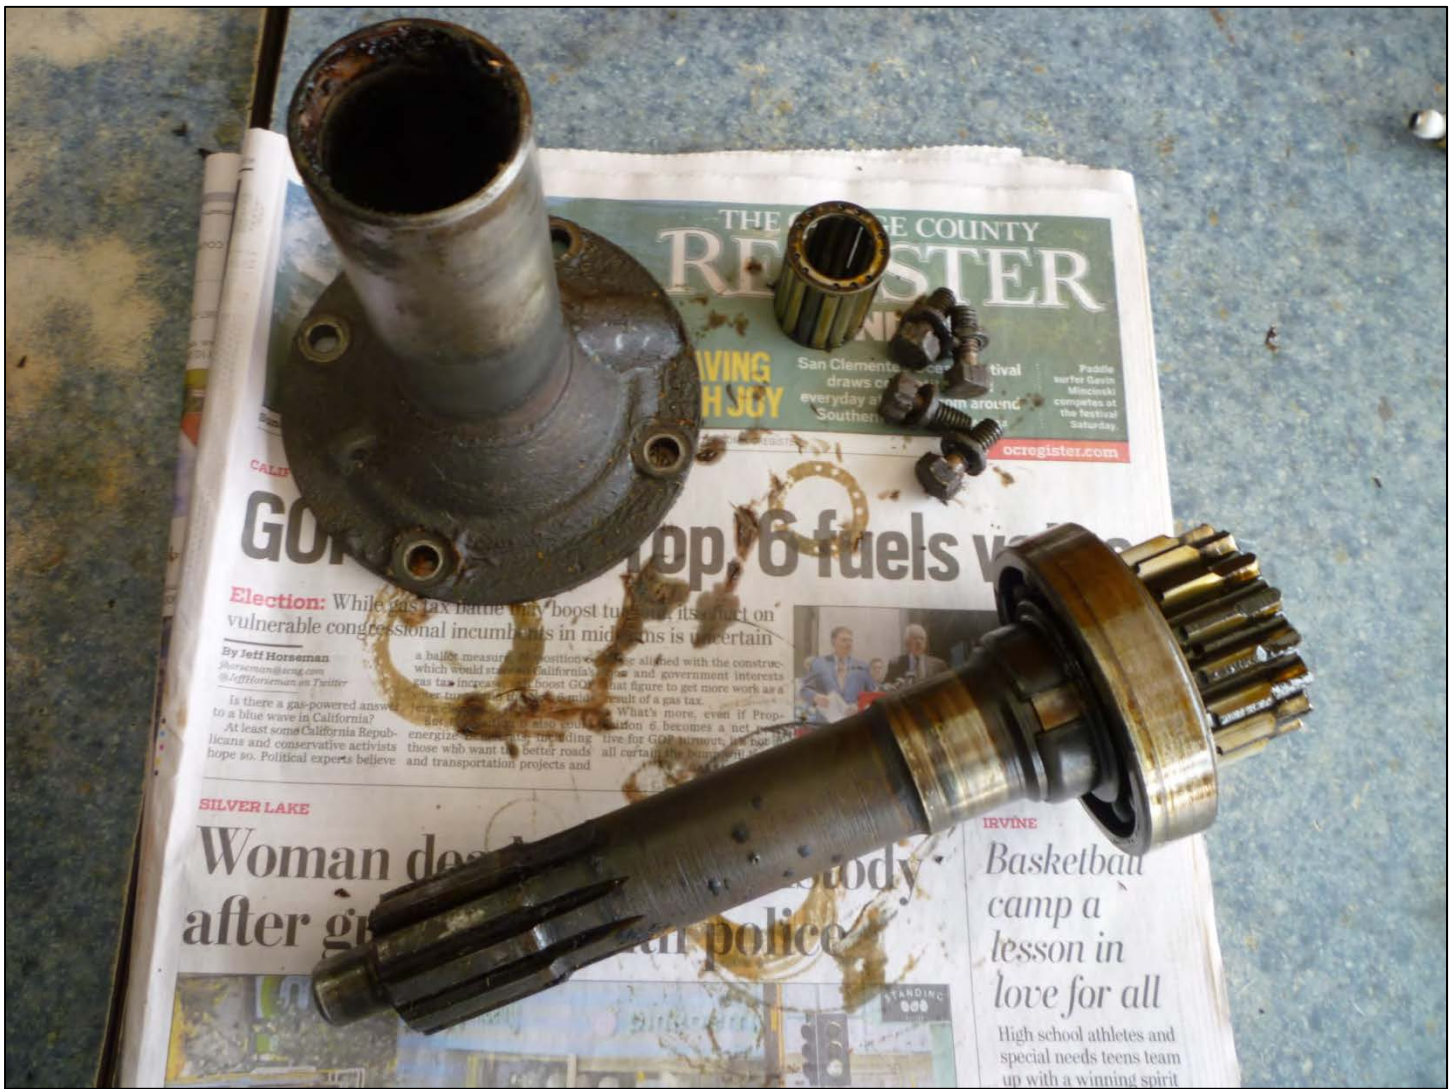
Shown here is the removed front bearing retainer, the roller bearing, and the input shaft.

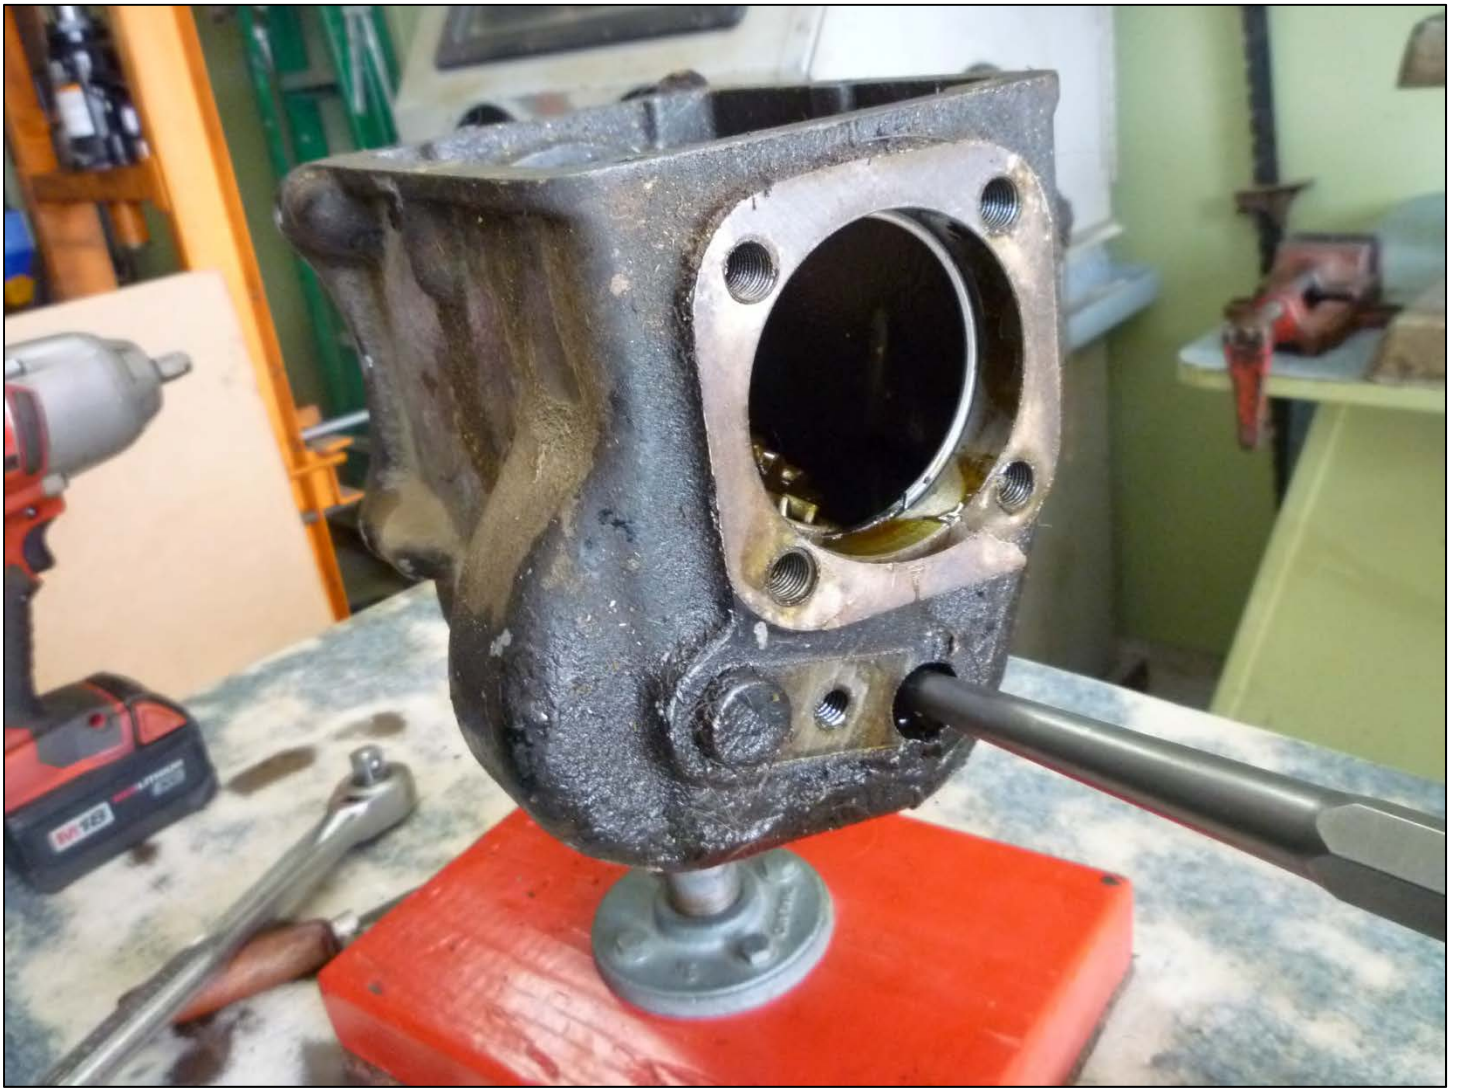
With a long punch place it against the cluster gear shaft at the back of the transmission and drive the shaft out the front.

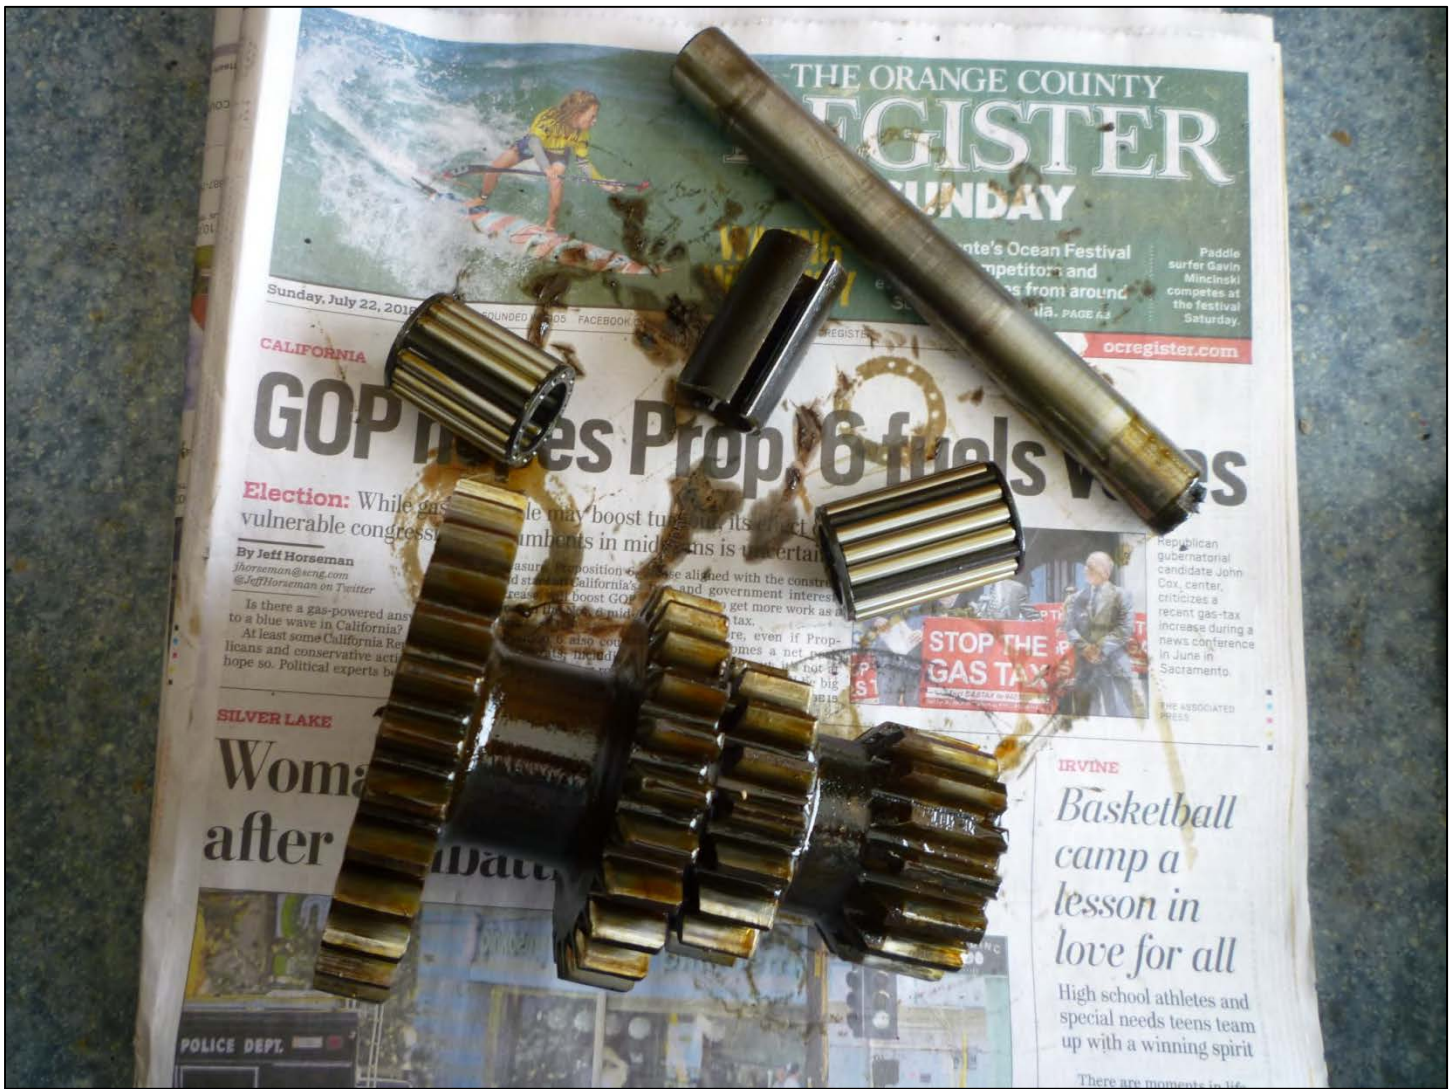
With the cluster gear shaft removed reach in through the top of the transmission and grasp the cluster gear and lift it straight up and out. Inside the cluster gear should be two roller bearings (a short, and a long), and a spacer.

Shown here are the removed cluster gear, the cluster gear shaft, the two bearings, and the spacer.

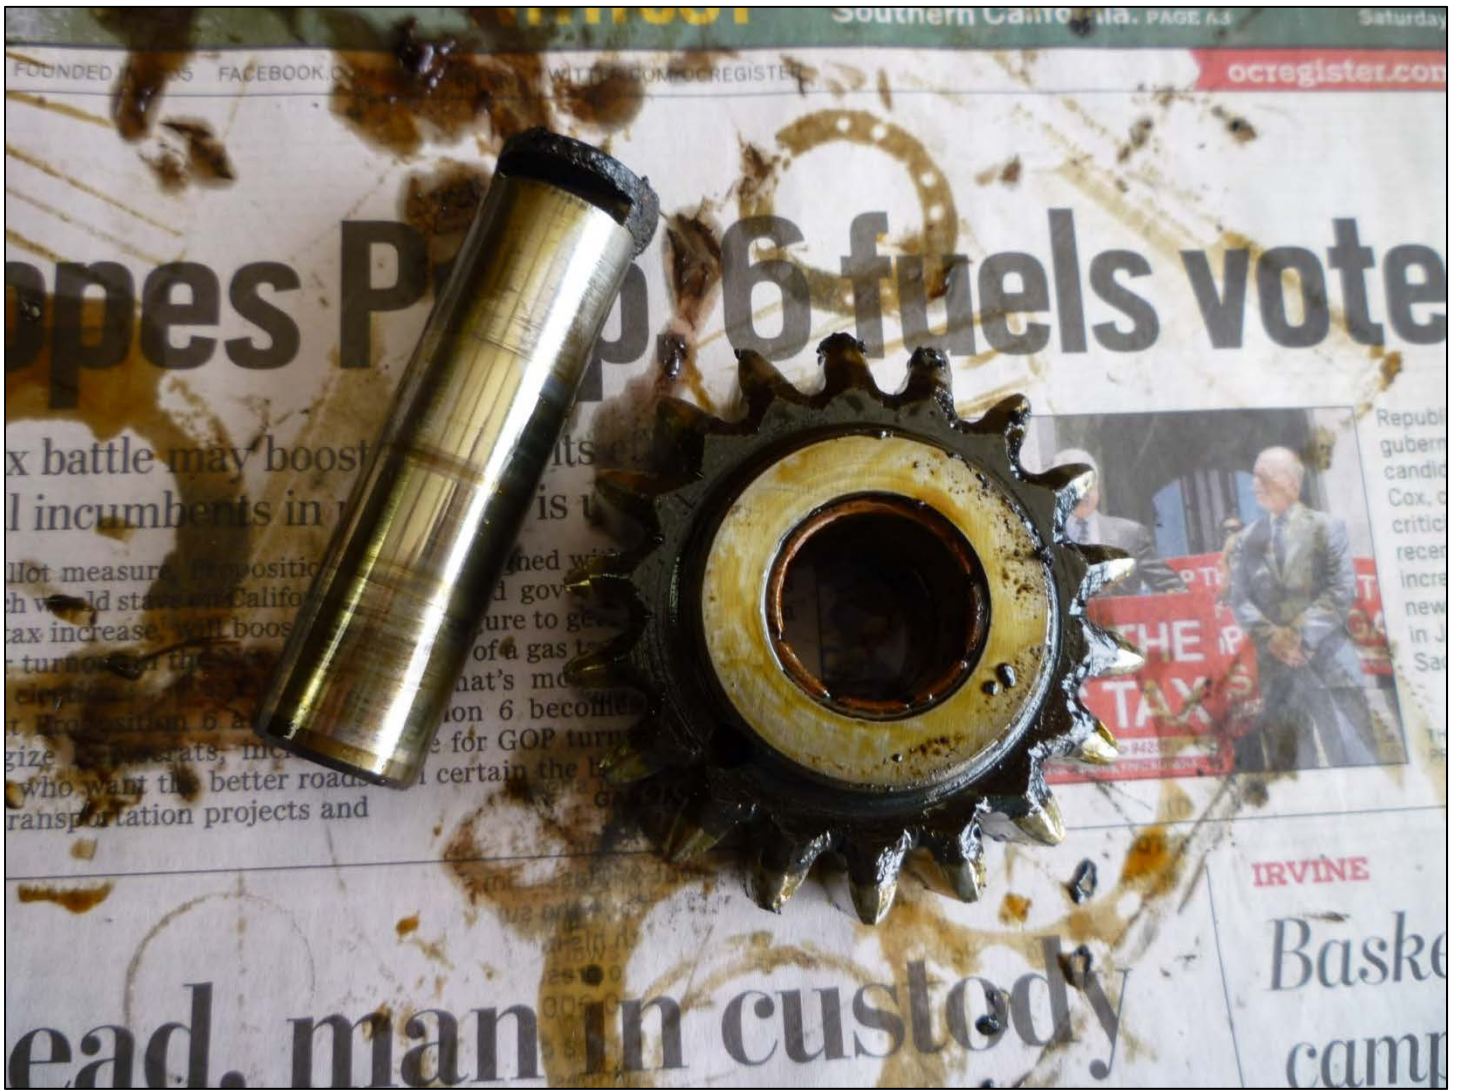
Shown here is the removed reverse idler gear and the shaft.
