Transmission Overhaul Pictorial August 2018

by Tom Endy

The Model A transmission is not difficult to overhaul. It can be done with simple hand tools. However you do need a shop press to remove and install the front and rear ball bearings. There are some areas that can cause grief unless you are aware of some subtle differences in the evolution of the design. In addition, there are also some parts that can easily be installed incorrectly.

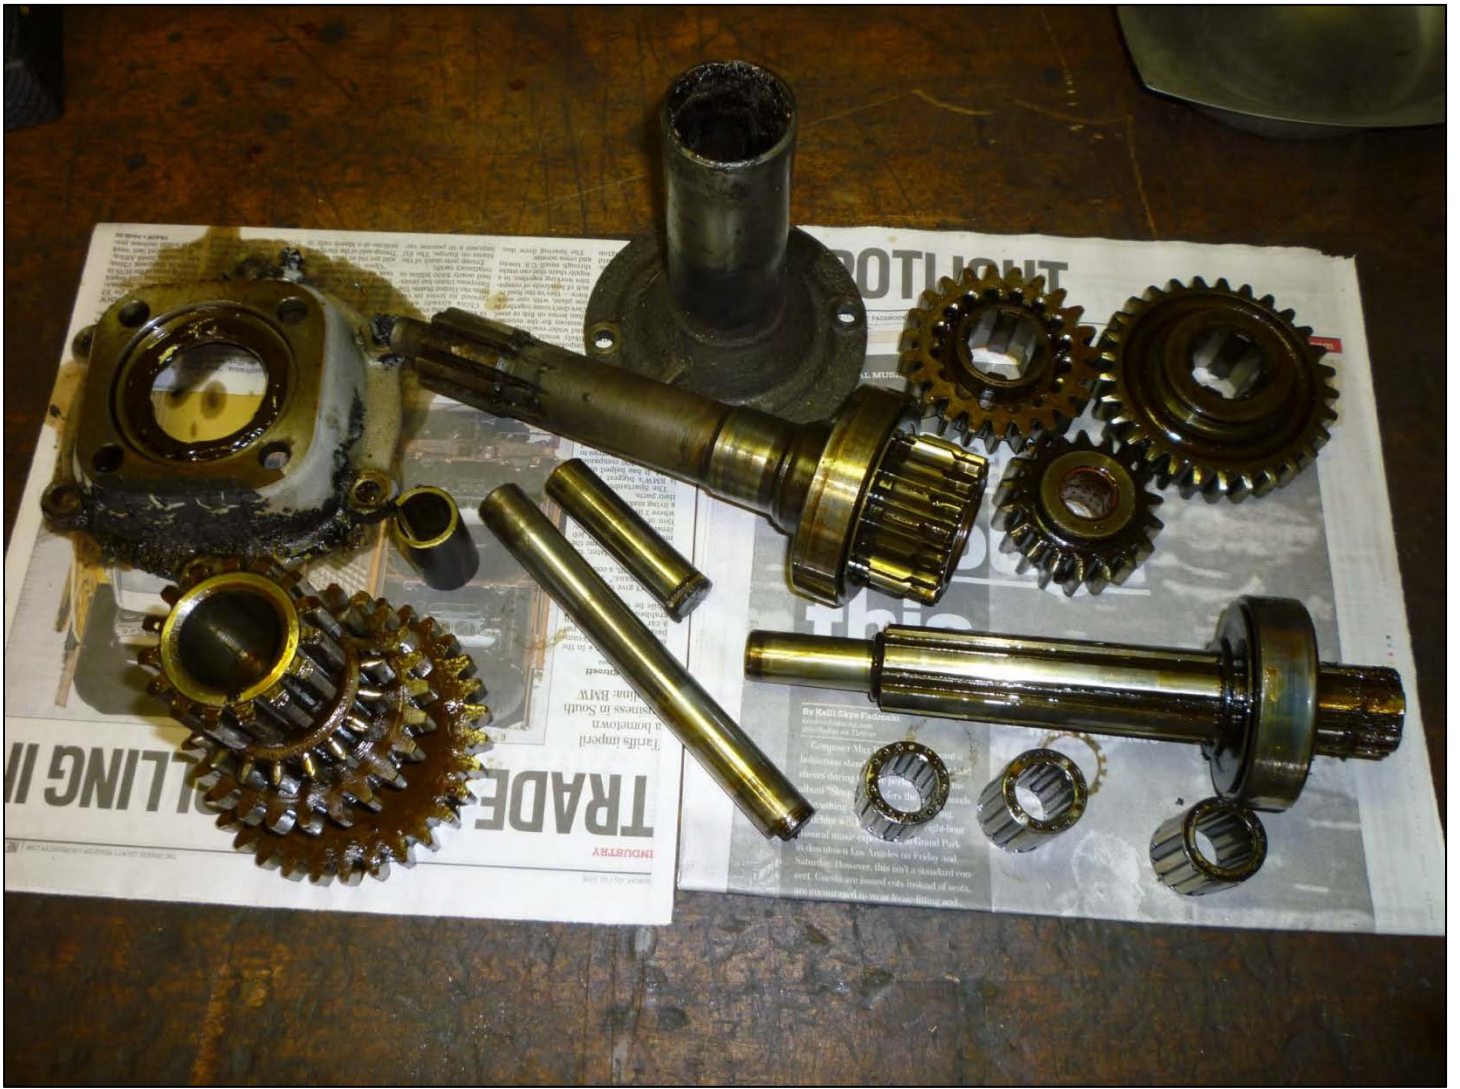
Shown here are all the internal parts of the transmission that have been removed.

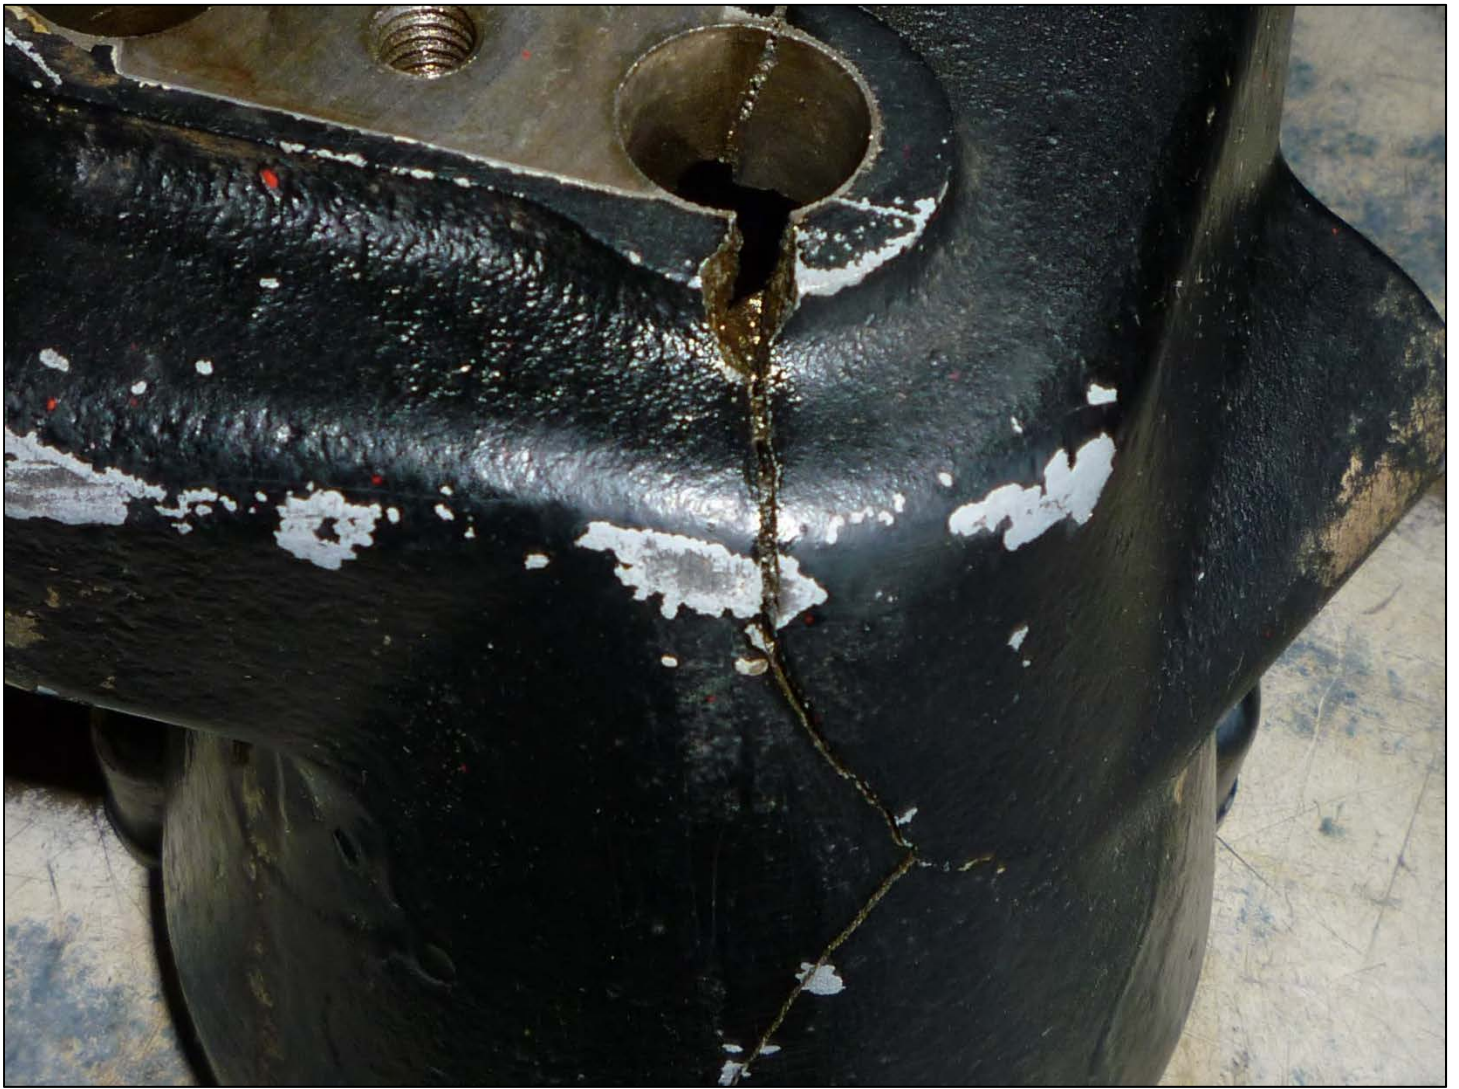
The cause of the profuse oil leak is found to be a gigantic crack that runs from the cluster gear shaft hole along the bottom of the transmission housing to the front.

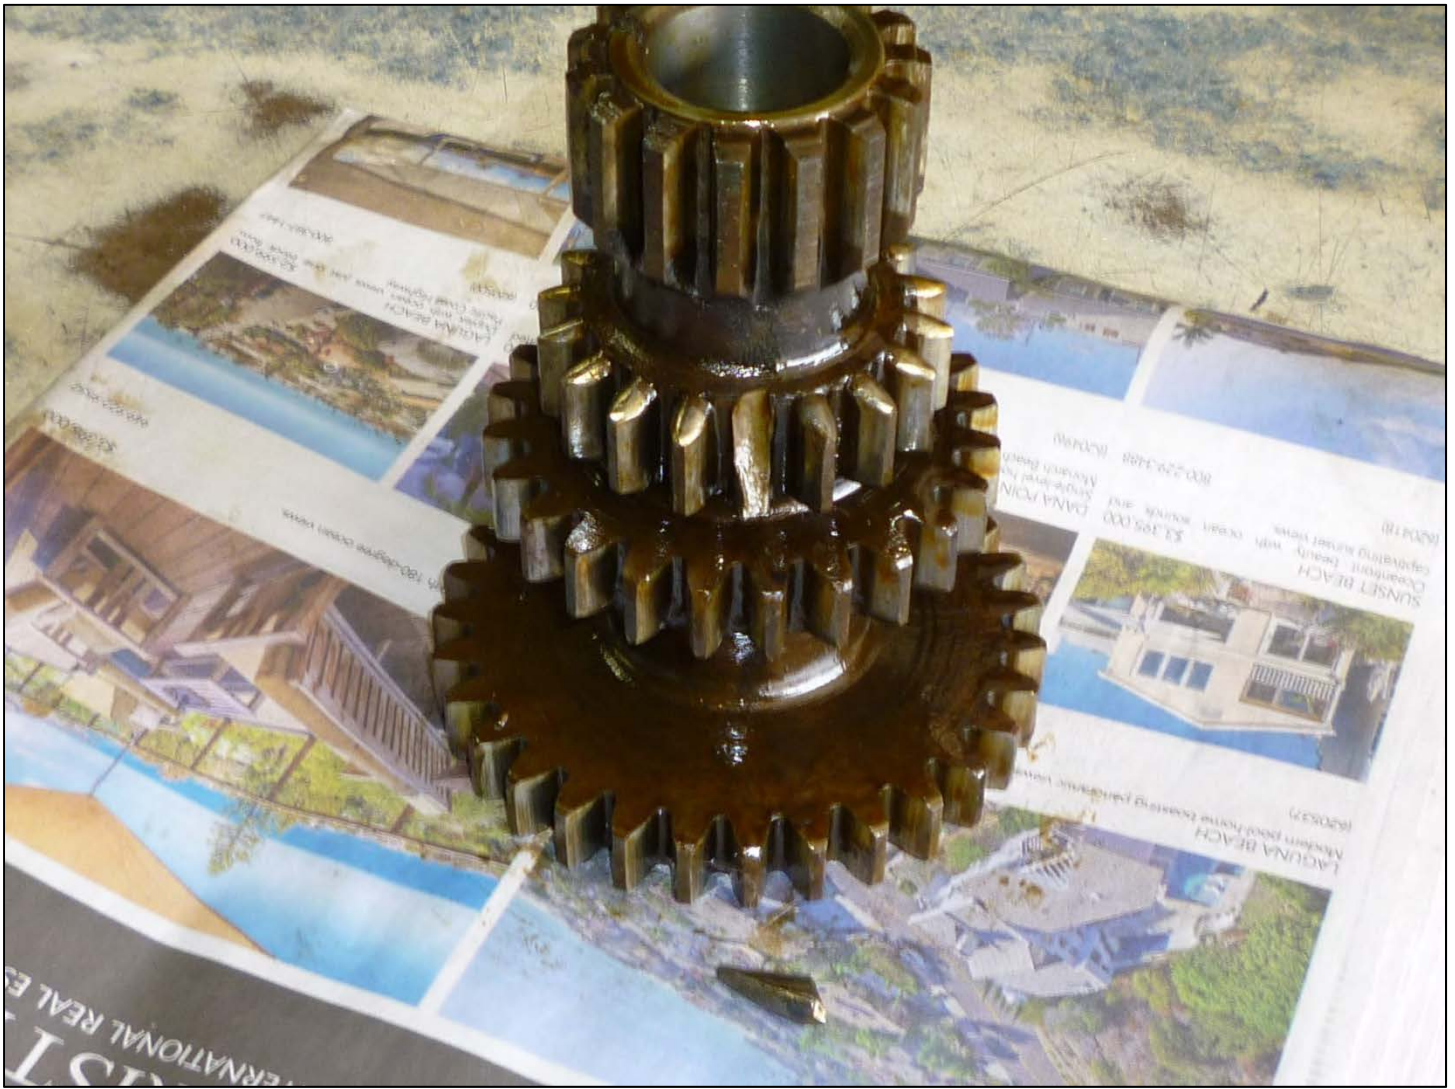
The cause of the crack in the housing is a tooth broken off the cluster gear at the gear section for the low gear. The broken tooth migrated to the bottom of the housing and got under the reverse idler gear.

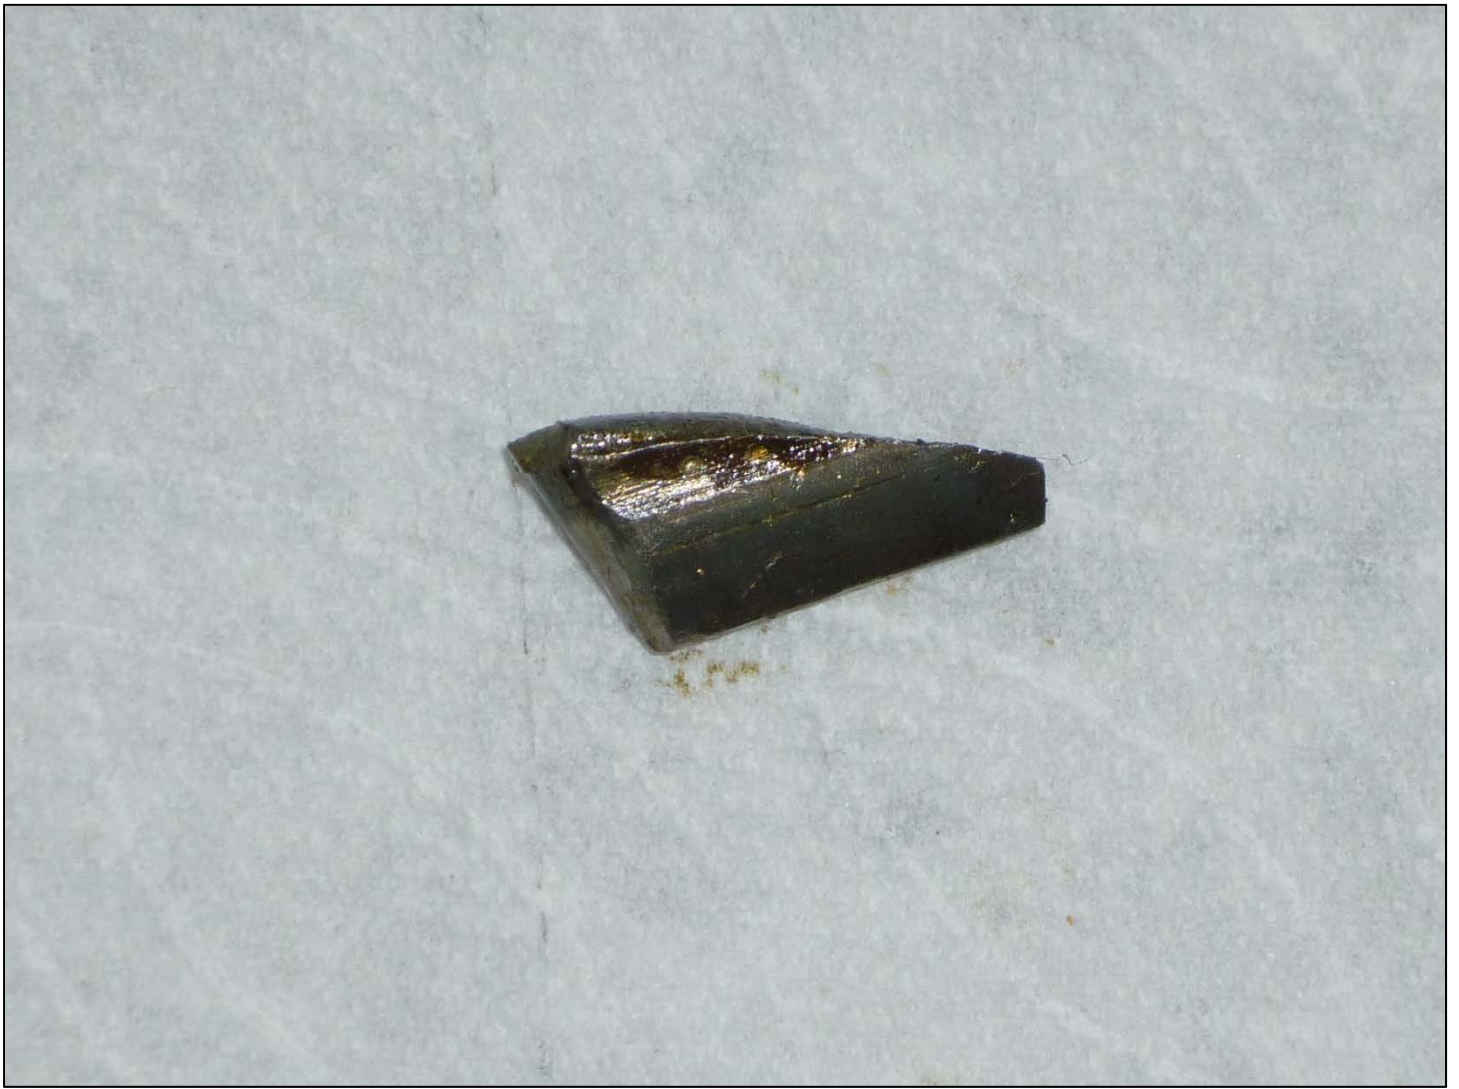
The culprit!!!

The tooth broken off the low gear on the cluster gear:

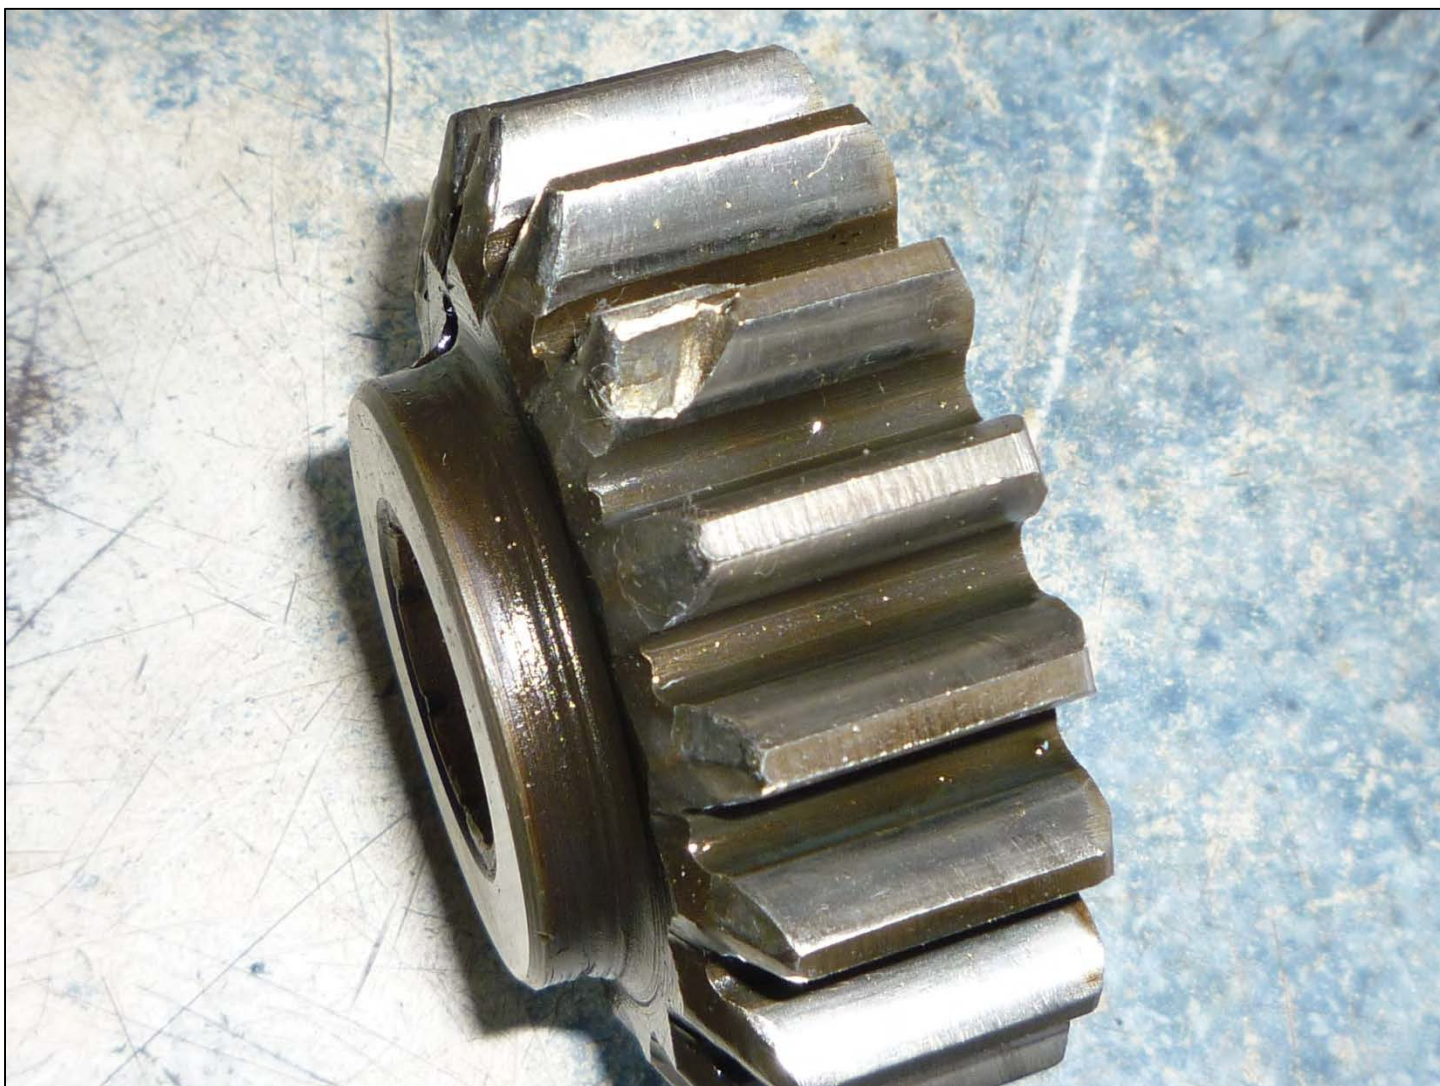
Shown here is the reverse idler gear with several damaged teeth. The damage to the housing was caused by the broken tooth off the cluster gear that got in between the reverse idler gear and the bottom of the case and caused the housing to crack.

This failure was more than likely caused by the driver trying to put the car in low gear while it was still traveling.

The instructions say to have the car at a full stop before attempting to shift into low or reverse.

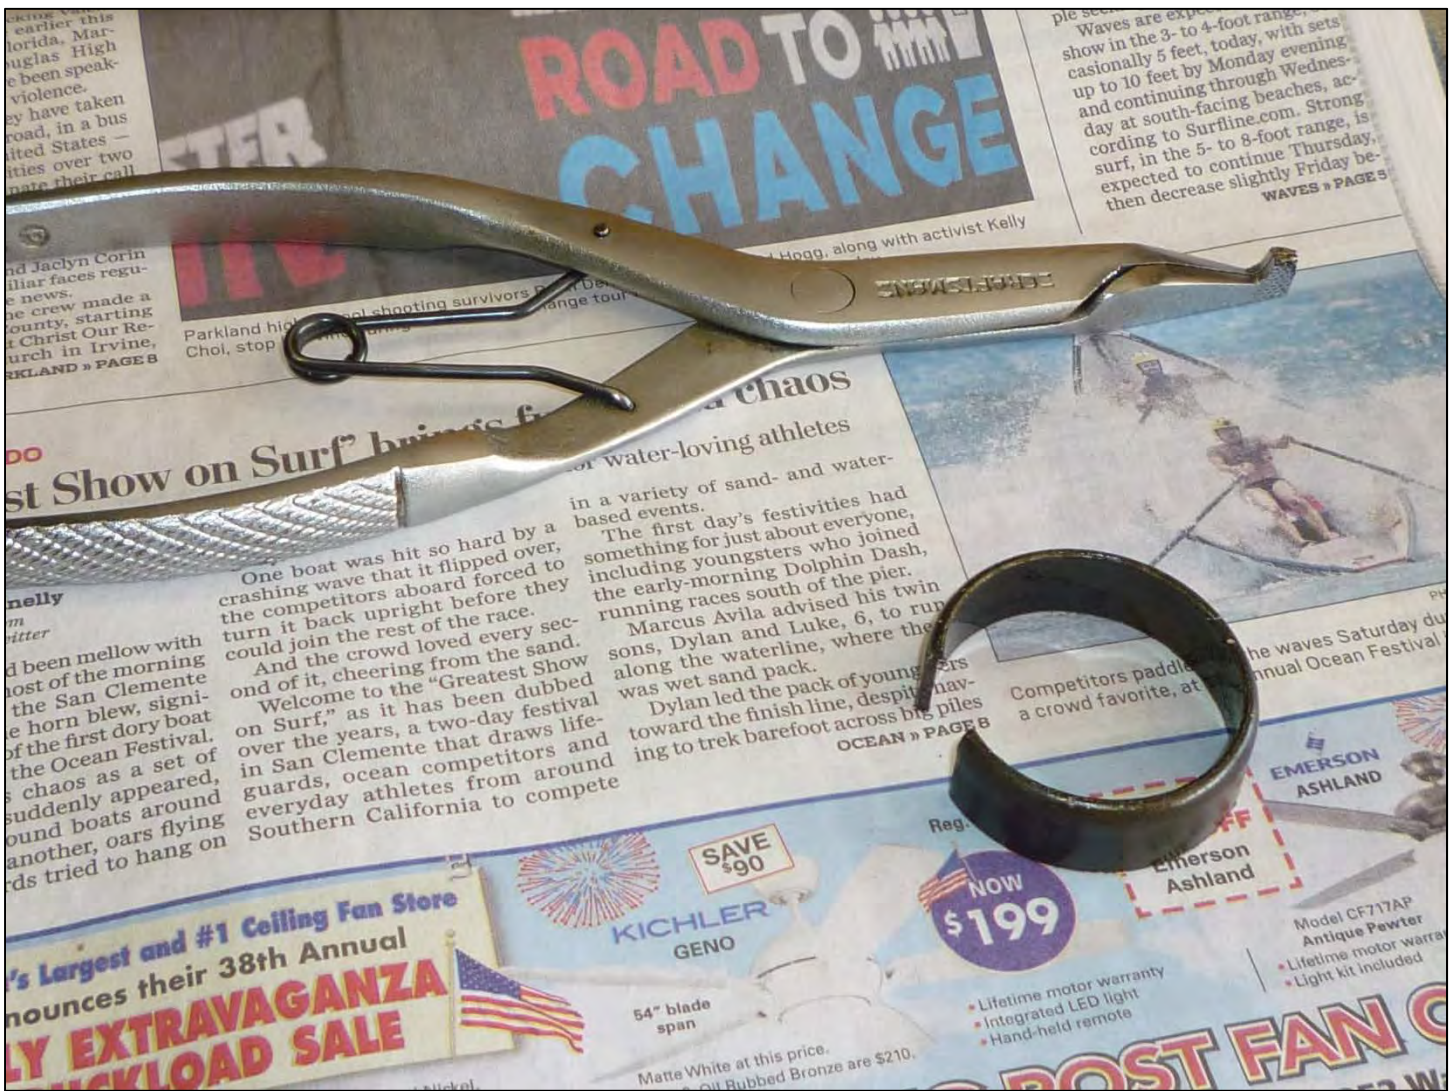
Shown here is a pair of snap ring pliers and Henry's not so better idea C-shaped bearing retainer removed from the input shaft.

The cross section of the retainer spans the space on front of the bearing on the input shaft and the ridge at the top is supposed to snap into the groove on the shaft. If the retainer is distorted it can easily come loose and allow the retainer and the front bearing to migrate forward.

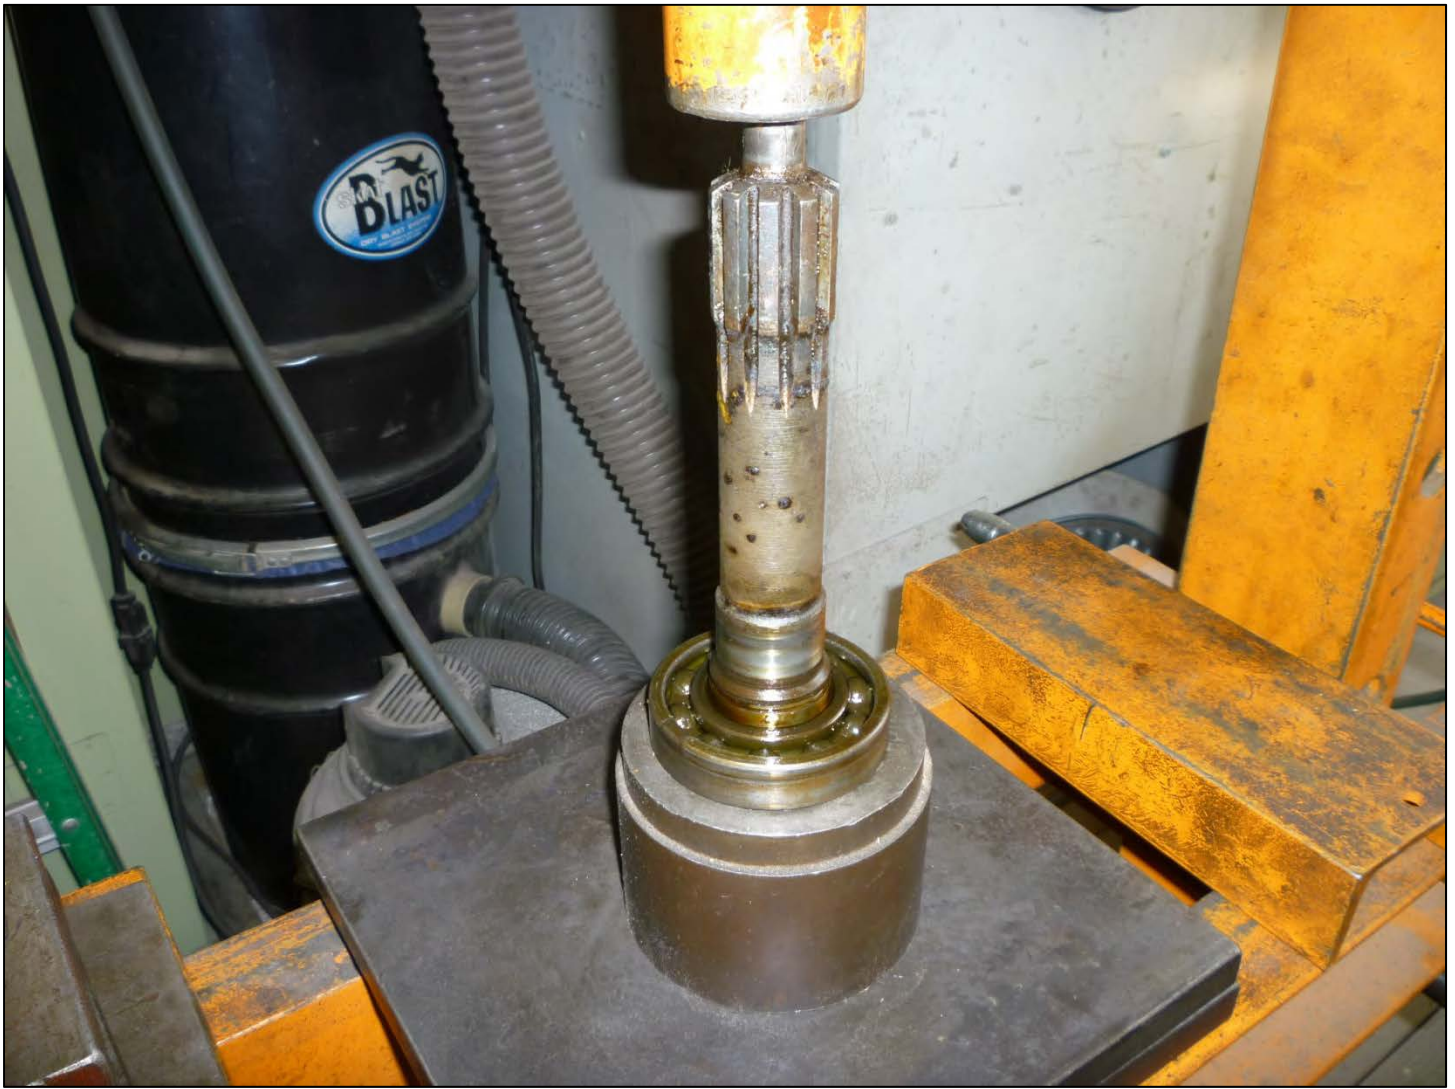
Shown here is the front ball bearing being pressed off of the input shaft after the C-shaped retainer was removed. A shop press is needed to do this task as the bearing is usually pressed on tight.

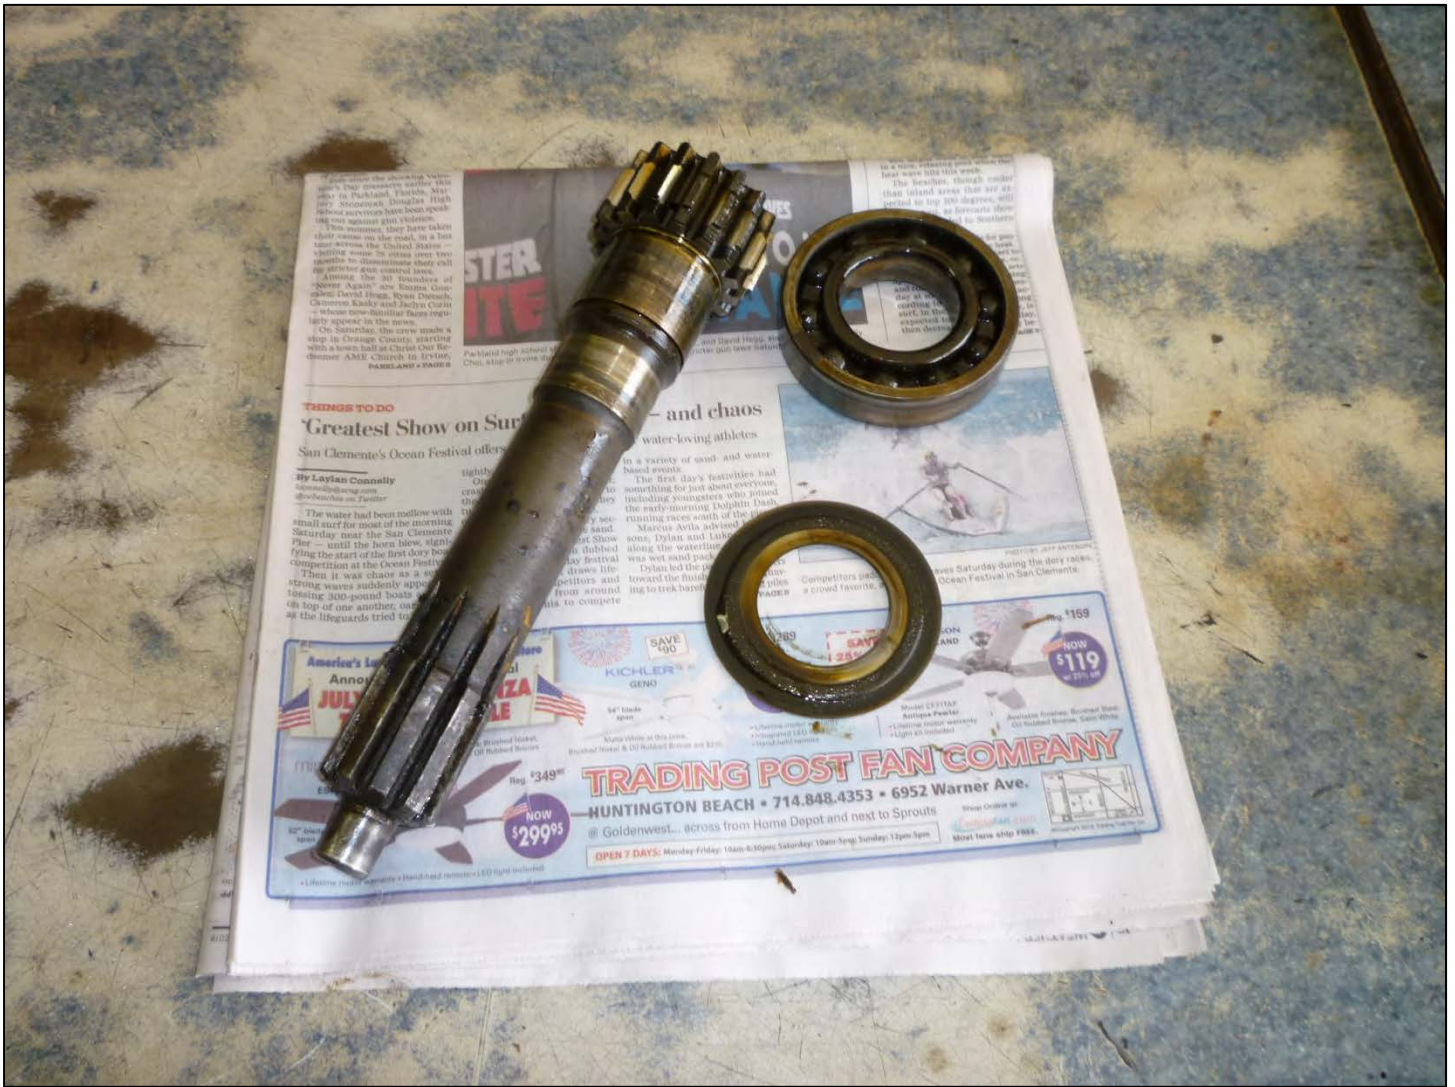
Shown here is the input shaft and the front ball bearing after it was pressed off the shaft. Also shown is the front bearing oil baffle that installs between the bearing and the gear end of the shaft.

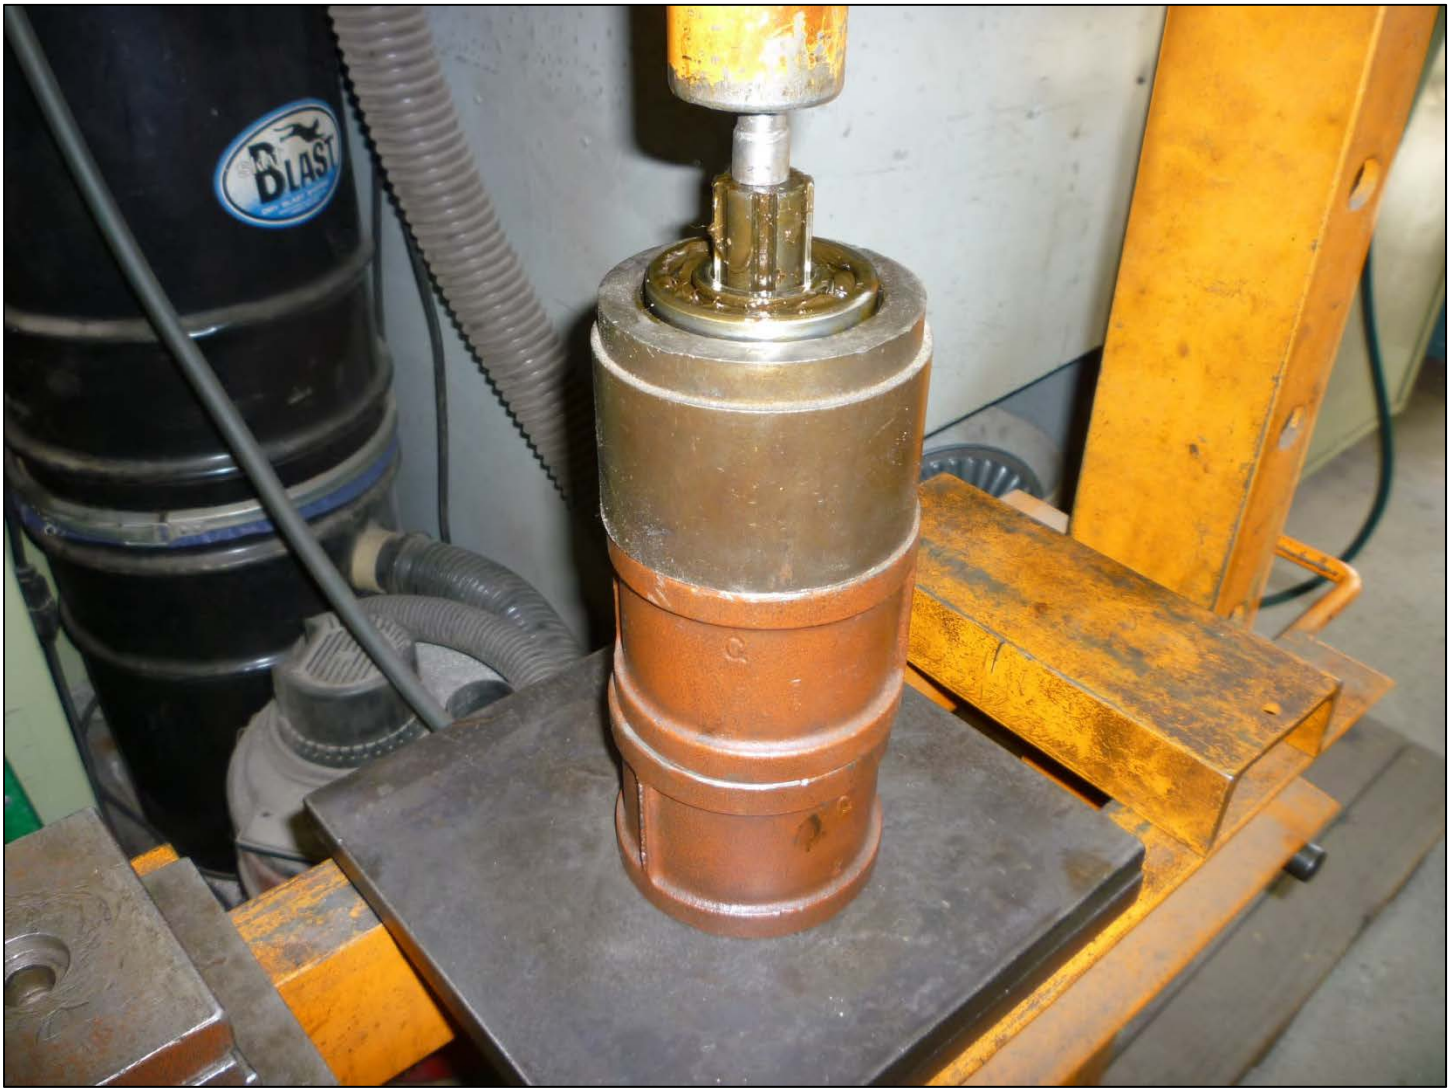
Shown here is the rear ball bearing on the main shaft being pressed off using a shop press.

The rear ball bearing is not pressed onto the main shaft tightly. Often a shop press is not needed as the bearing will slide off the shaft with little effort.

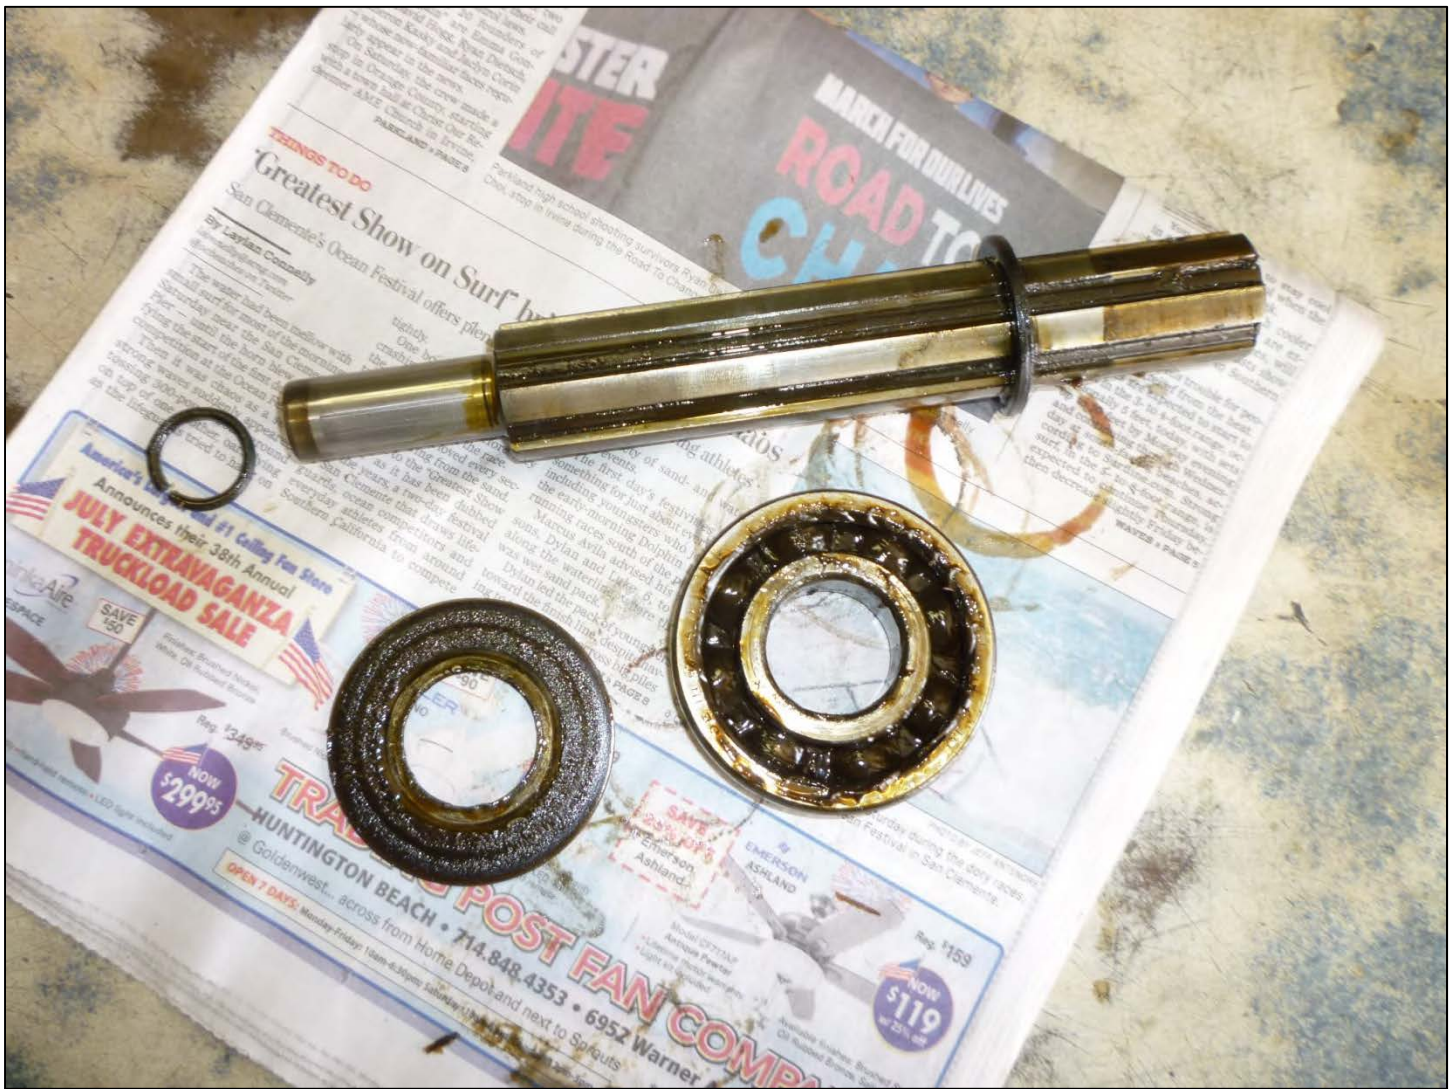
Shown here is the main shaft with the rear ball bearing removed. Also shown is the oil baffle that installs between the bearing and the bearing stop on the right end of the main shaft.

Also shown here is the pilot bearing spacer that installs on the left end of the main shaft up against the spline. It is easily pried off the shaft with a screwdriver. It is always prudent to replace this spacer during an overhaul as the front side is usually worn flat from riding against the rotating pilot bearing.

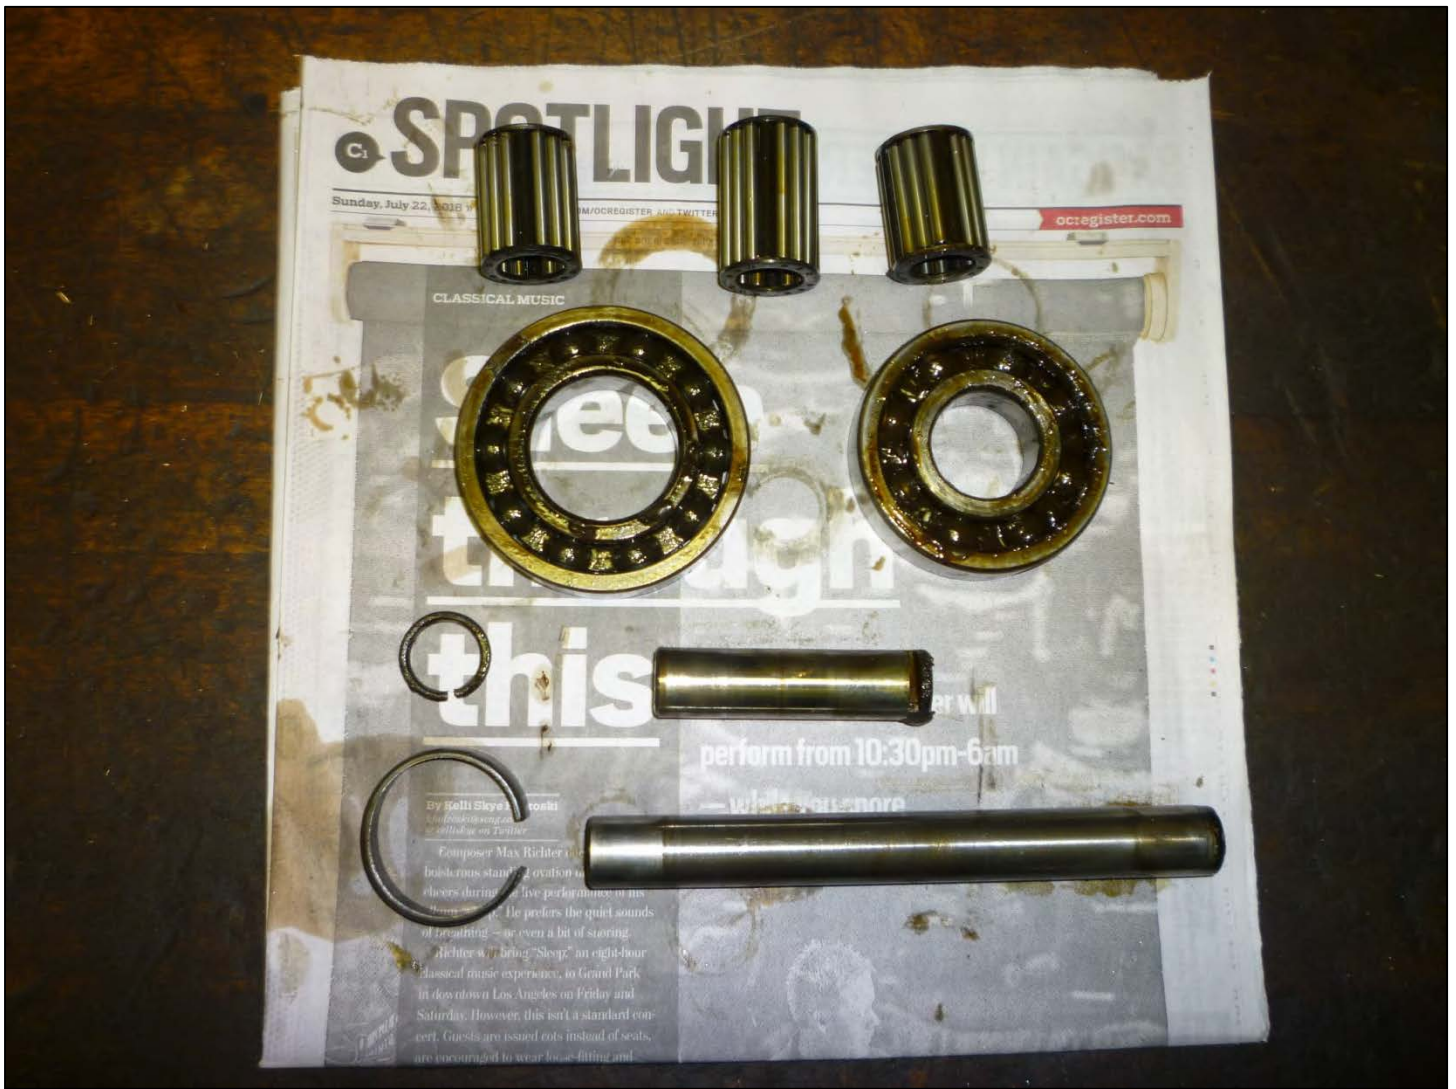
Shown here are the 100% replaceable parts removed from the transmission that will be replaced.

At the top of the photo are the three roller bearings. Next are the two ball bearings. Below that is the pilot bearing spacer and the revers idler gear shaft.

At the bottom are the C-shaped front ball bearing retainer and the cluster gear shaft.

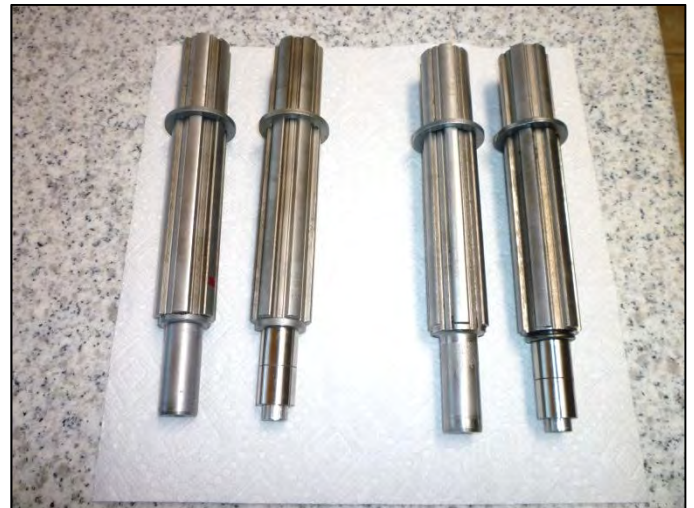
The two main shafts on the lefts are of the early design that has a thrust washer as an integral part of the shaft. The shaft on the left is an early shaft shown in its original configuration. The one to the right of it is an early shaft that has been machined and has two of the Thornington bearing races pressed onto it.

The two main shafts on the right are of the later design that uses a removable thrust washer that is circular and is shaped much like a key ring. The shaft on the left is shown in its original configuration. The one on the right is a later shaft that has been machined and has two Thornington bearing races pressed on.

On the later shafts care must be taken when doing the machining so that the radius for the removable thrust washer is left intact.

Whenever rebuilding a Model A transmission it is prudent to always replace the removable thrust washer on the later design main shafts as they are generally found worn flat on the front surface.

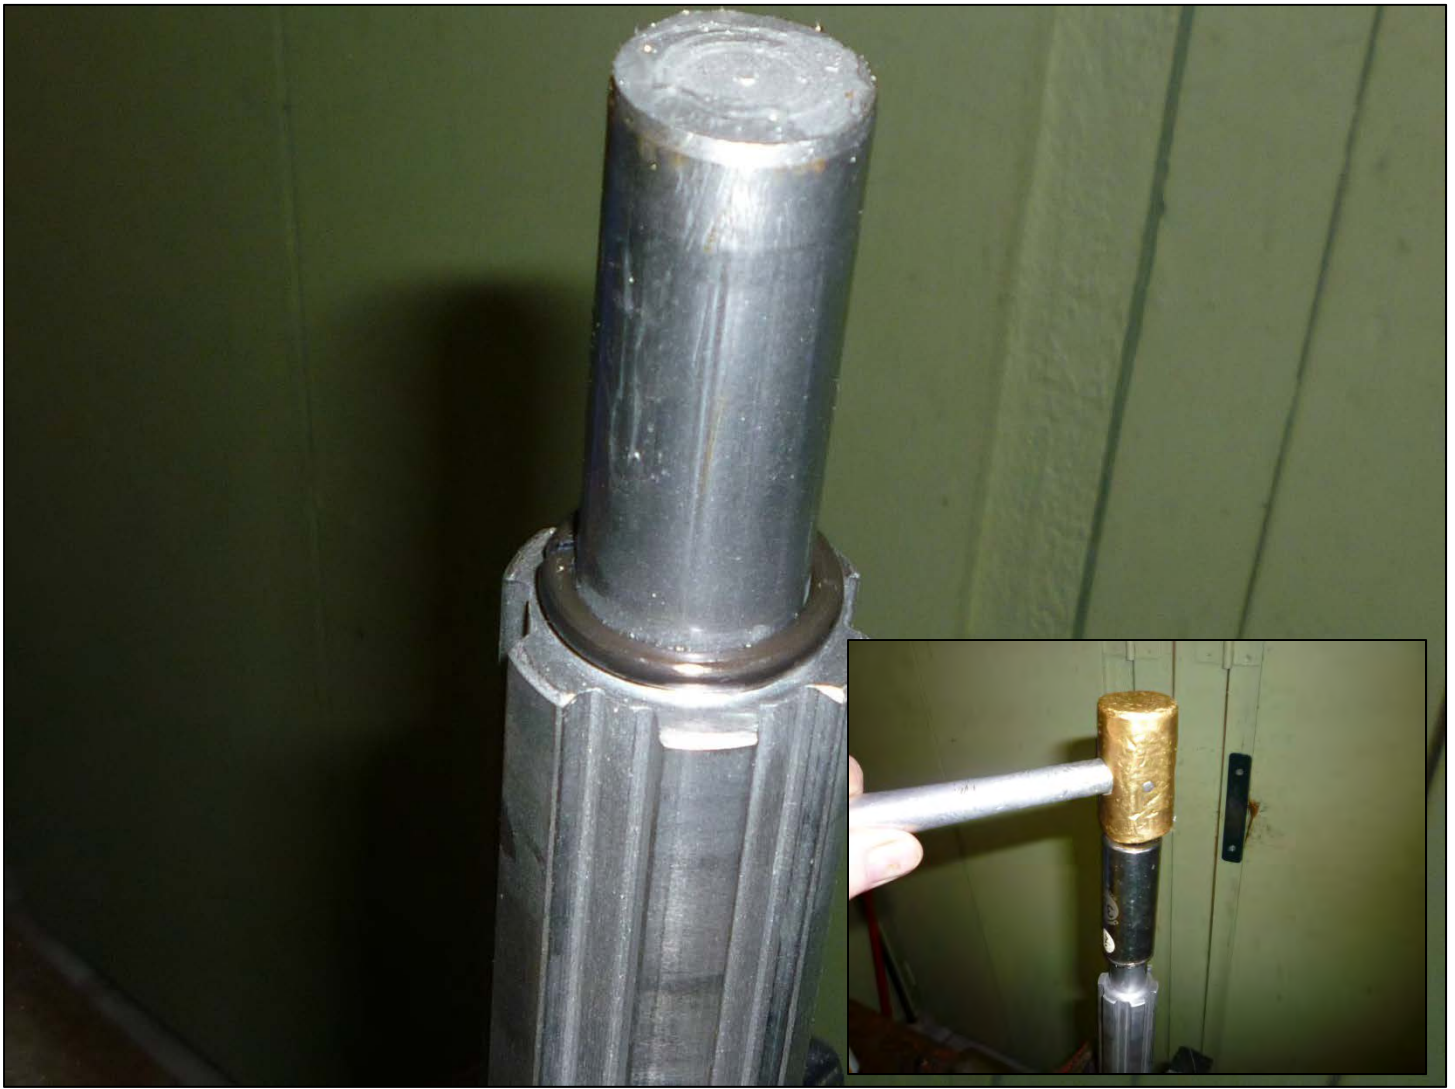
A new pilot bearing spacer is installed on the bearing end of the main shaft; this is easily accomplished by tapping it on using a 3\4" deep socket. Coat the shaft bearing surface with Vaseline first to aid sliding it into place without damaging the bearing surface. The inset photo shows the spacer being tapped into place. What appears to be markings on the bearing surface is a disruption of the Vaseline coating.

The early main shafts have a flat washer that is integral to the shaft that is the pilot bearing spacer and it is not removable. If you are installing an early main shaft don't make the mistake, as some have done, of installing the replaceable pilot bearings spacer on top of the integral one, as you will jam up the transmission.

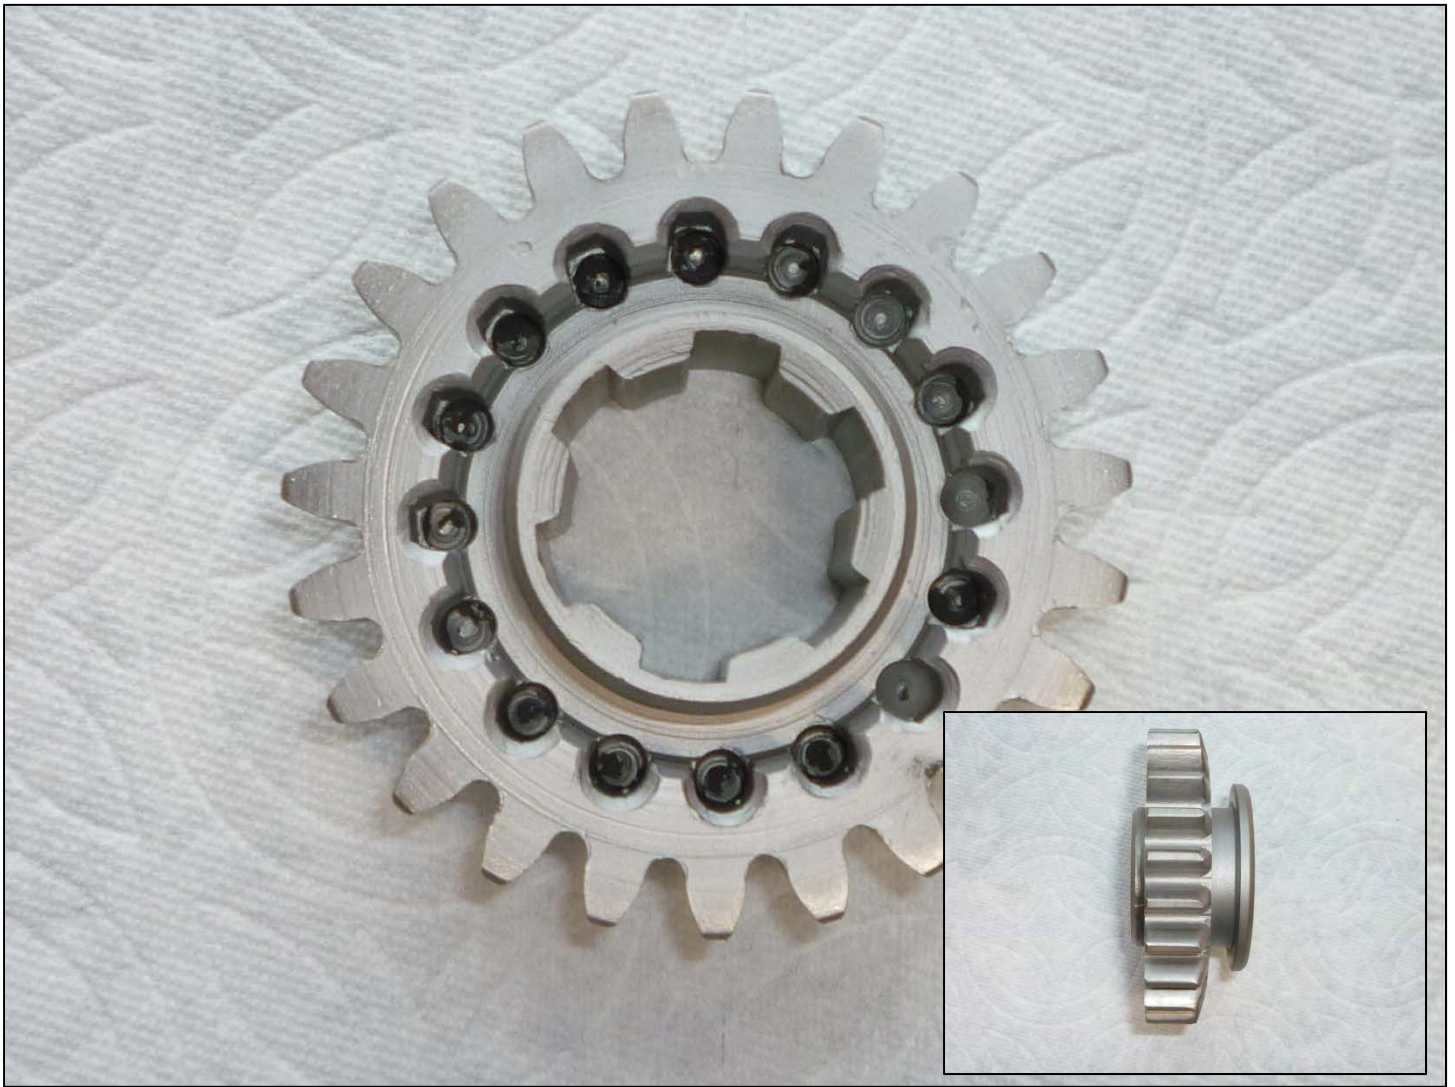
Shown here is the front slider gear after it was degreased and bead blasted. This gear is used for both second gear and high gear. It is important that all the teeth are in good condition with no broken, chipped, or eroded teeth. The inset photo shows the gear teeth. Note the shifting fork slot is located on the right side of the gear.

The series of holes on the front side of the gear is where it engages the back side of the gear on the input shaft. This is the design for the high gear. When the two gears are engaged the rotation of the engine is driving straight through the transmission and no “gearing” is going on. The output shaft is then rotating at the same speed as the input shaft.

The series of holes should not appear to be wallowed or otherwise distorted or it can cause the transmission to slip out of high gear.

This gear appears to be in excellent condition.
