Transmission Overhaul Pictorial August 2018

by Tom Endy

The Model A transmission is not difficult to overhaul. It can be done with simple hand tools. However you do need a shop press to remove and install the front and rear ball bearings. There are some areas that can cause grief unless you are aware of some subtle differences in the evolution of the design. In addition, there are also some parts that can easily be installed incorrectly.

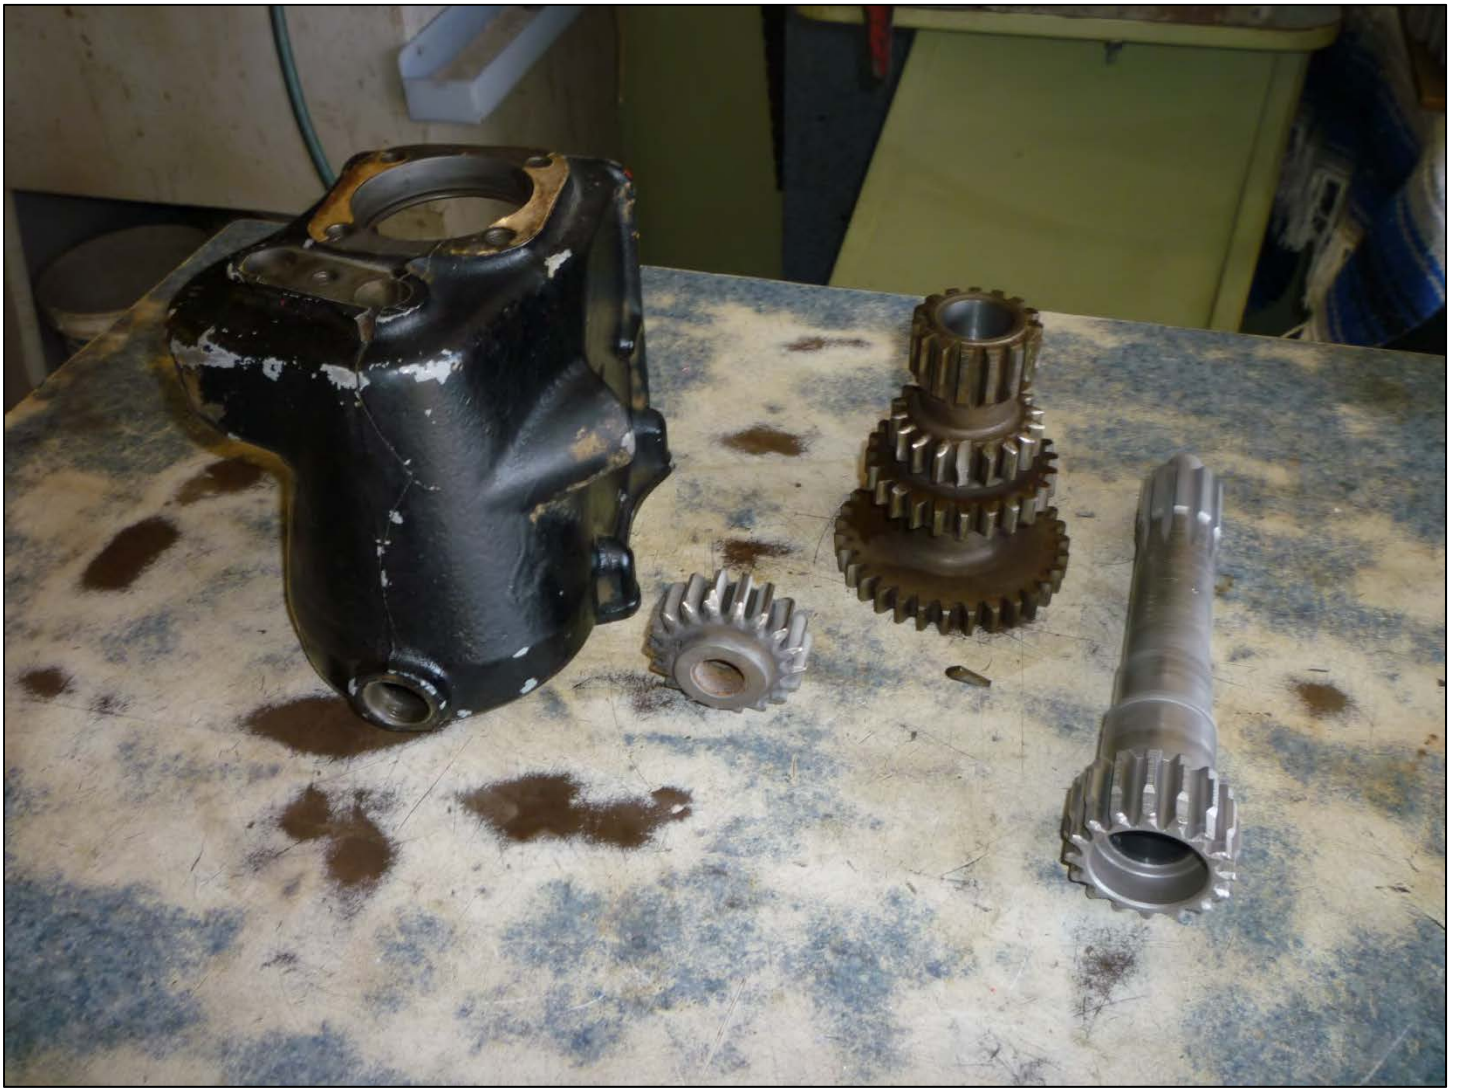
Shown here are all the rejected components that will have to be replaced before the transmission is assembled. These parts are in addition to the 100% replaceable parts.

Left to right: The transmission housing, the reverse idler gear, the cluster gear, and the input shaft.

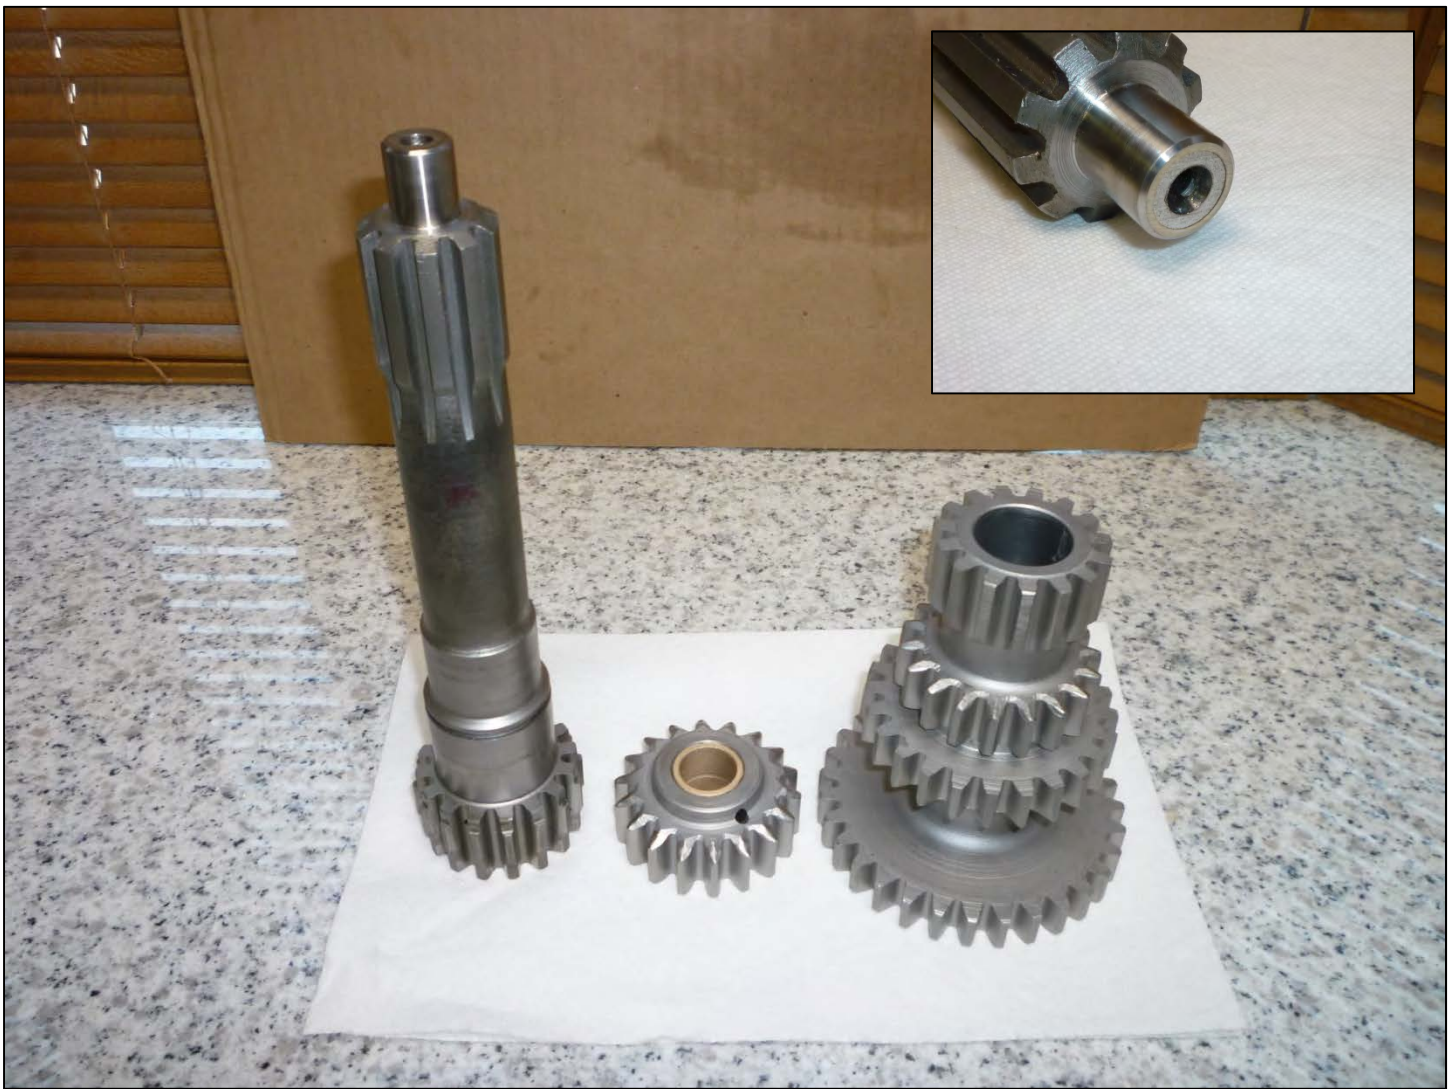
The replacement components: The input shaft has had the nose repaired. It was machined down and a drill bushing sleeve pressed on. See inset photo. The reverse idler shaft and the cluster gear are originals in excellent condition.

The bushing inside the reverse idler gear is replaceable; however, it is not necessary as they are usually never worn. The idler gear only goes along for the ride, the only time there is any load on it is when in reverse.

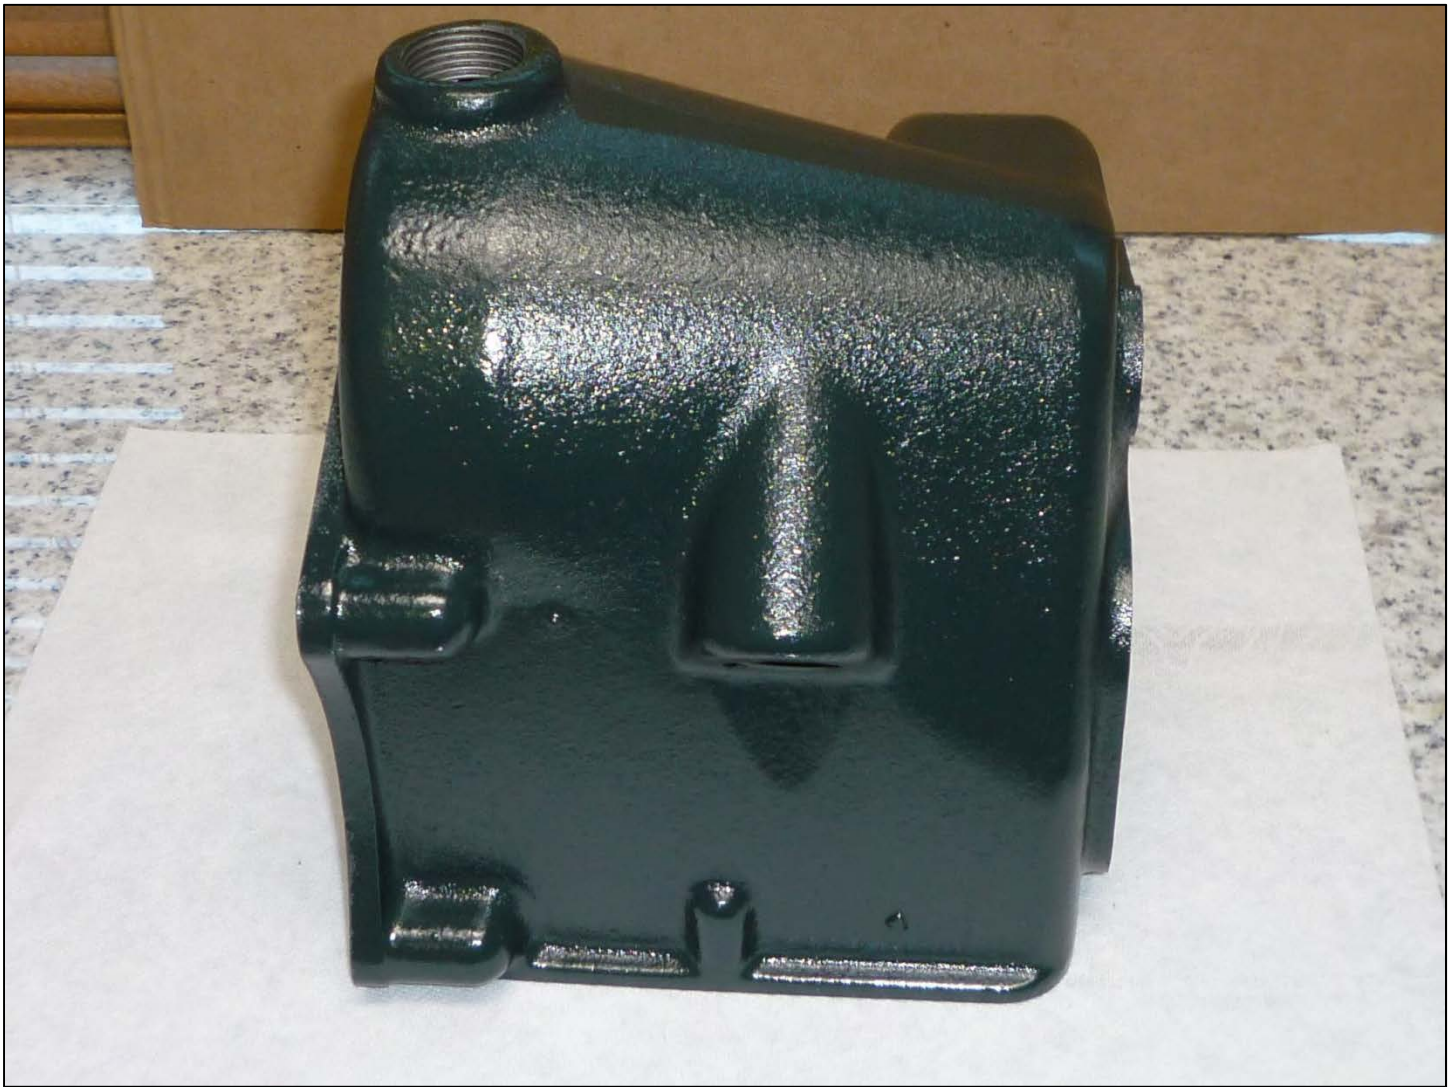
The replacement transmission housing: It has been degreased, bead blasted, and painted. It is the later style with snap ring bearing stops as was the one it is replacing.

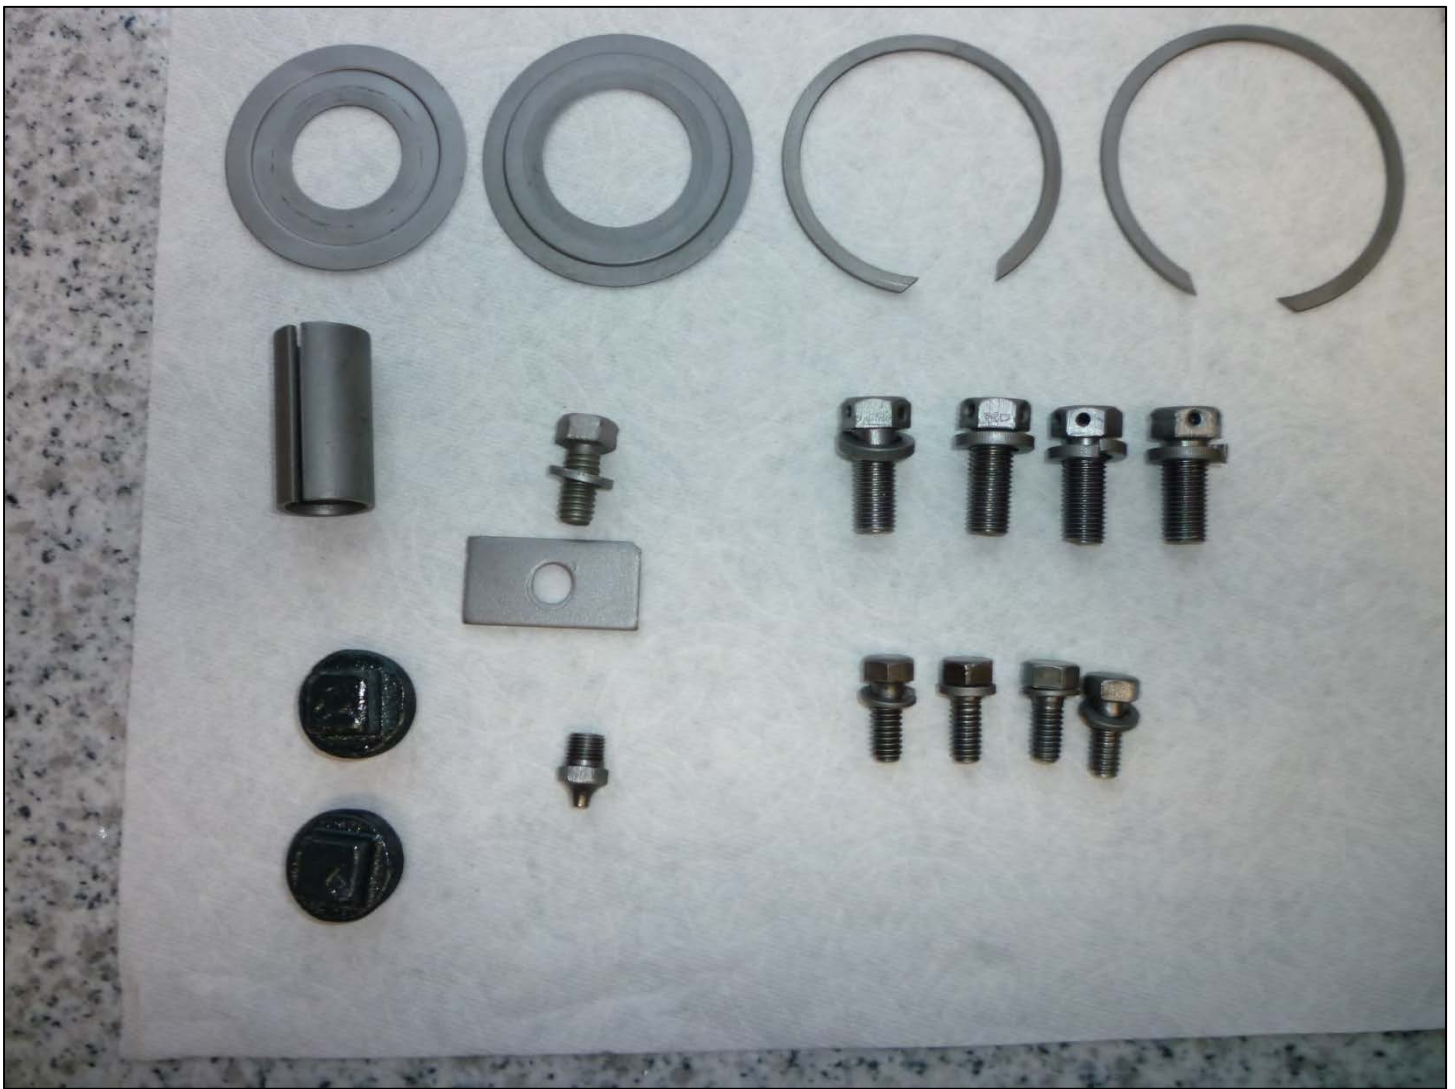
The miscellaneous parts have been degreased, bead blasted, and the threads of the bolts wire wheeled.

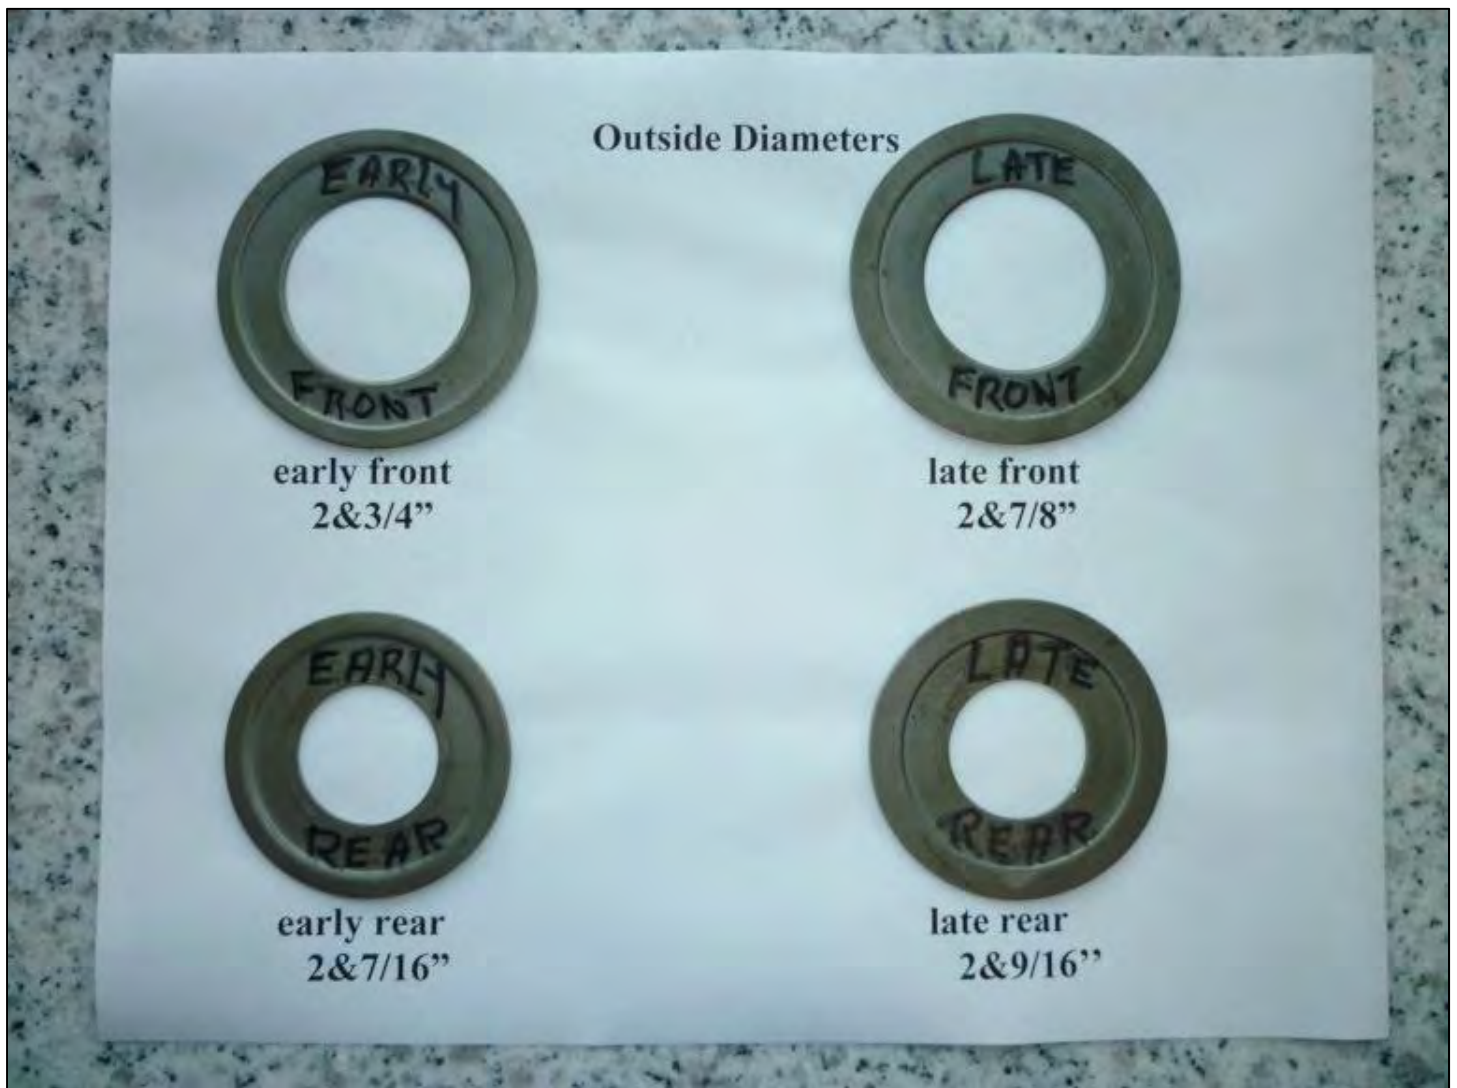
The first task in the assembly process is to press the front ball bearing onto the input shaft and the rear ball bearing onto the main shaft. Before doing this it must be determined which housing you are using, early or late.

If you are using an early housing that have bearing stops that are integral to the housing you should use the early oil baffles shown here in the left column of the photo. If you are using a late housing that has snap rings for bearing stops you should use oil baffles shown in the right column of the photo.

You can get away with using early baffles in a late transmission housing as they will not cause a problem. However, if you use late oil baffles in an early transmission housing it will jam up the transmission.

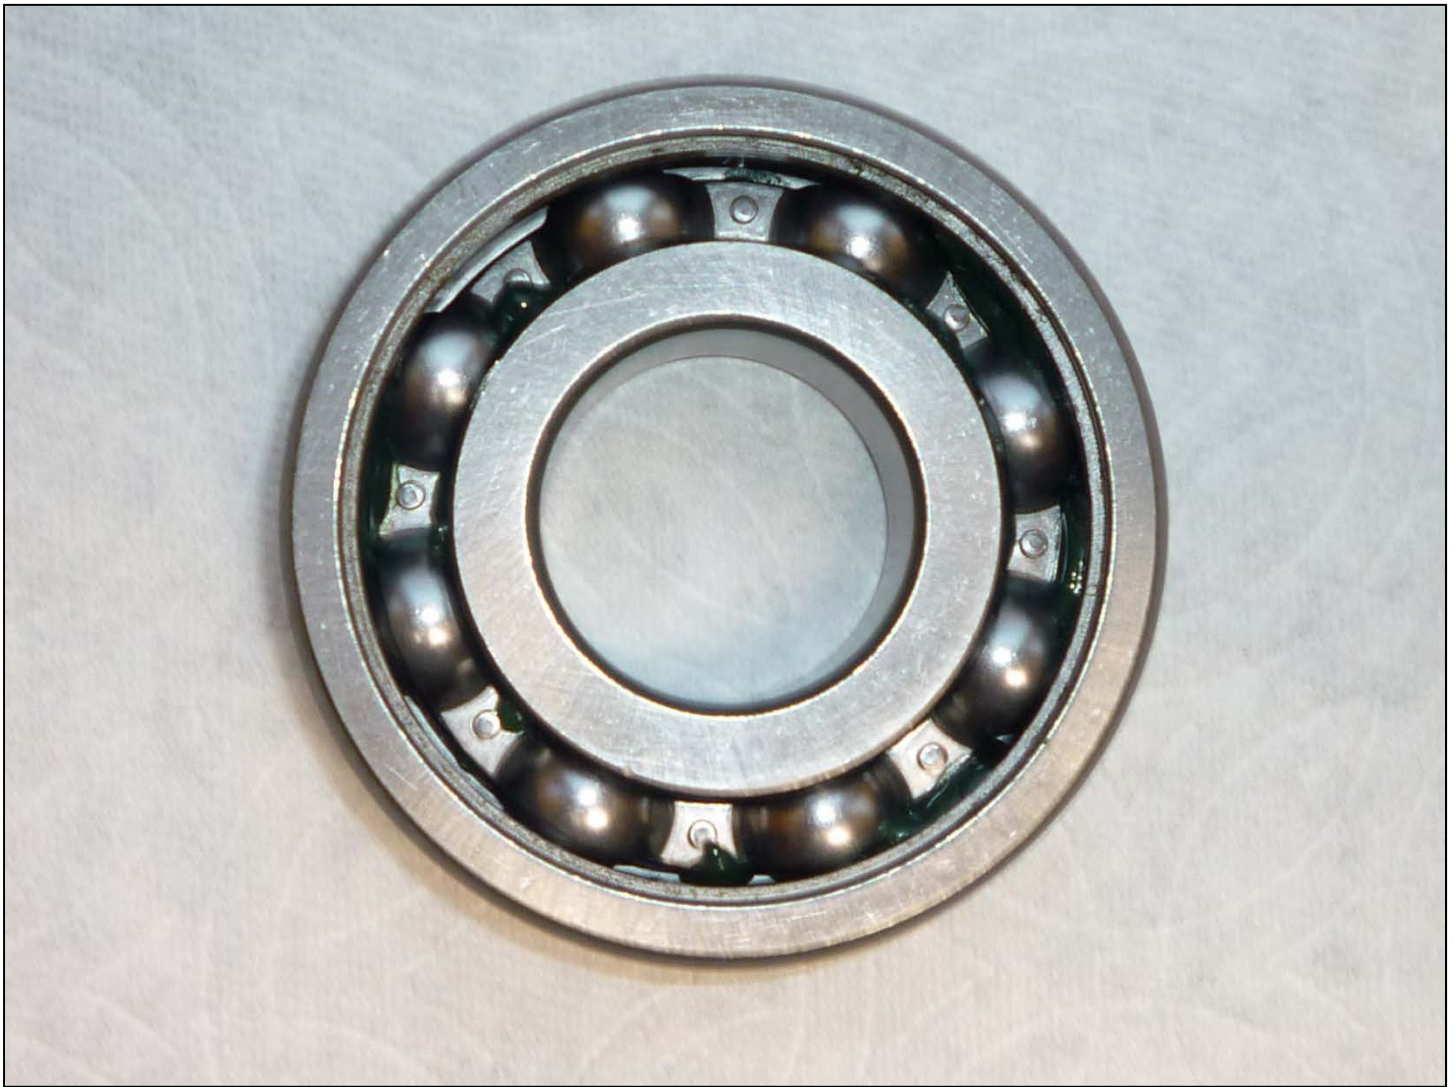
This is a close up of the rear bearing with the seal removed. Note there is very little grease applied by the manufacturer.

There are those who advocate that the seals should be retained on both sides, the theory being that it will keep out metallic wear particles that contaminate the oil.

I don't agree with this theory. I believe the bearing elements should receive continuous oil lubrication, and for that reason I always remove the seals from the inboard side of the bearings.

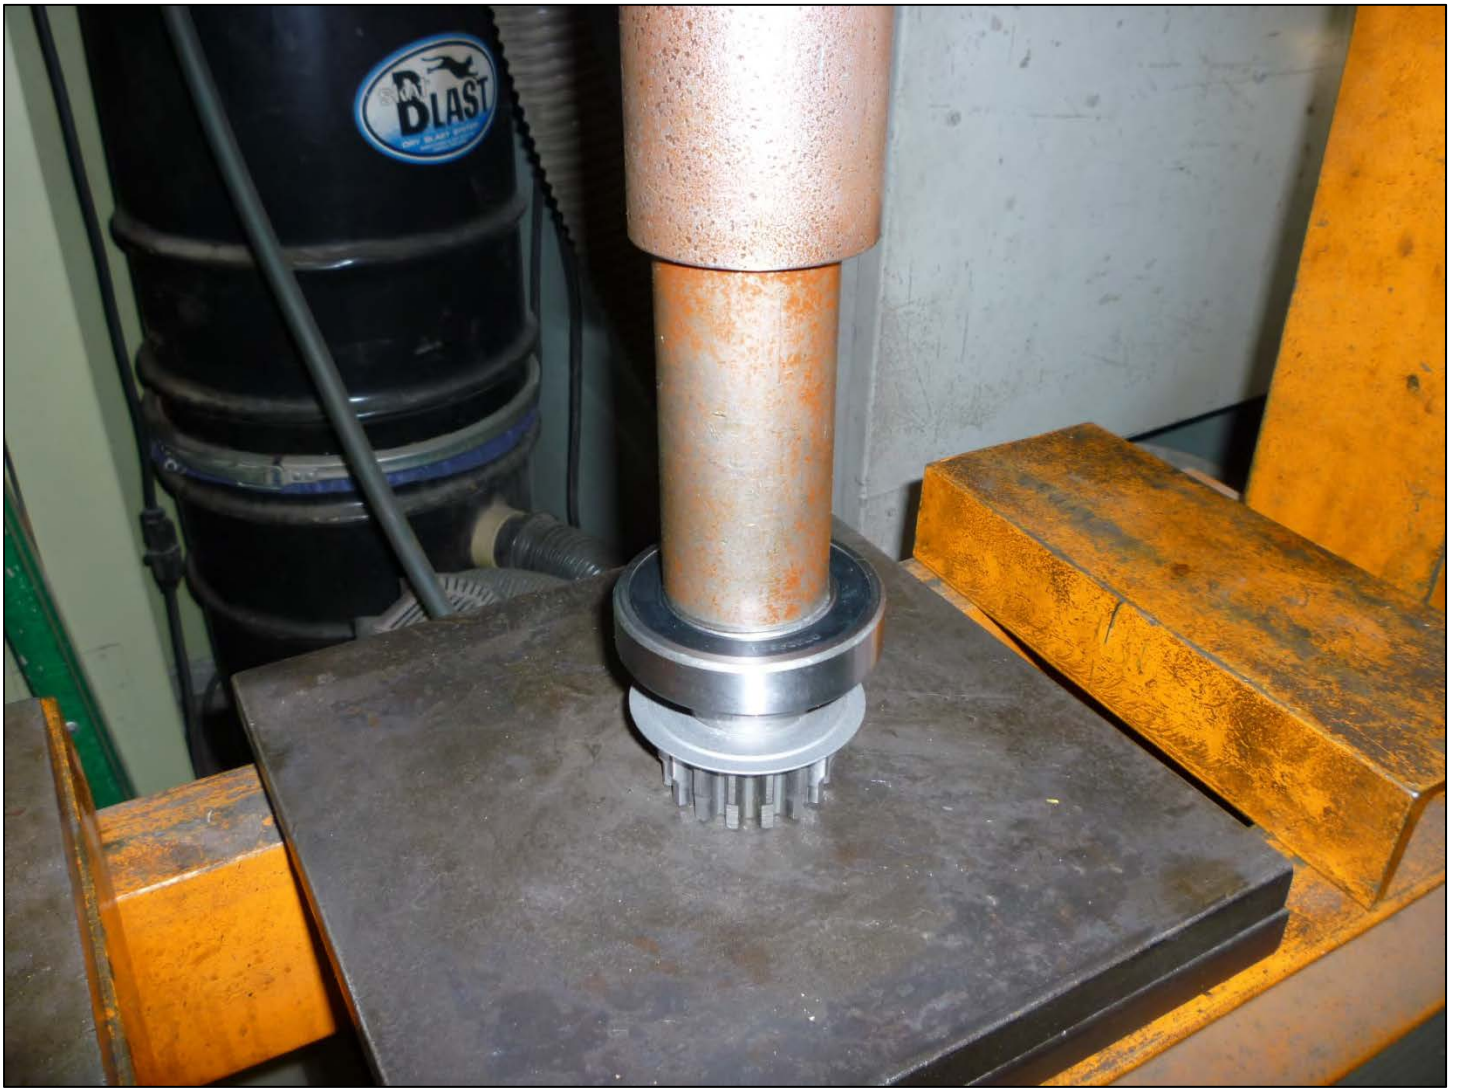
Shown here is the front ball bearing being pressed onto the input shaft. The oil baffle is put on first with the indent facing the bearing. The side of the bearing where the seal was removed is facing the oil baffle.

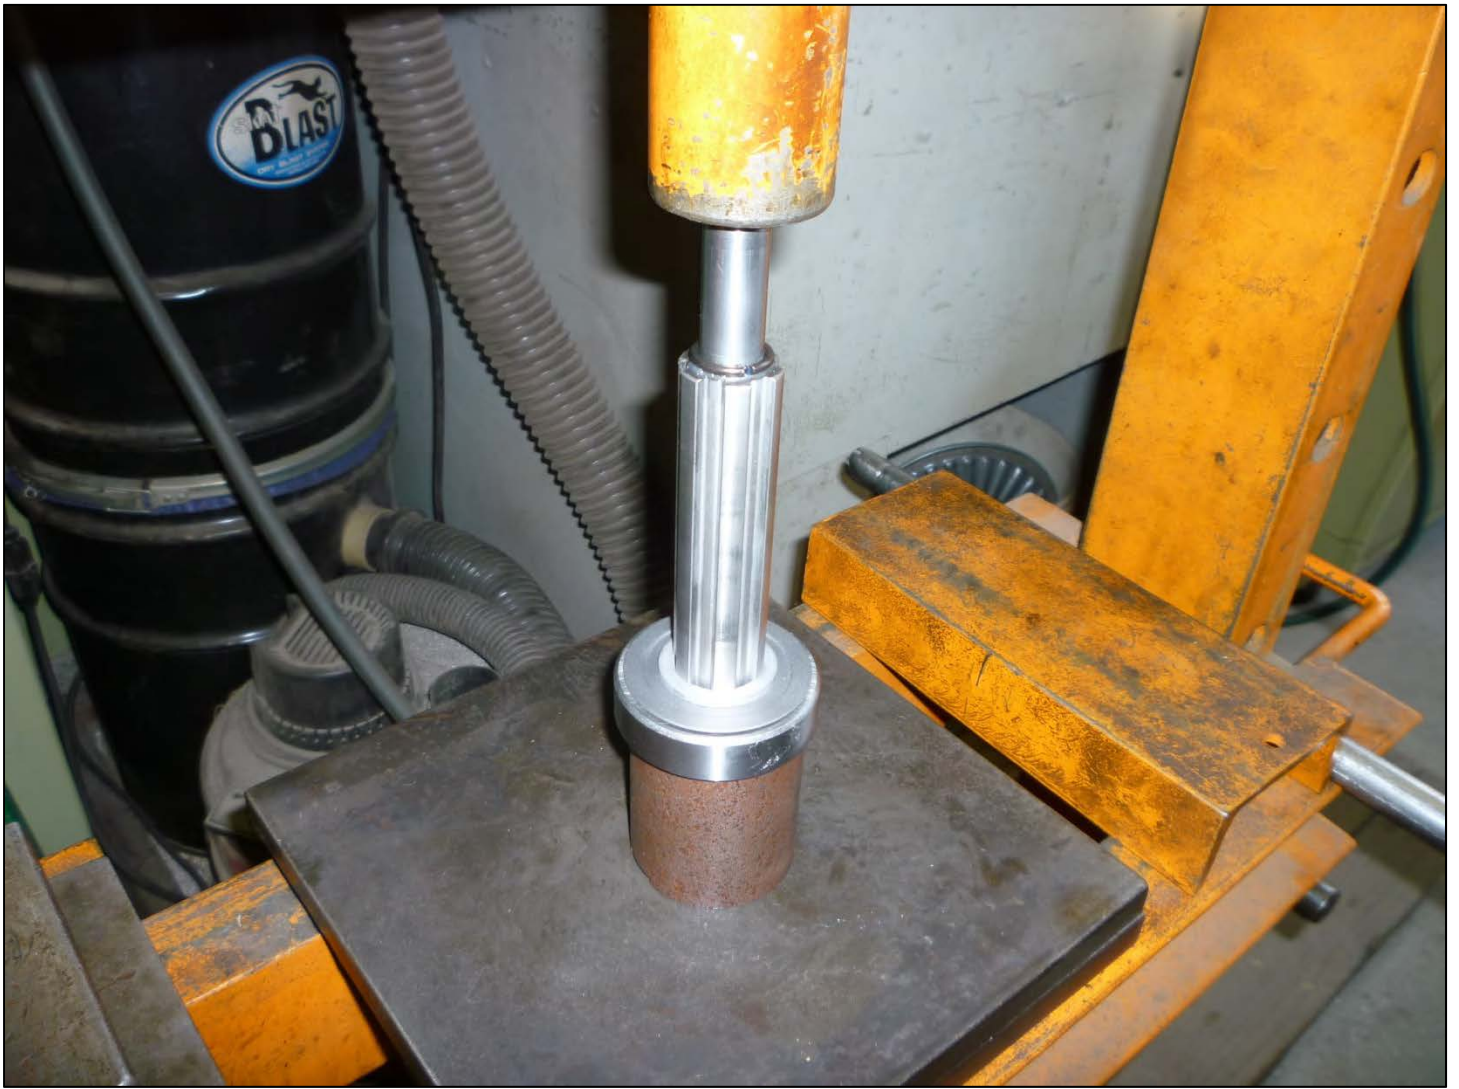
Shown here is the rear ball bearing being pressed onto the main shaft. The oil baffle has been put on first. The side of the bearing where the oil seal was removed is facing the baffle.

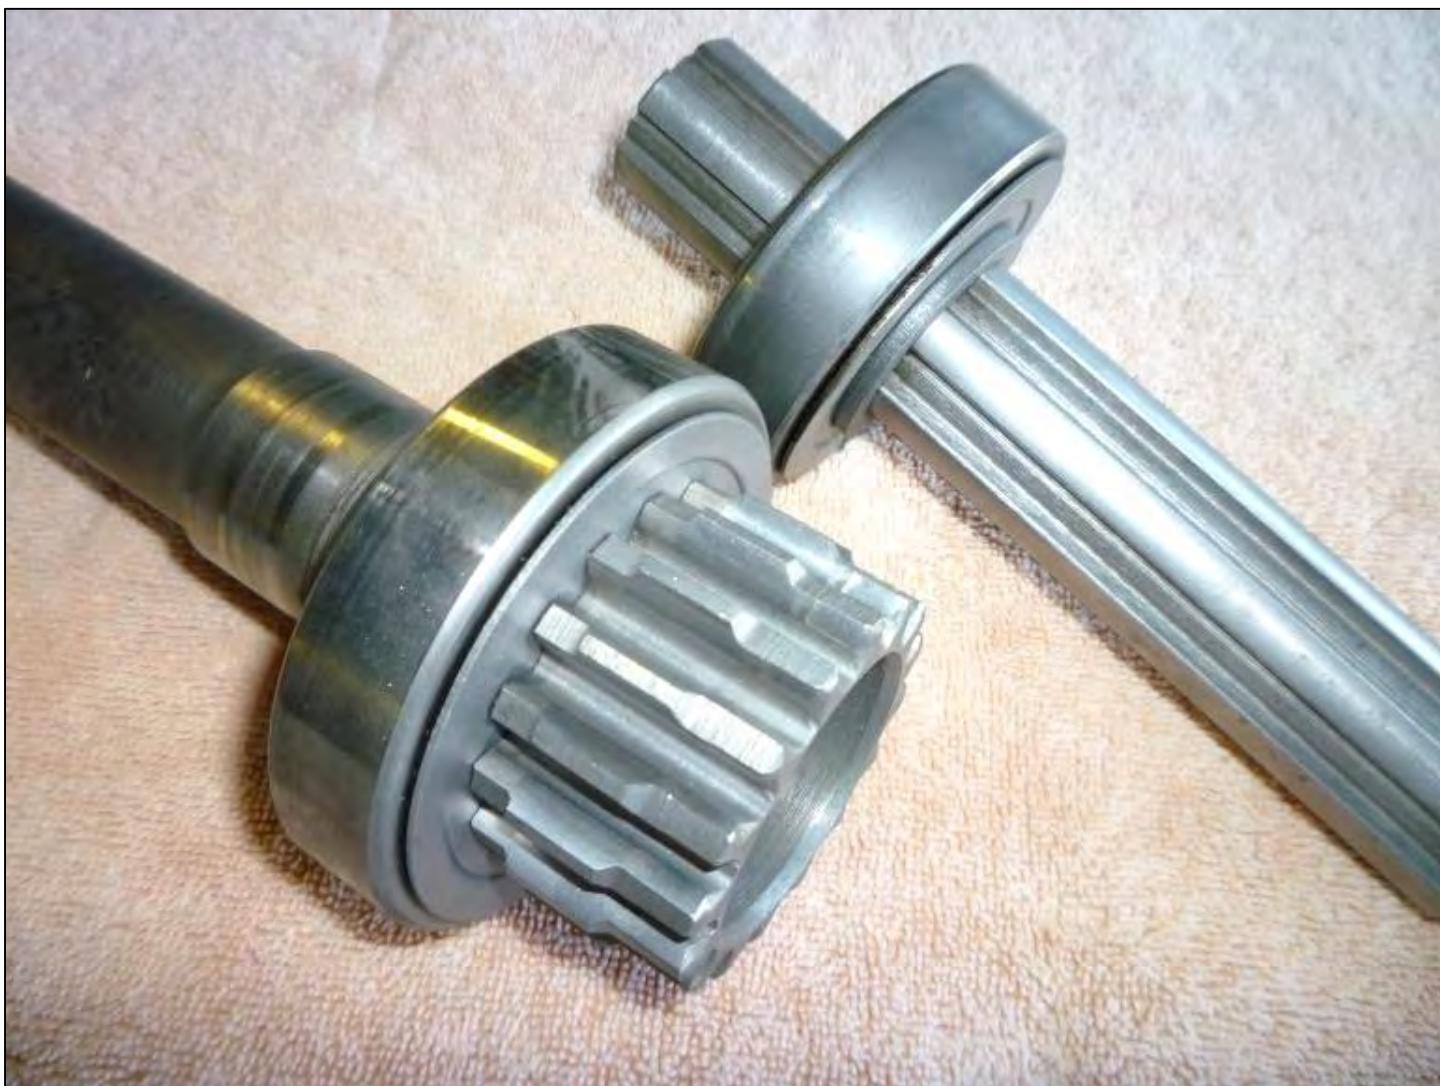
This photo shows the two bearings pressed onto both the input shaft and the main shaft. Note how there is about a 1\16” space between the oil baffle and the bearing. This is important; if the baffles had been put on backwards, as is often the case, the baffle would be jammed against the bearing and no oil would reach the bearing and metal would be continuously ground off the baffle as the bearing rotates.

If there is any distortion to the baffle that affects the spacing, slide a putty knife between the bearing and the baffle to straighten it out.

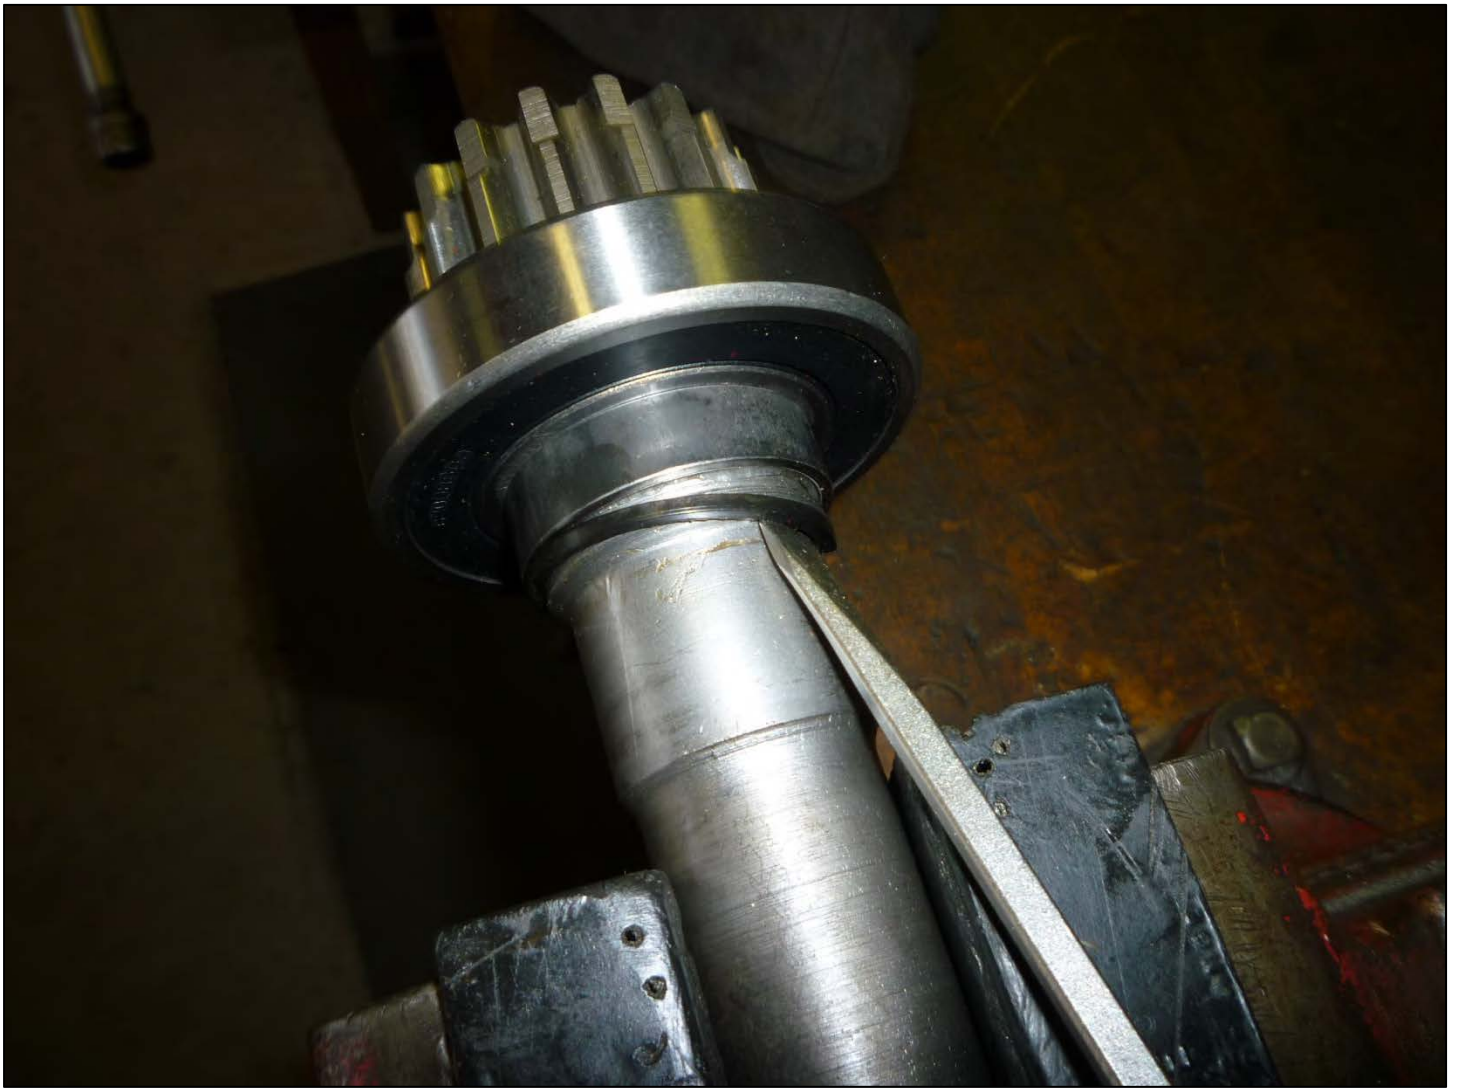
The sleeve and snap ring are slid onto the shaft and the shaft clamped in a vice. The snap ring is then worried into the groove in the shaft with a screwdriver.

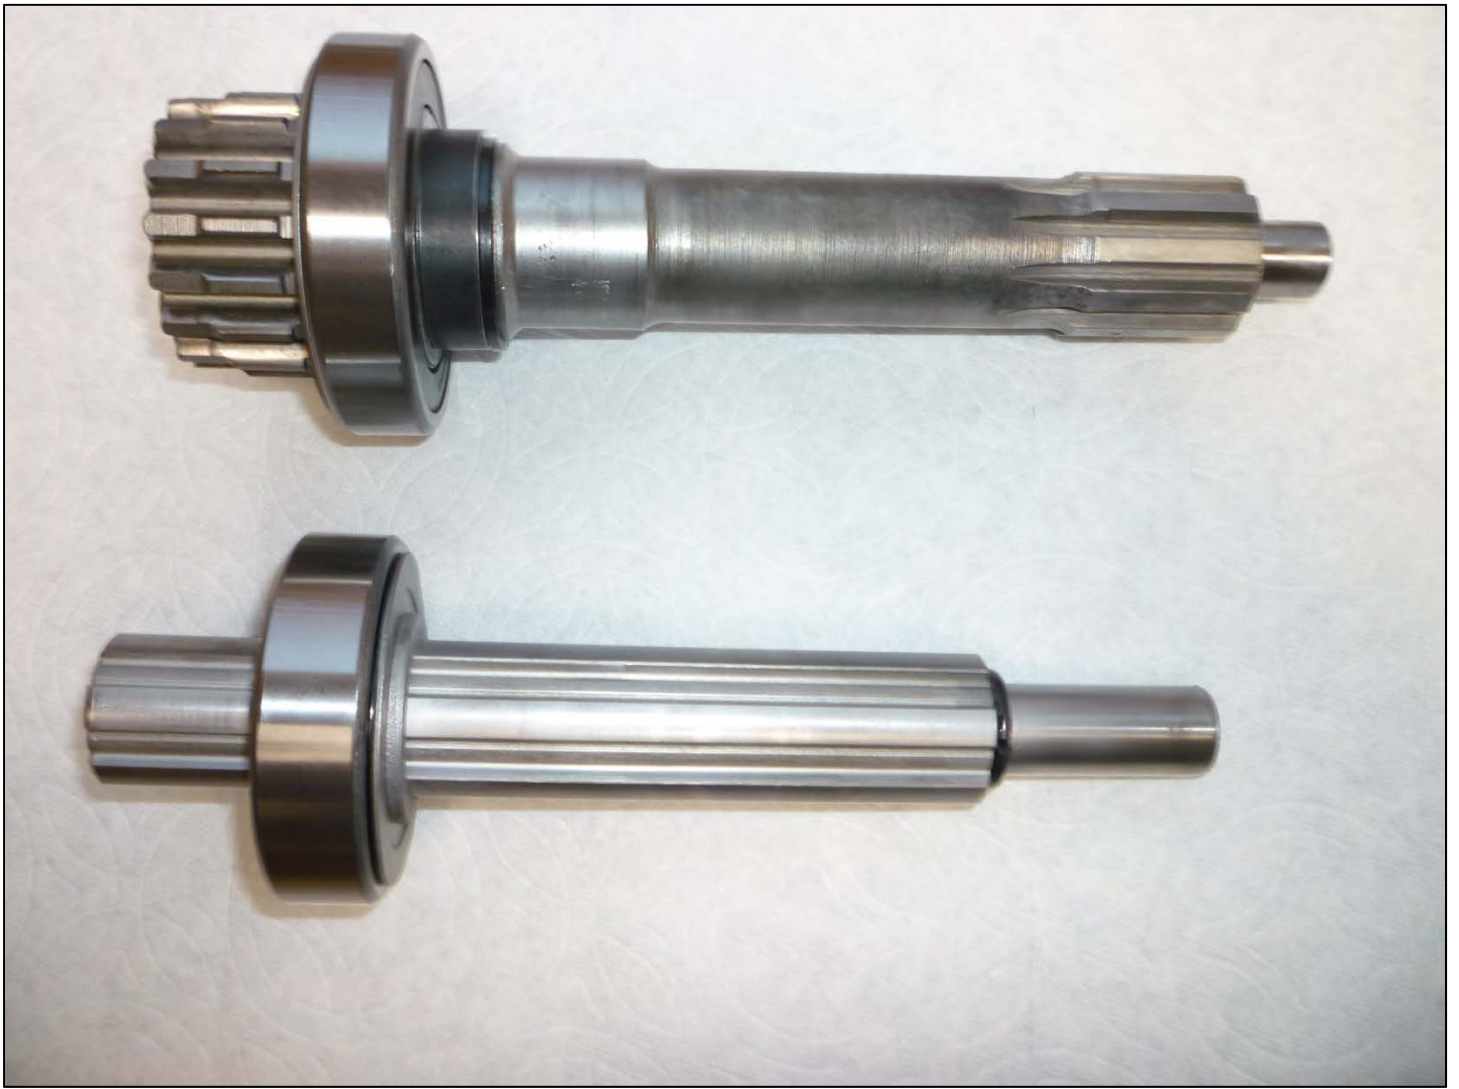
Both the input shaft and the main shaft are now ready to install in the transmission. However, they are temporarily set aside while other components are installed in the transmission.

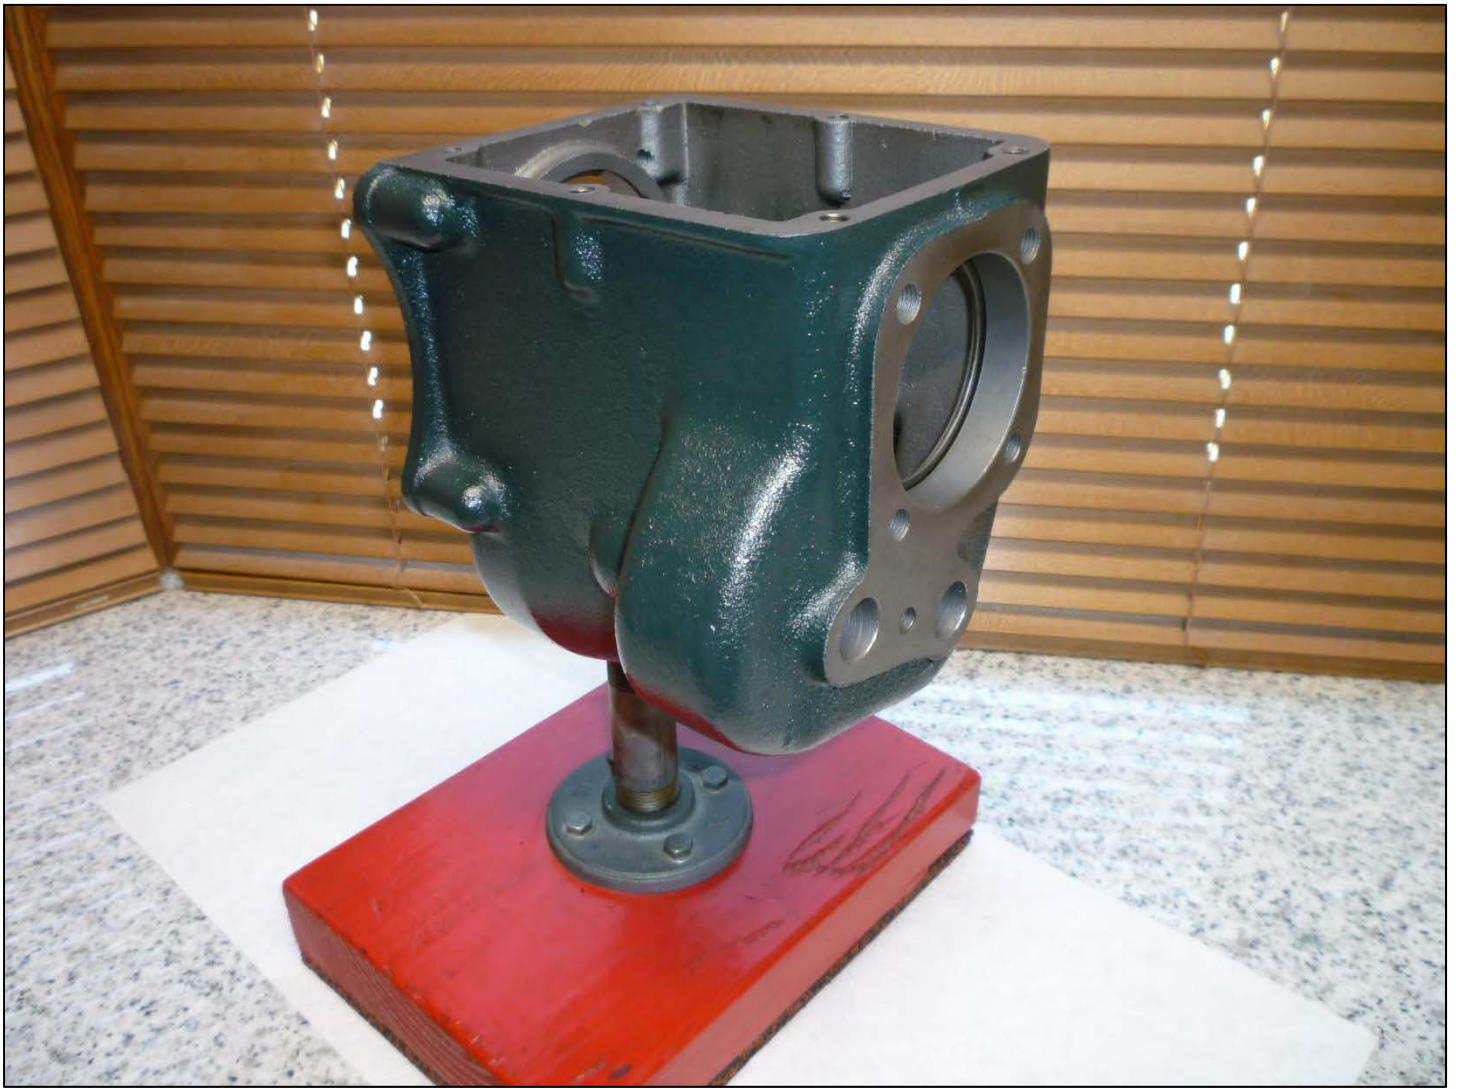
The new replacement cluster shaft and reverse idler shaft both have been modified to provide O-ring seals to the rear of the transmission housing.

Model A Ford transmissions are notorious for leaking oil out the back of the transmission at both shafts. The O-ring mod will eliminate the leaks at the two shafts.

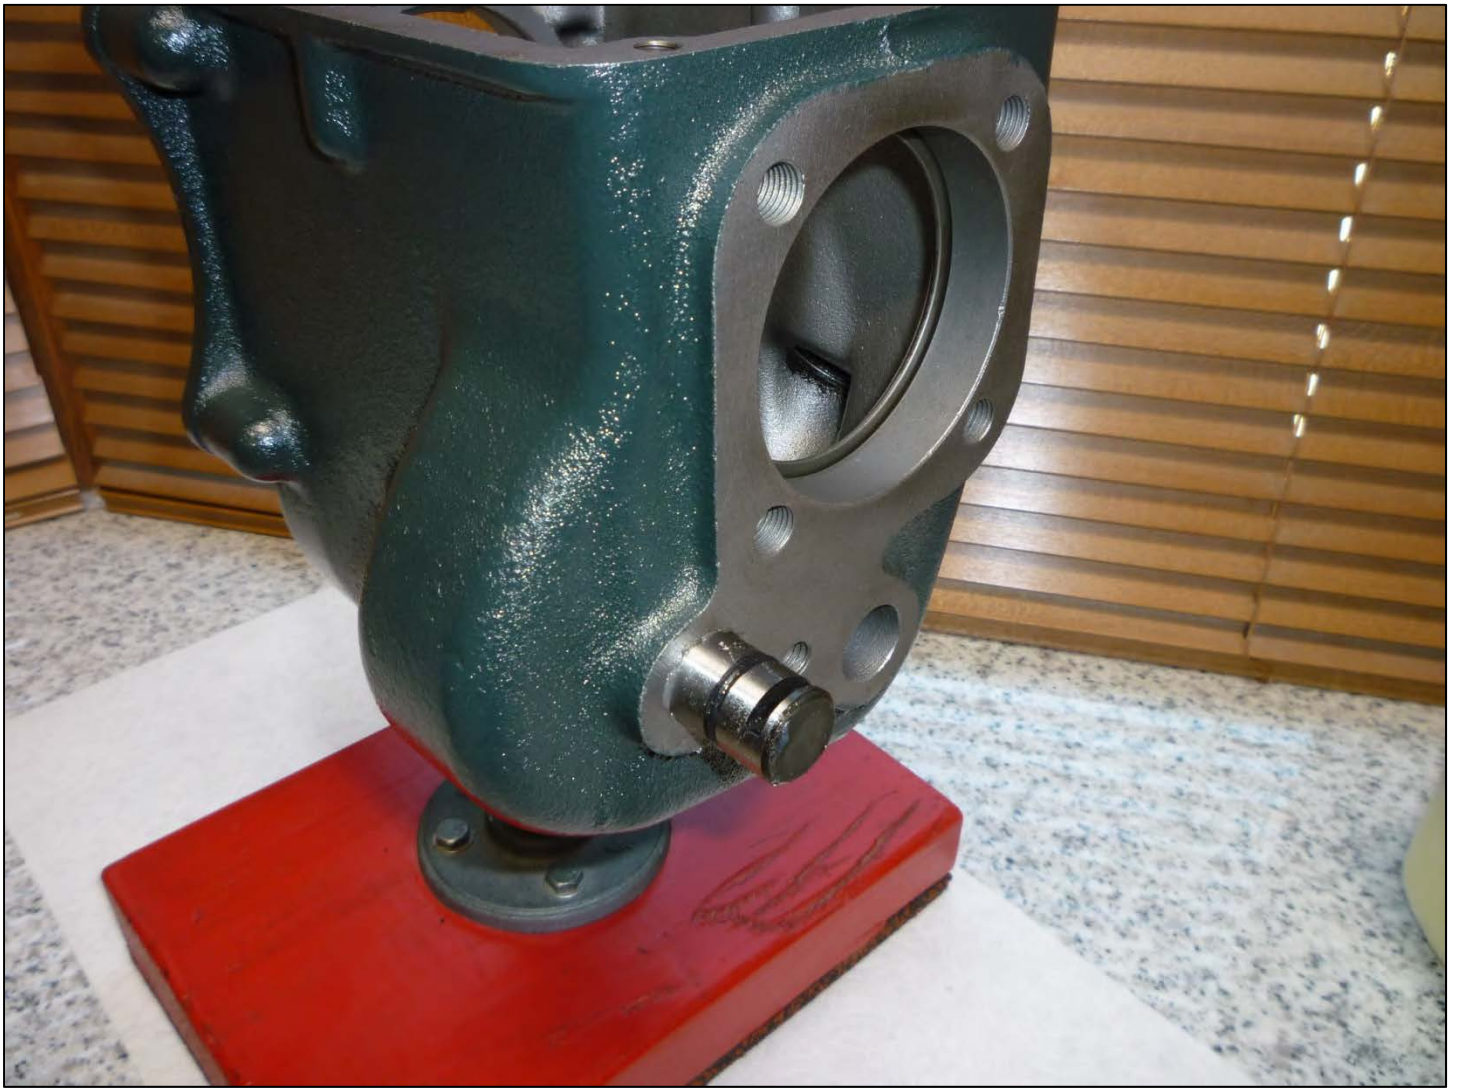
Coat the reverse idler shaft and O-ring with Vaseline and slide it into the shaft hole part way. Place the reverse idler gear inside the transmission housing and slip it over the shaft.
