Transmission Overhaul Pictorial August 2018

by Tom Endy

The Model A transmission is not difficult to overhaul. It can be done with simple hand tools. However you do need a shop press to remove and install the front and rear ball bearings. There are some areas that can cause grief unless you are aware of some subtle differences in the evolution of the design. In addition, there are also some parts that can easily be installed incorrectly.

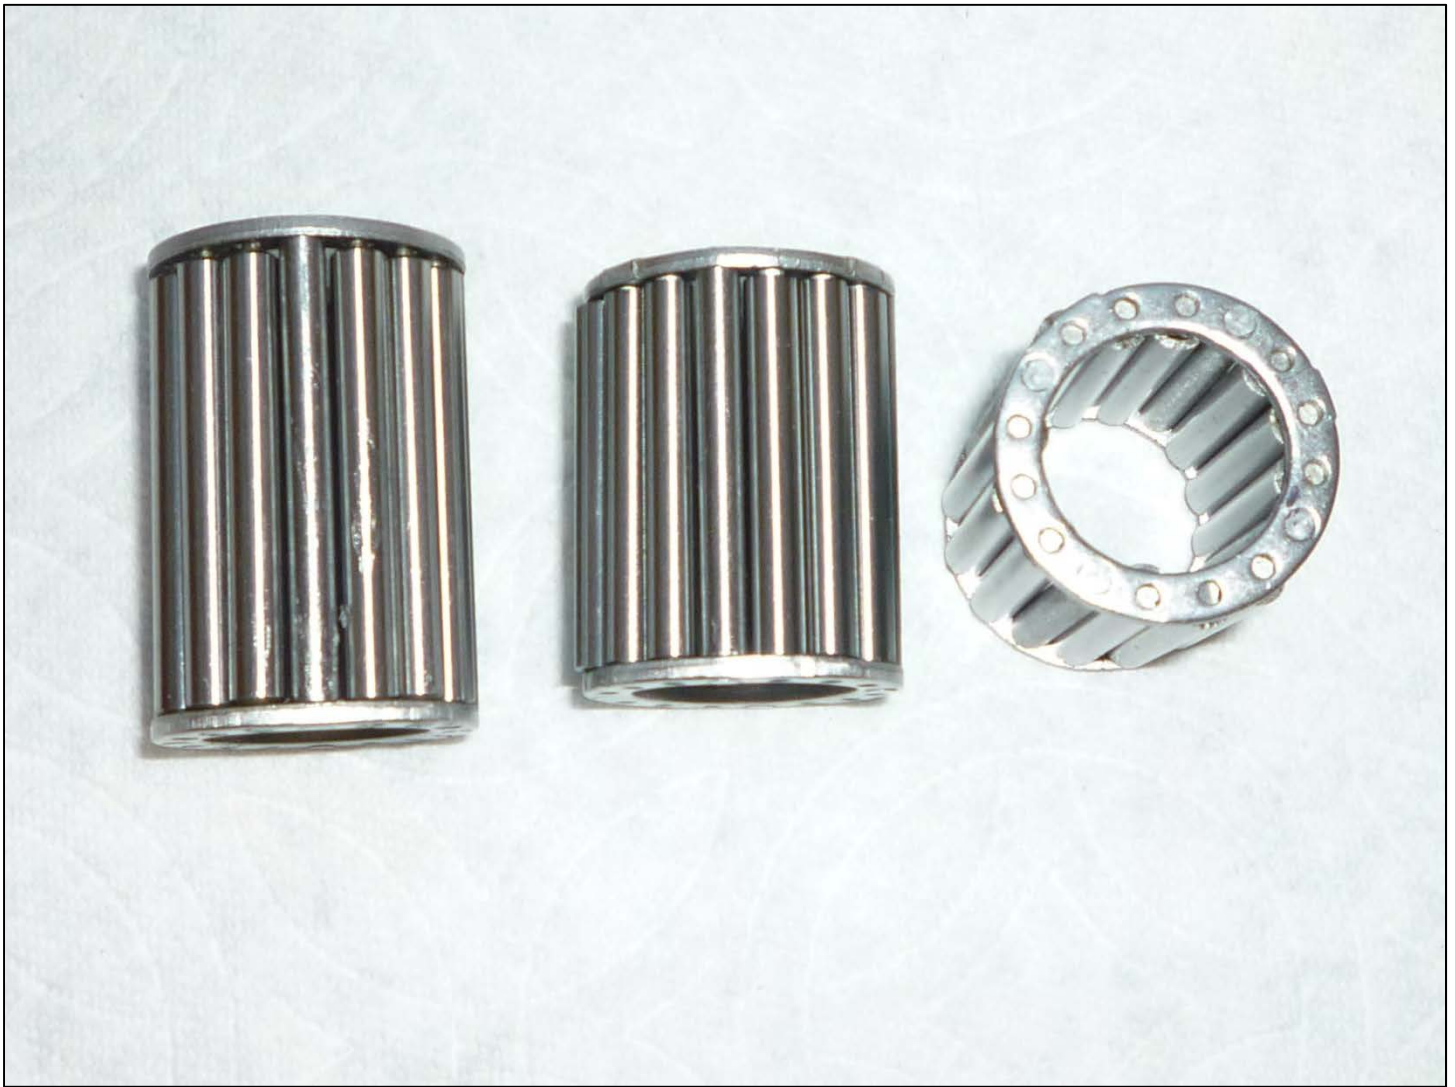
This is a close up of a roller bearing from Bratton's Antique Auto that shows how it is constructed. Each bearing element has a small axle at each end that fits through holes drilled into each end of substantial end cages.

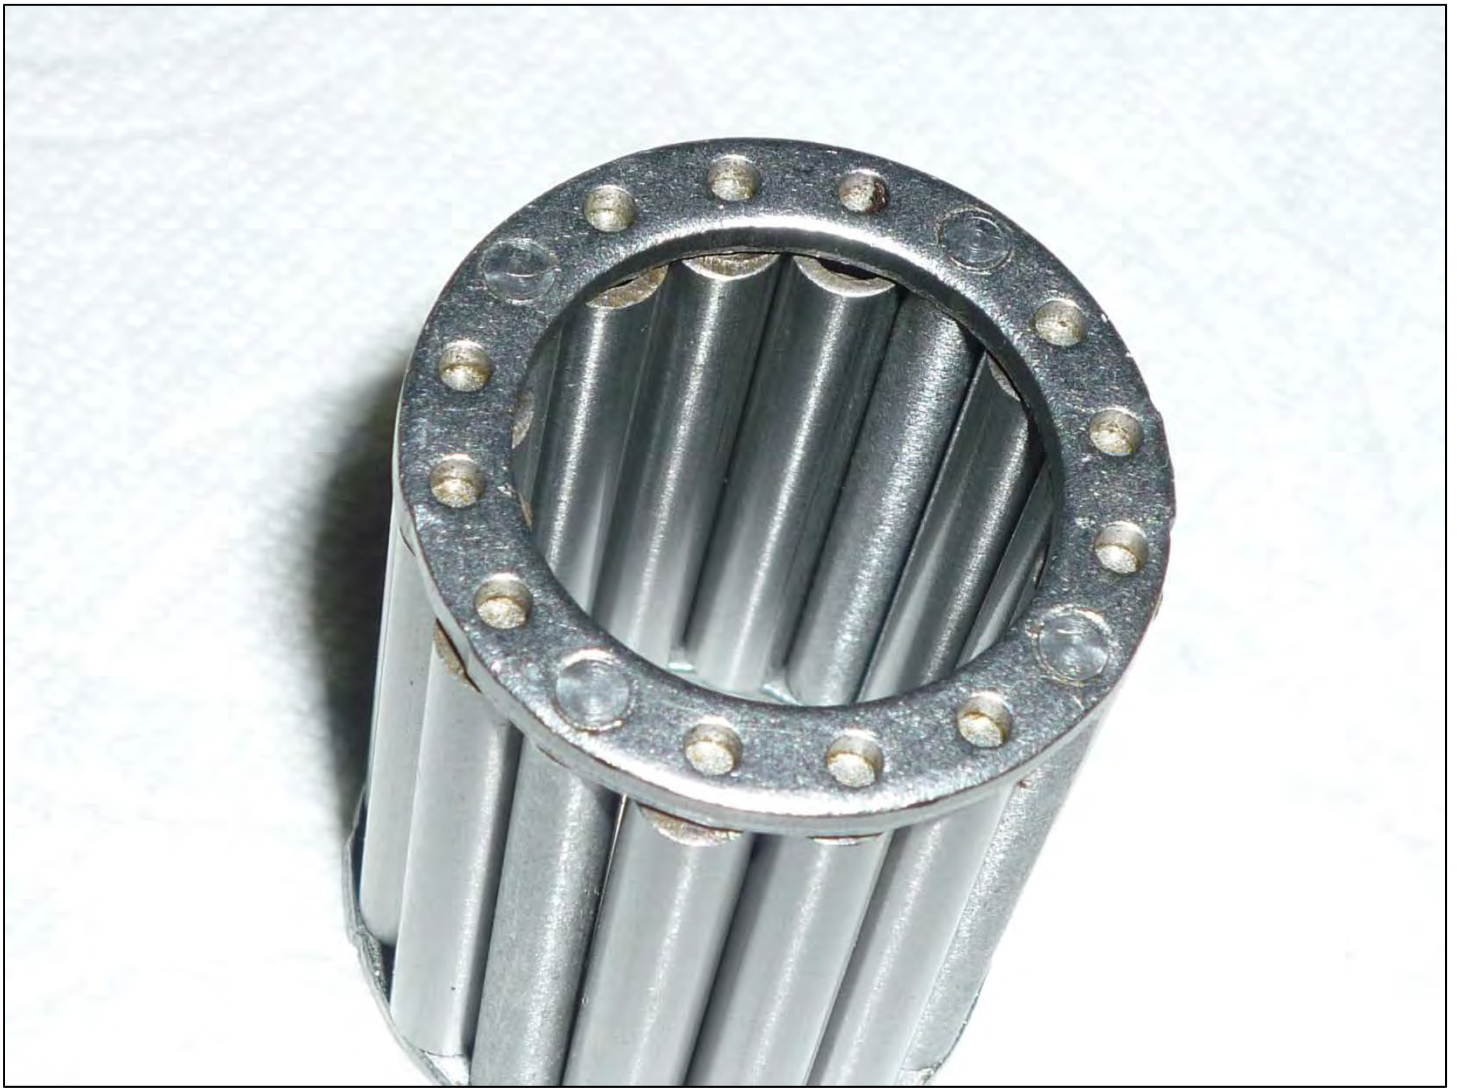
The cluster shaft assembly is installed next. This photo shows the orientation of the bearings and spacer that fit inside the cluster gear, Note that the longer of the two roller bearings goes in at the rear of the cluster gear (the smaller end).

The shaft must install from the front of the transmission housing as the shaft hole in the front of the case is .001 larger than the one at the rear. This was supposed to fit the shaft tight at the rear and control oil leakage. However, it didn't do a very good job.

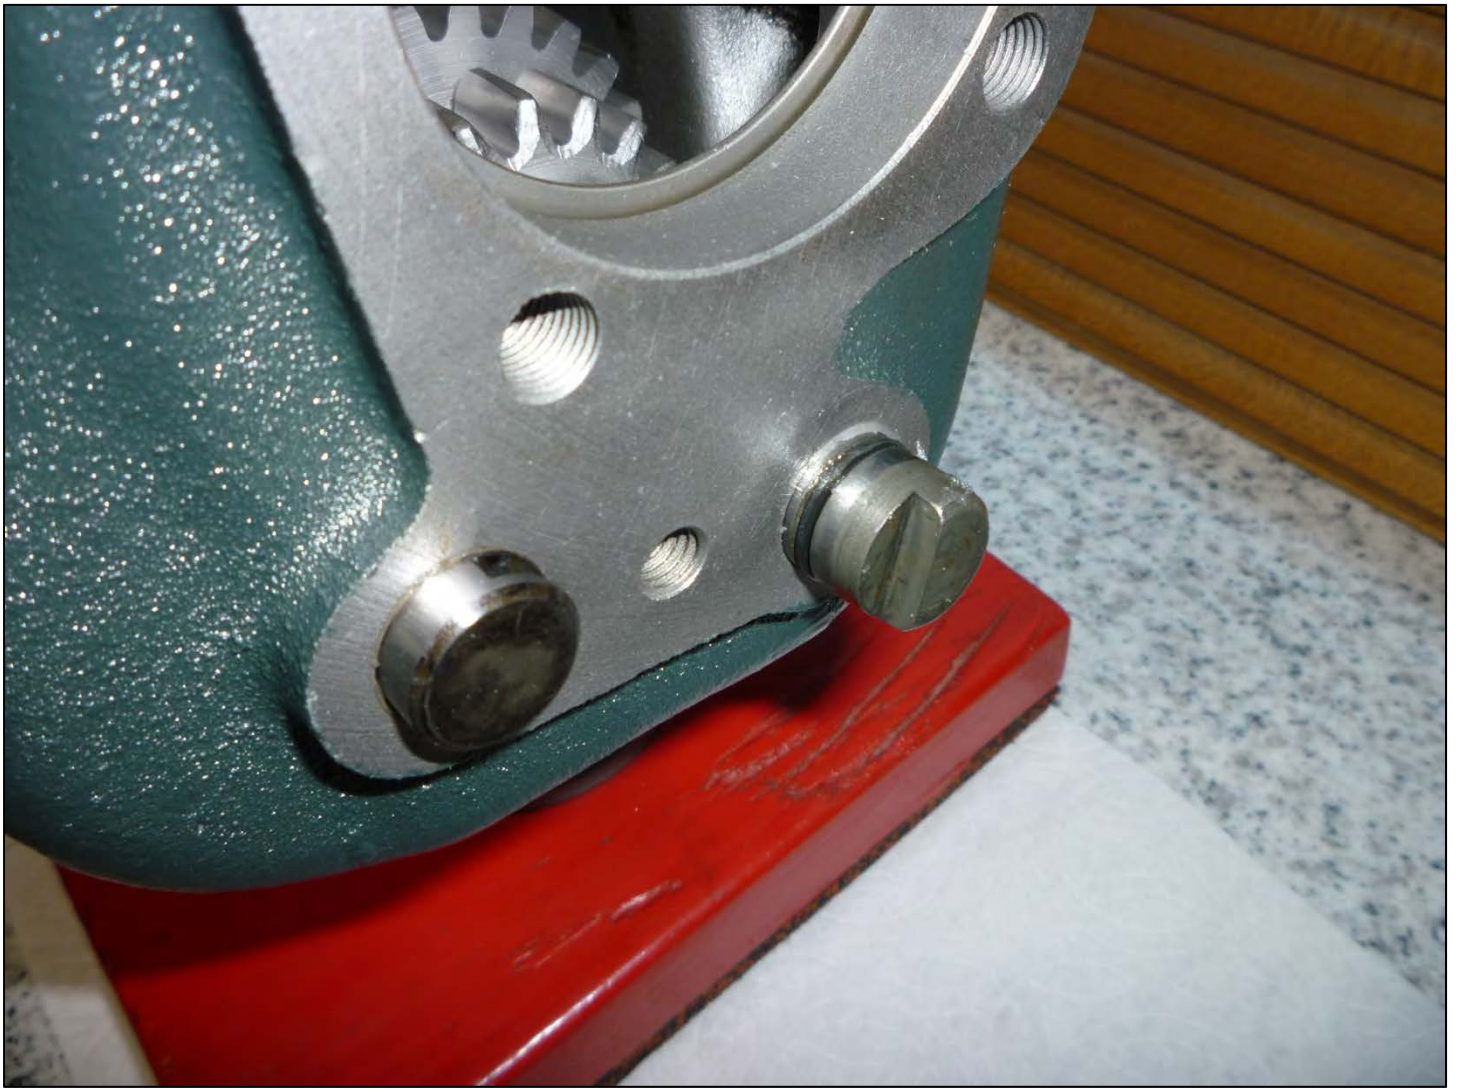
Push the cluster shaft through the transmission case until it protrudes a small distance past the end so that the O-ring can be installed.

Tap the shaft back into place after the O-ring has been reinstalled.

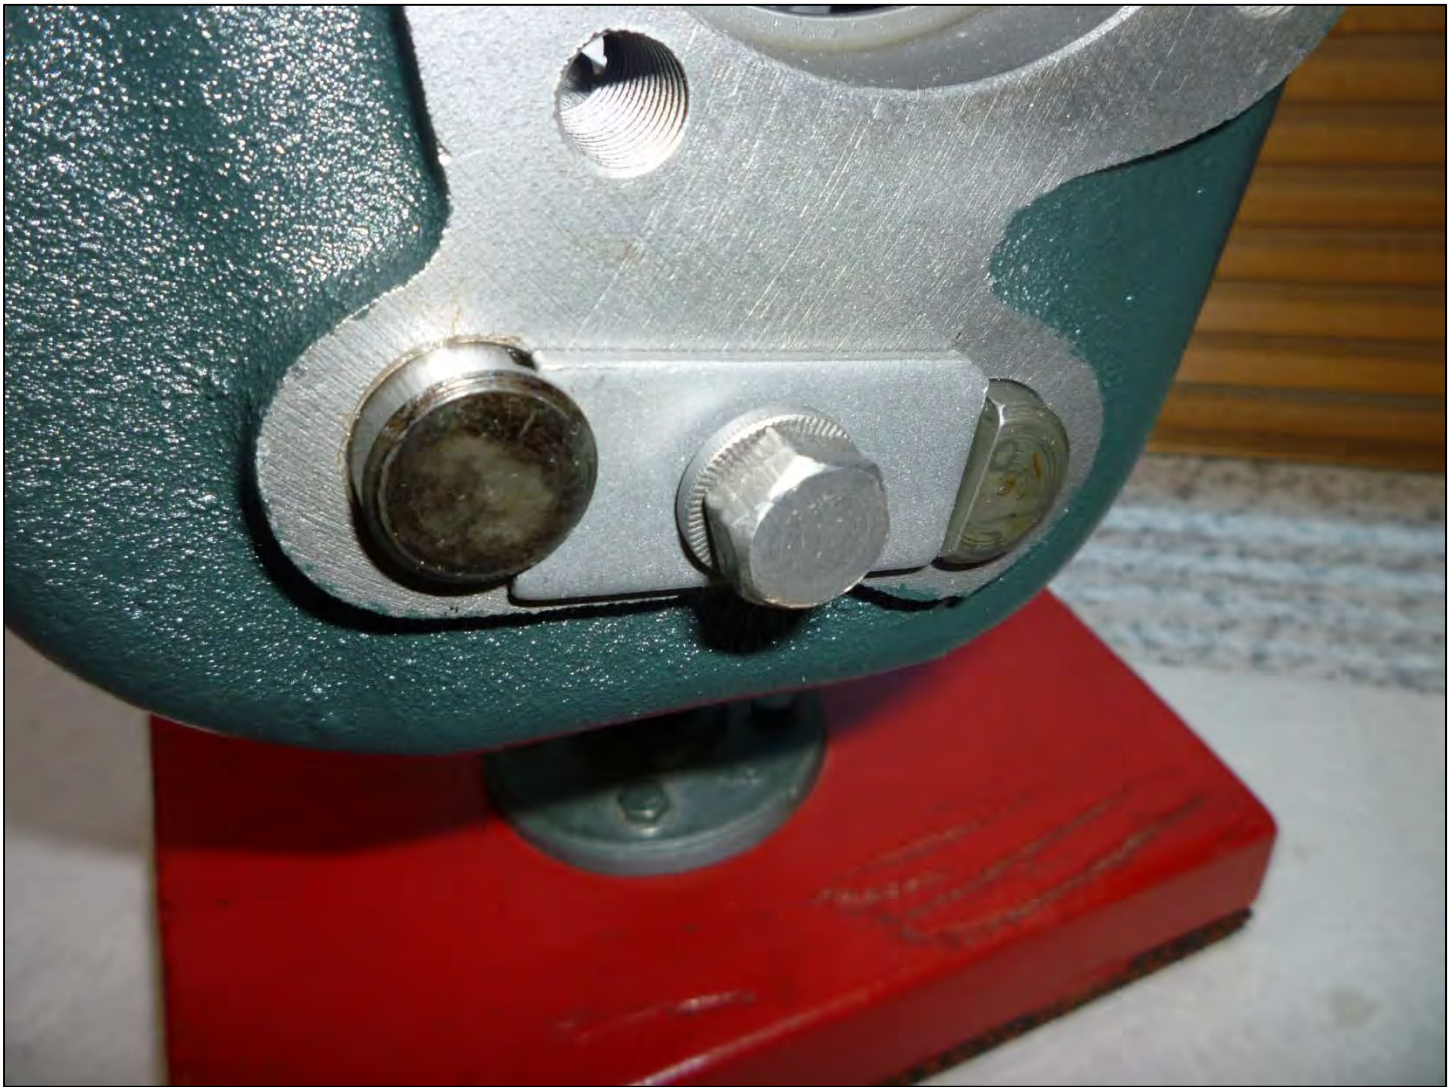
Install the bolt and retainer to secure the two shafts and prevent them from rotation. Apply some sealer to the threads of the bolt to prevent transmission oil from migrating past the threads.

It is important that the correct length bolt be installed. The early shafts were retained with a 3/16 inch thick retainer. The length of the bolt used was one inch long. A change to the shaft requires a retainer that is only 1/16 inch thick. As a result the length of the bolt was reduced to 3/4 inch long. The photo shows the later configuration on the left, the early on the right. Suppliers only supply the later configure cluster shaft. This will require the use of the thinner 1/16 inch thick retaining. When overhauling a transmission you may find the early retainer. It is therefore prudent to locate a 3/4 inch bolt or cut a quarter inch off the original one inch bolt, as the longer bolt may constrict with the reverse idler gear.

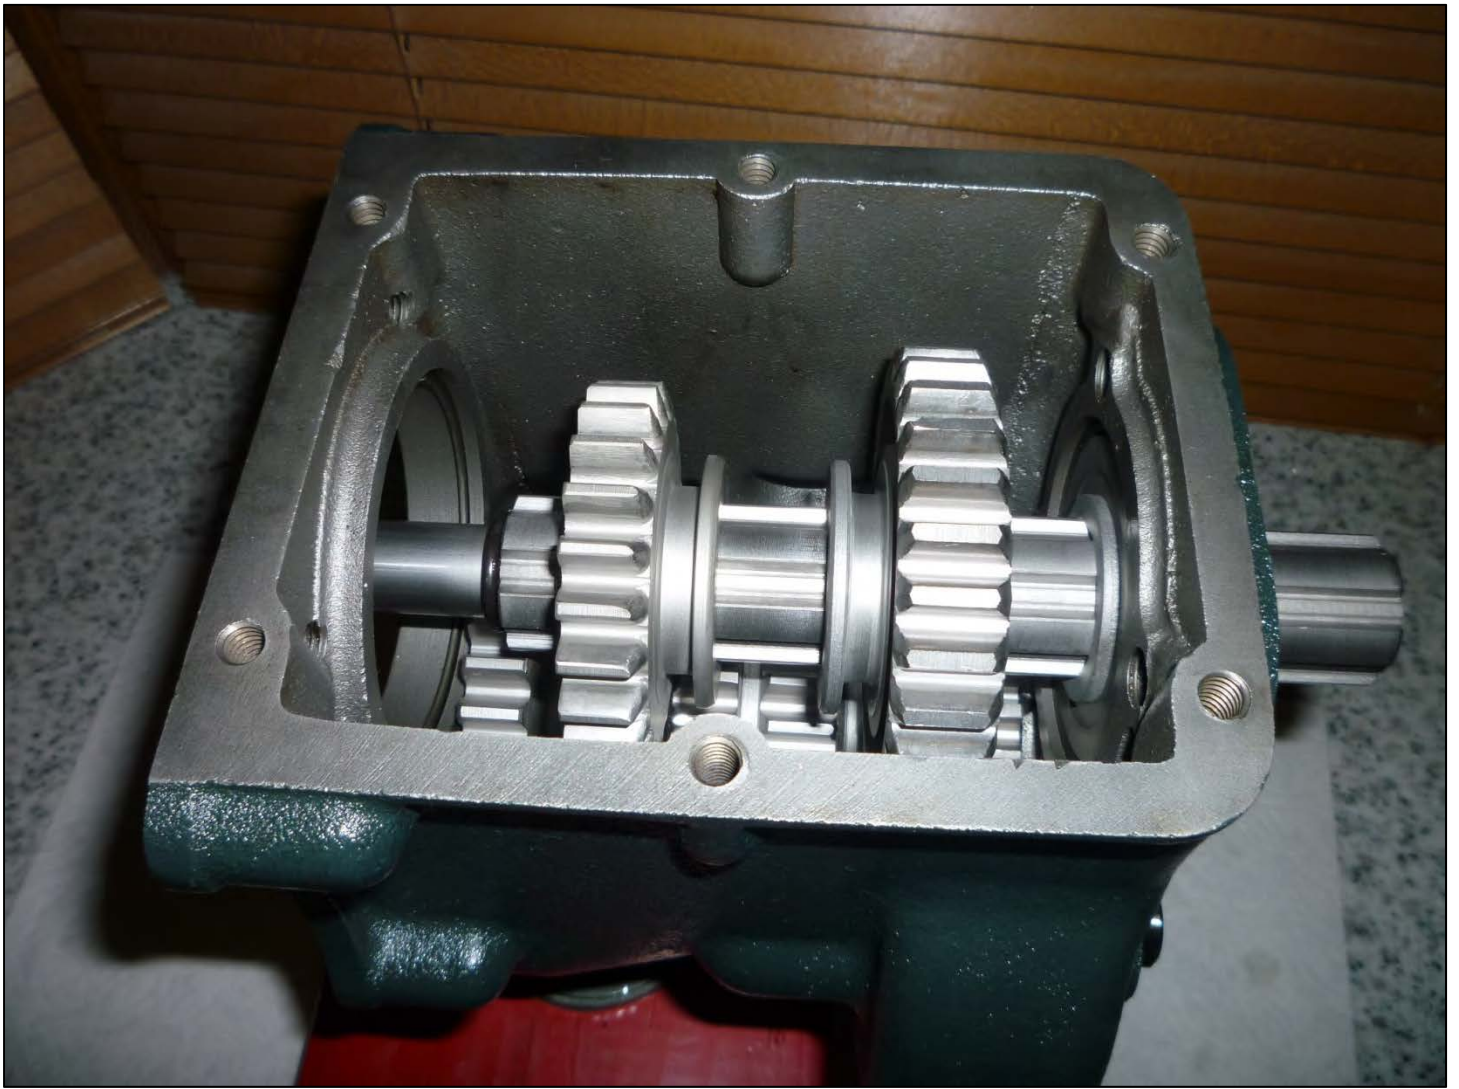
Shown here, the main shaft has been installed with the two slider gears riding on the spline of the shaft. Once the assembly is inside the housing push the rear bearing until it seats into the recess in the housing for the bearing and up against the snap ring.

With your fingers move the two slider gears to the neutral position as shown in the photo.

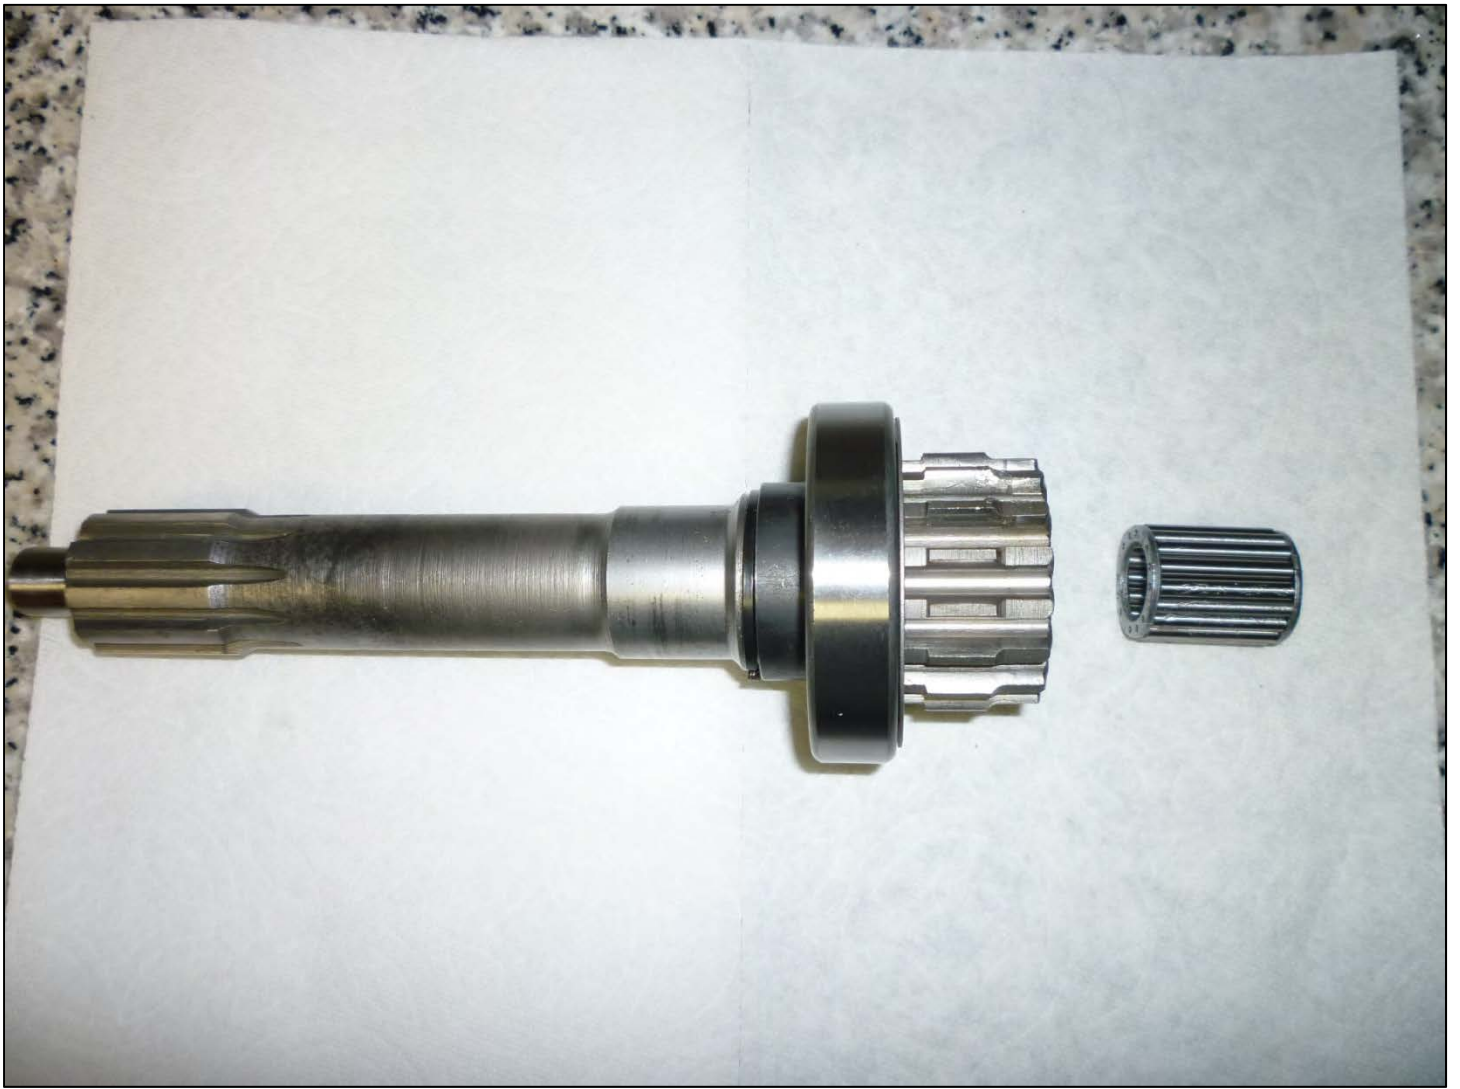
Put some oil on a short roller bearing and insert it into the gear end of the input shaft.
